OCS Study BOEM 2020-019

Seafloor Disturbance and Recovery Monitoring at the Block Island Wind Farm, Rhode Island – Summary Report

March 2020

Prepared under BOEM Award Contract No. M15PC00002 Task Order No. M17PD00015 By HDR 9781 S Meridian Boulevard, Suite 400 Englewood, CO 80112

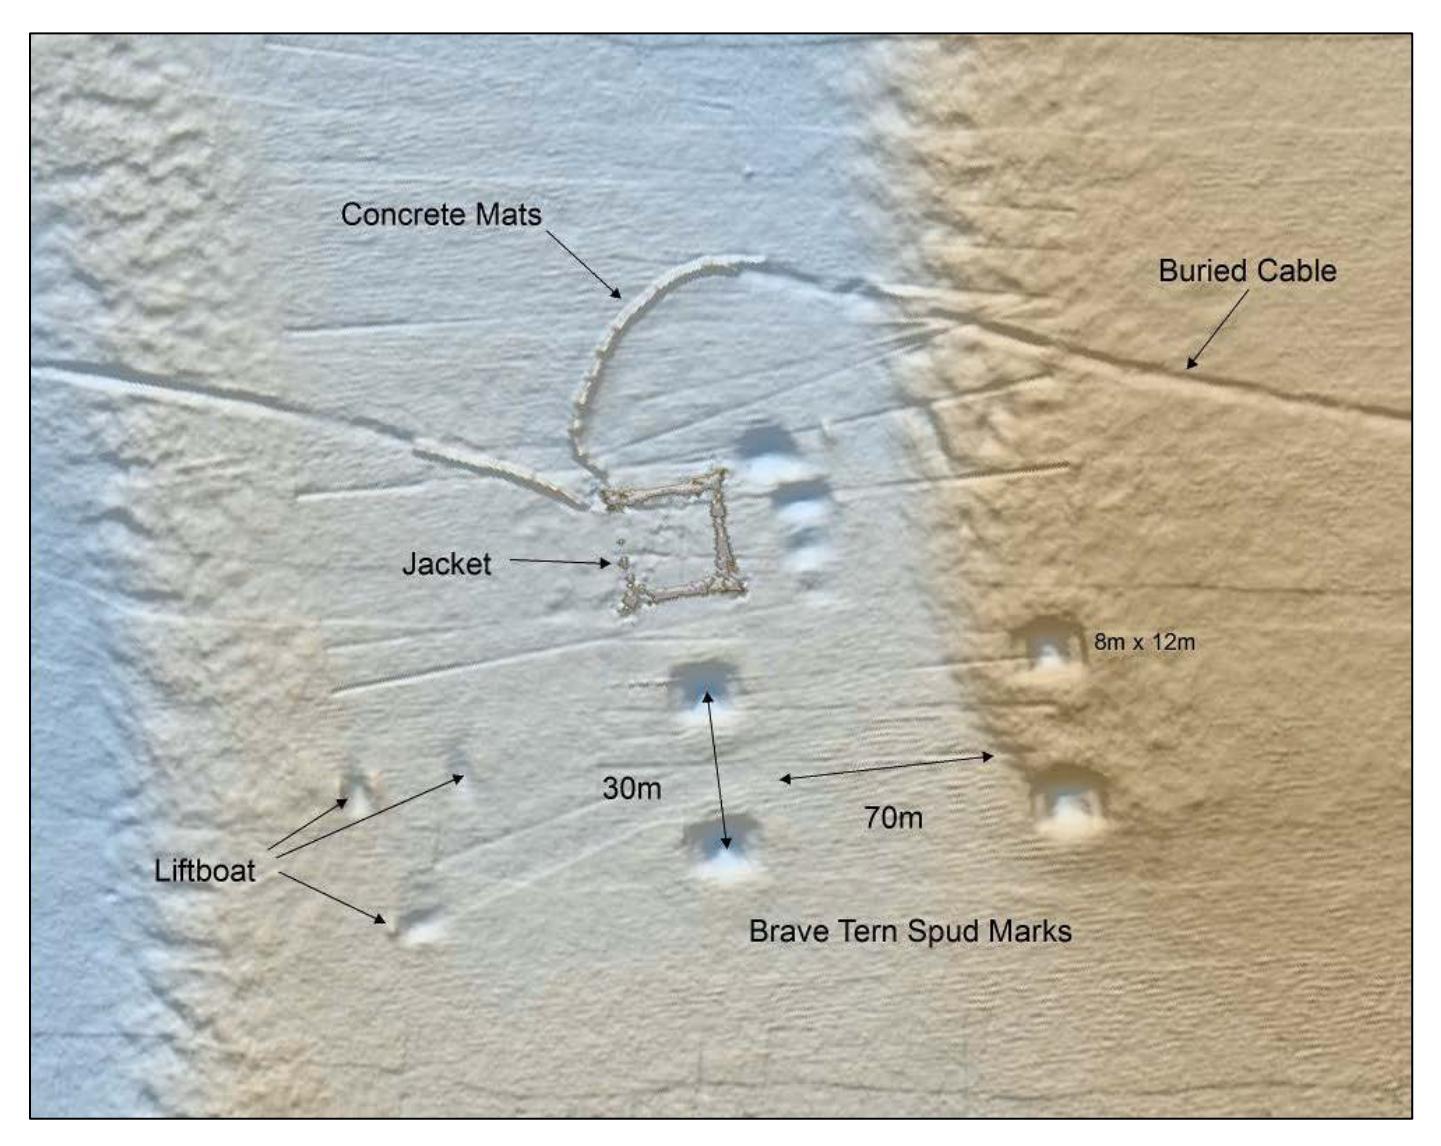
Figure 3. Examples of seafloor disturbance features. Note: Features shown in Figure 3 were observed near Turbine 4 during Survey 2.

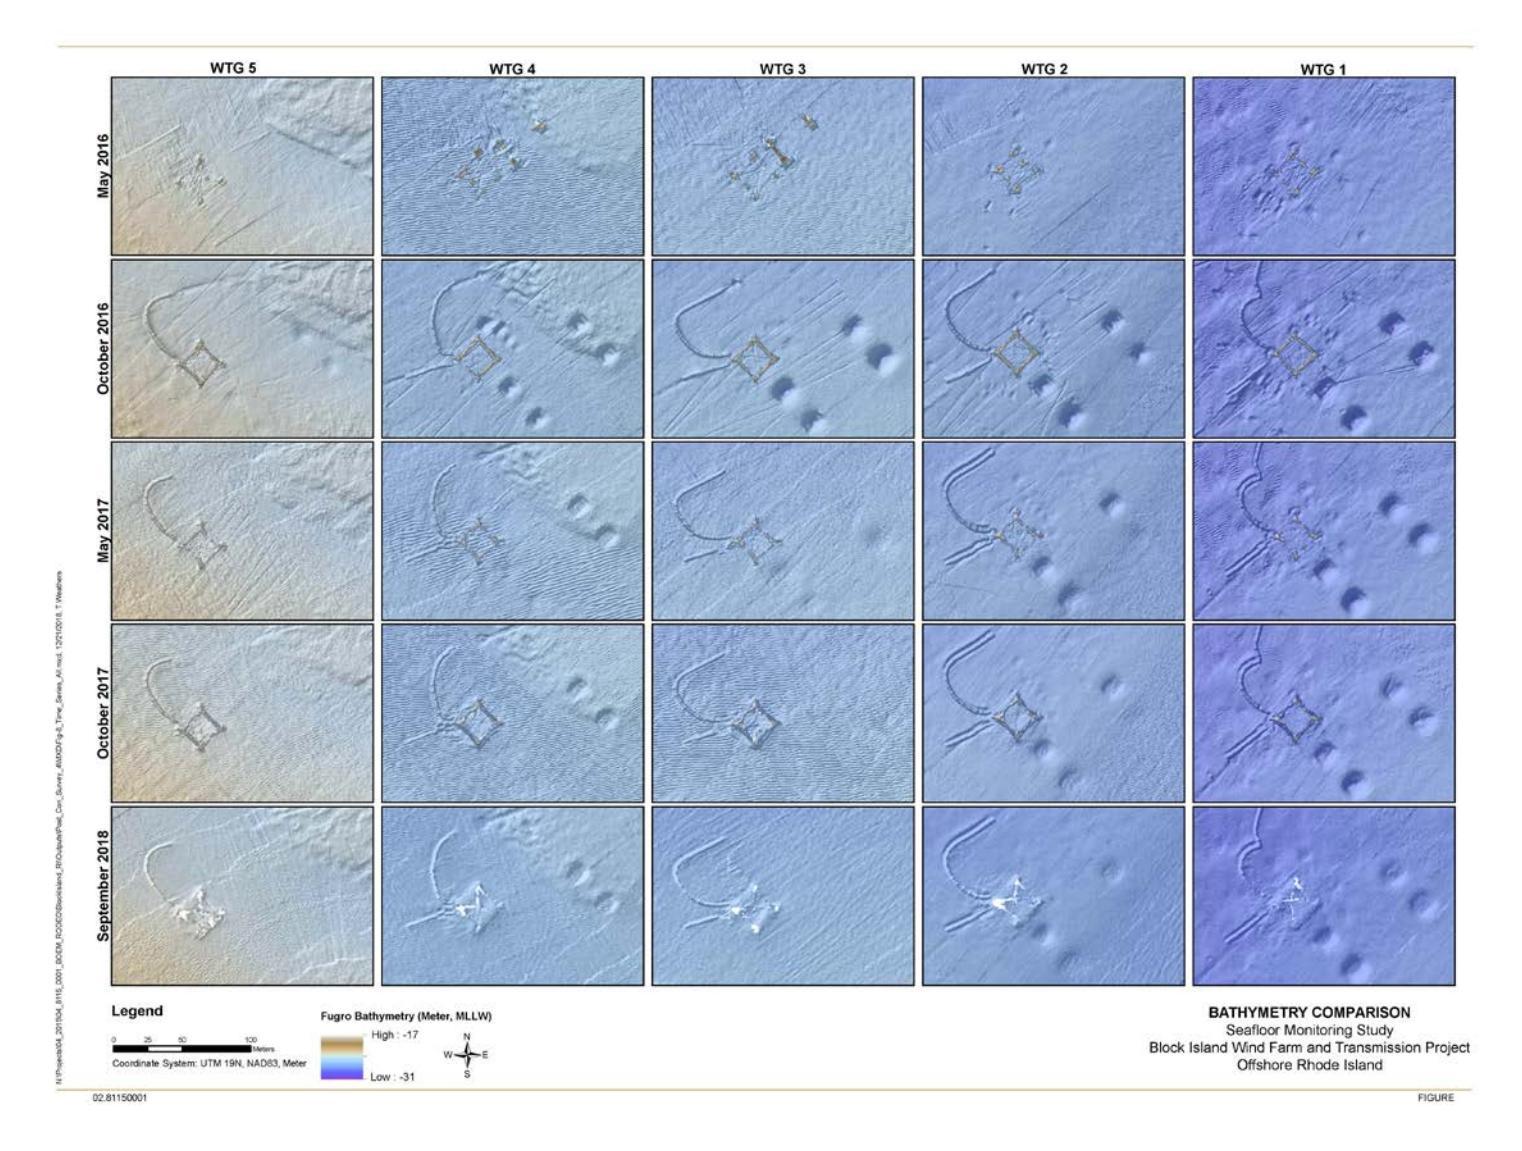
Figure 4. Time series from Survey 1 (May 2016) to Survey 5 (September 2018) for each Turbine, depicting seafloor disturbance and recovery.

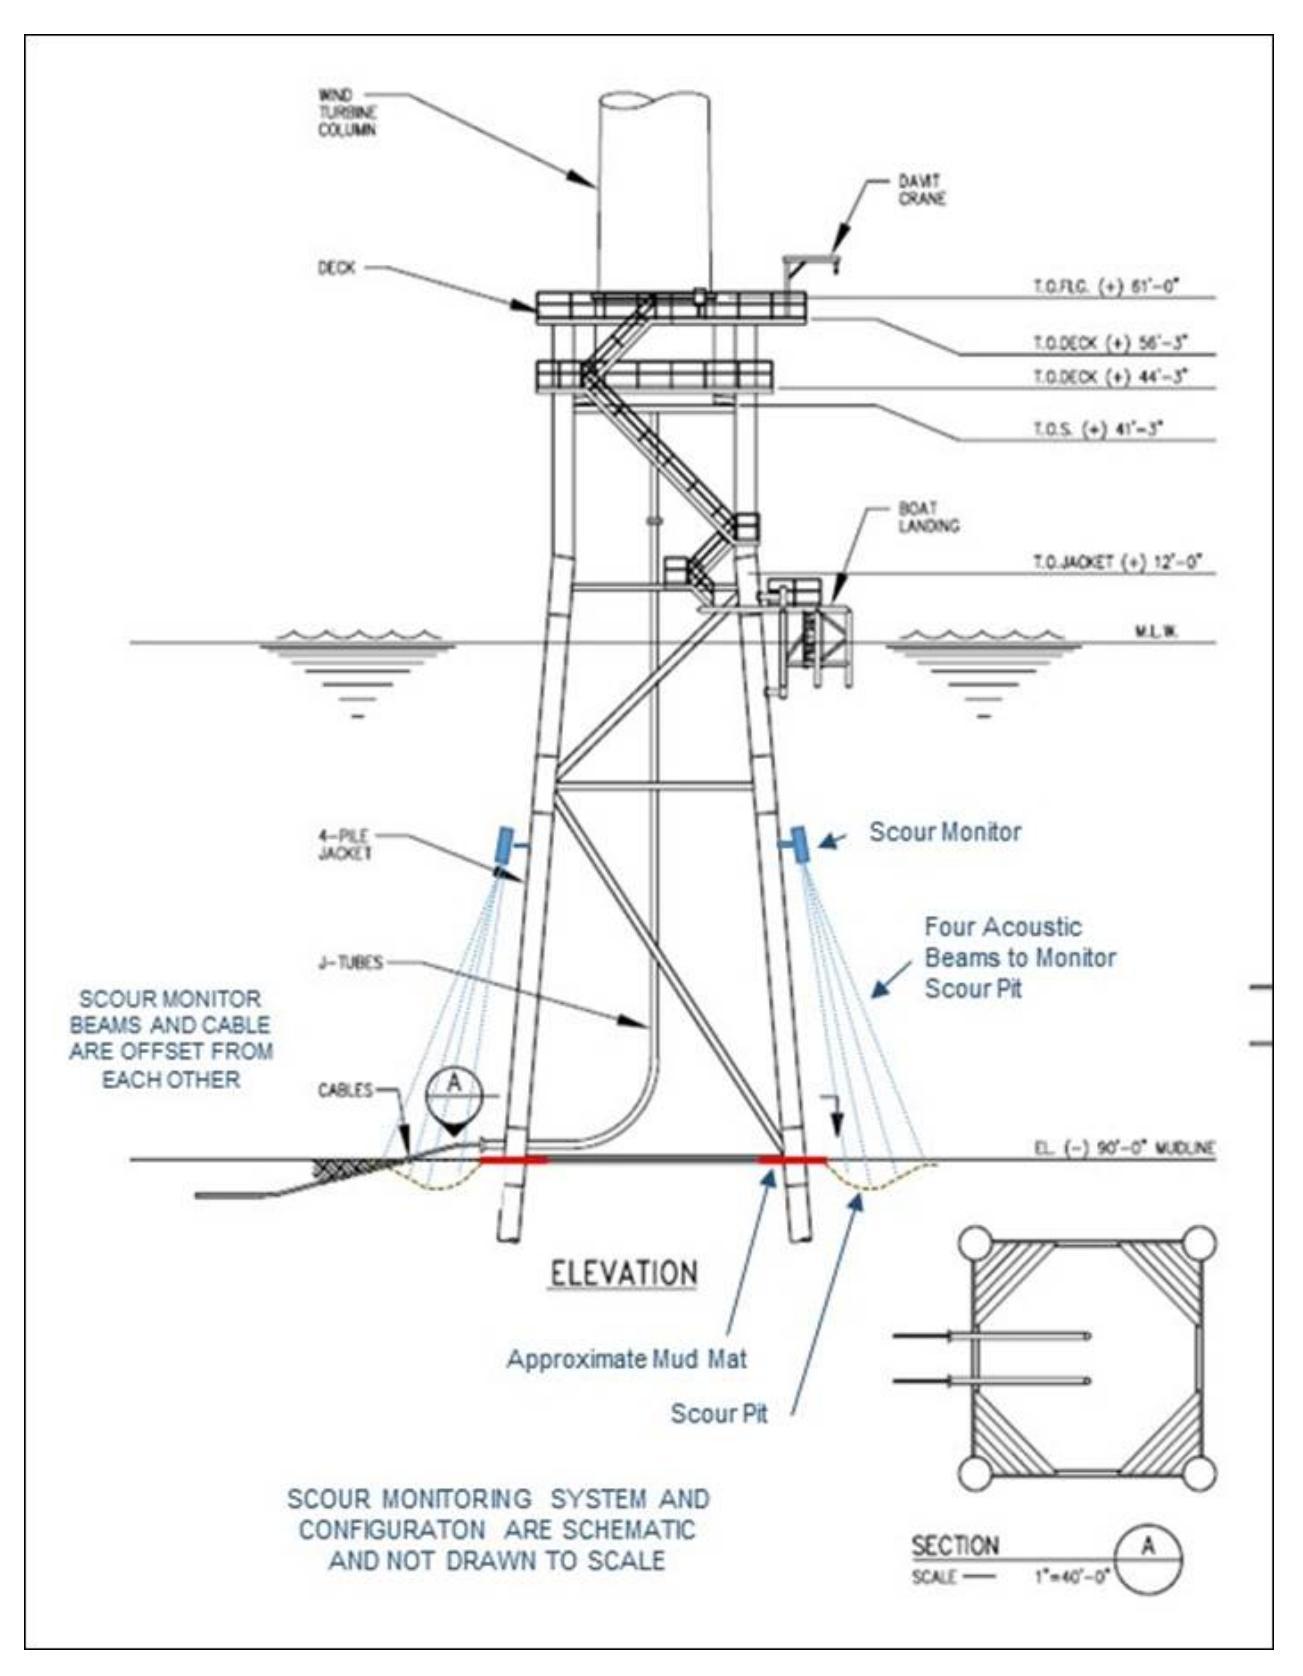
Figure 10. Positioning of the scour monitors on the turbine foundation.

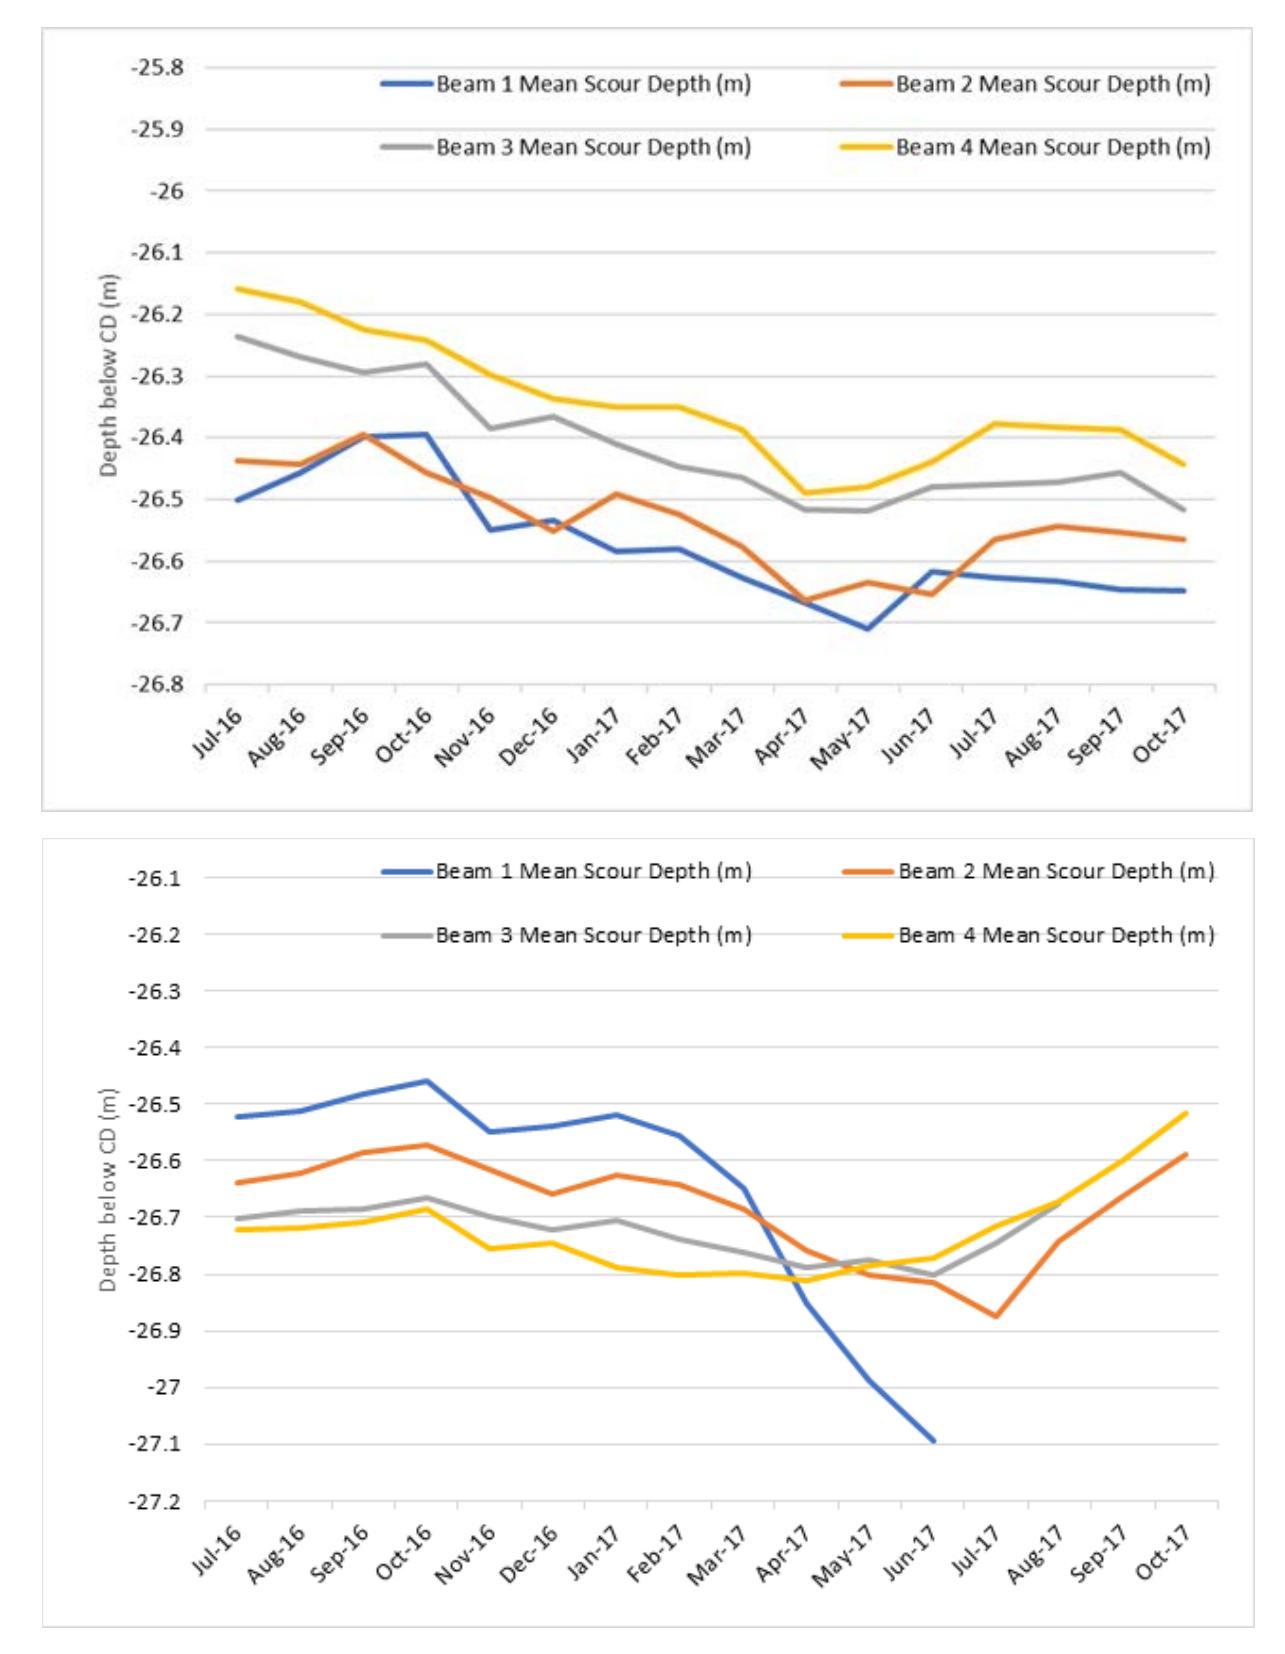
Figure 11. Mean scour depth of each beam per month.

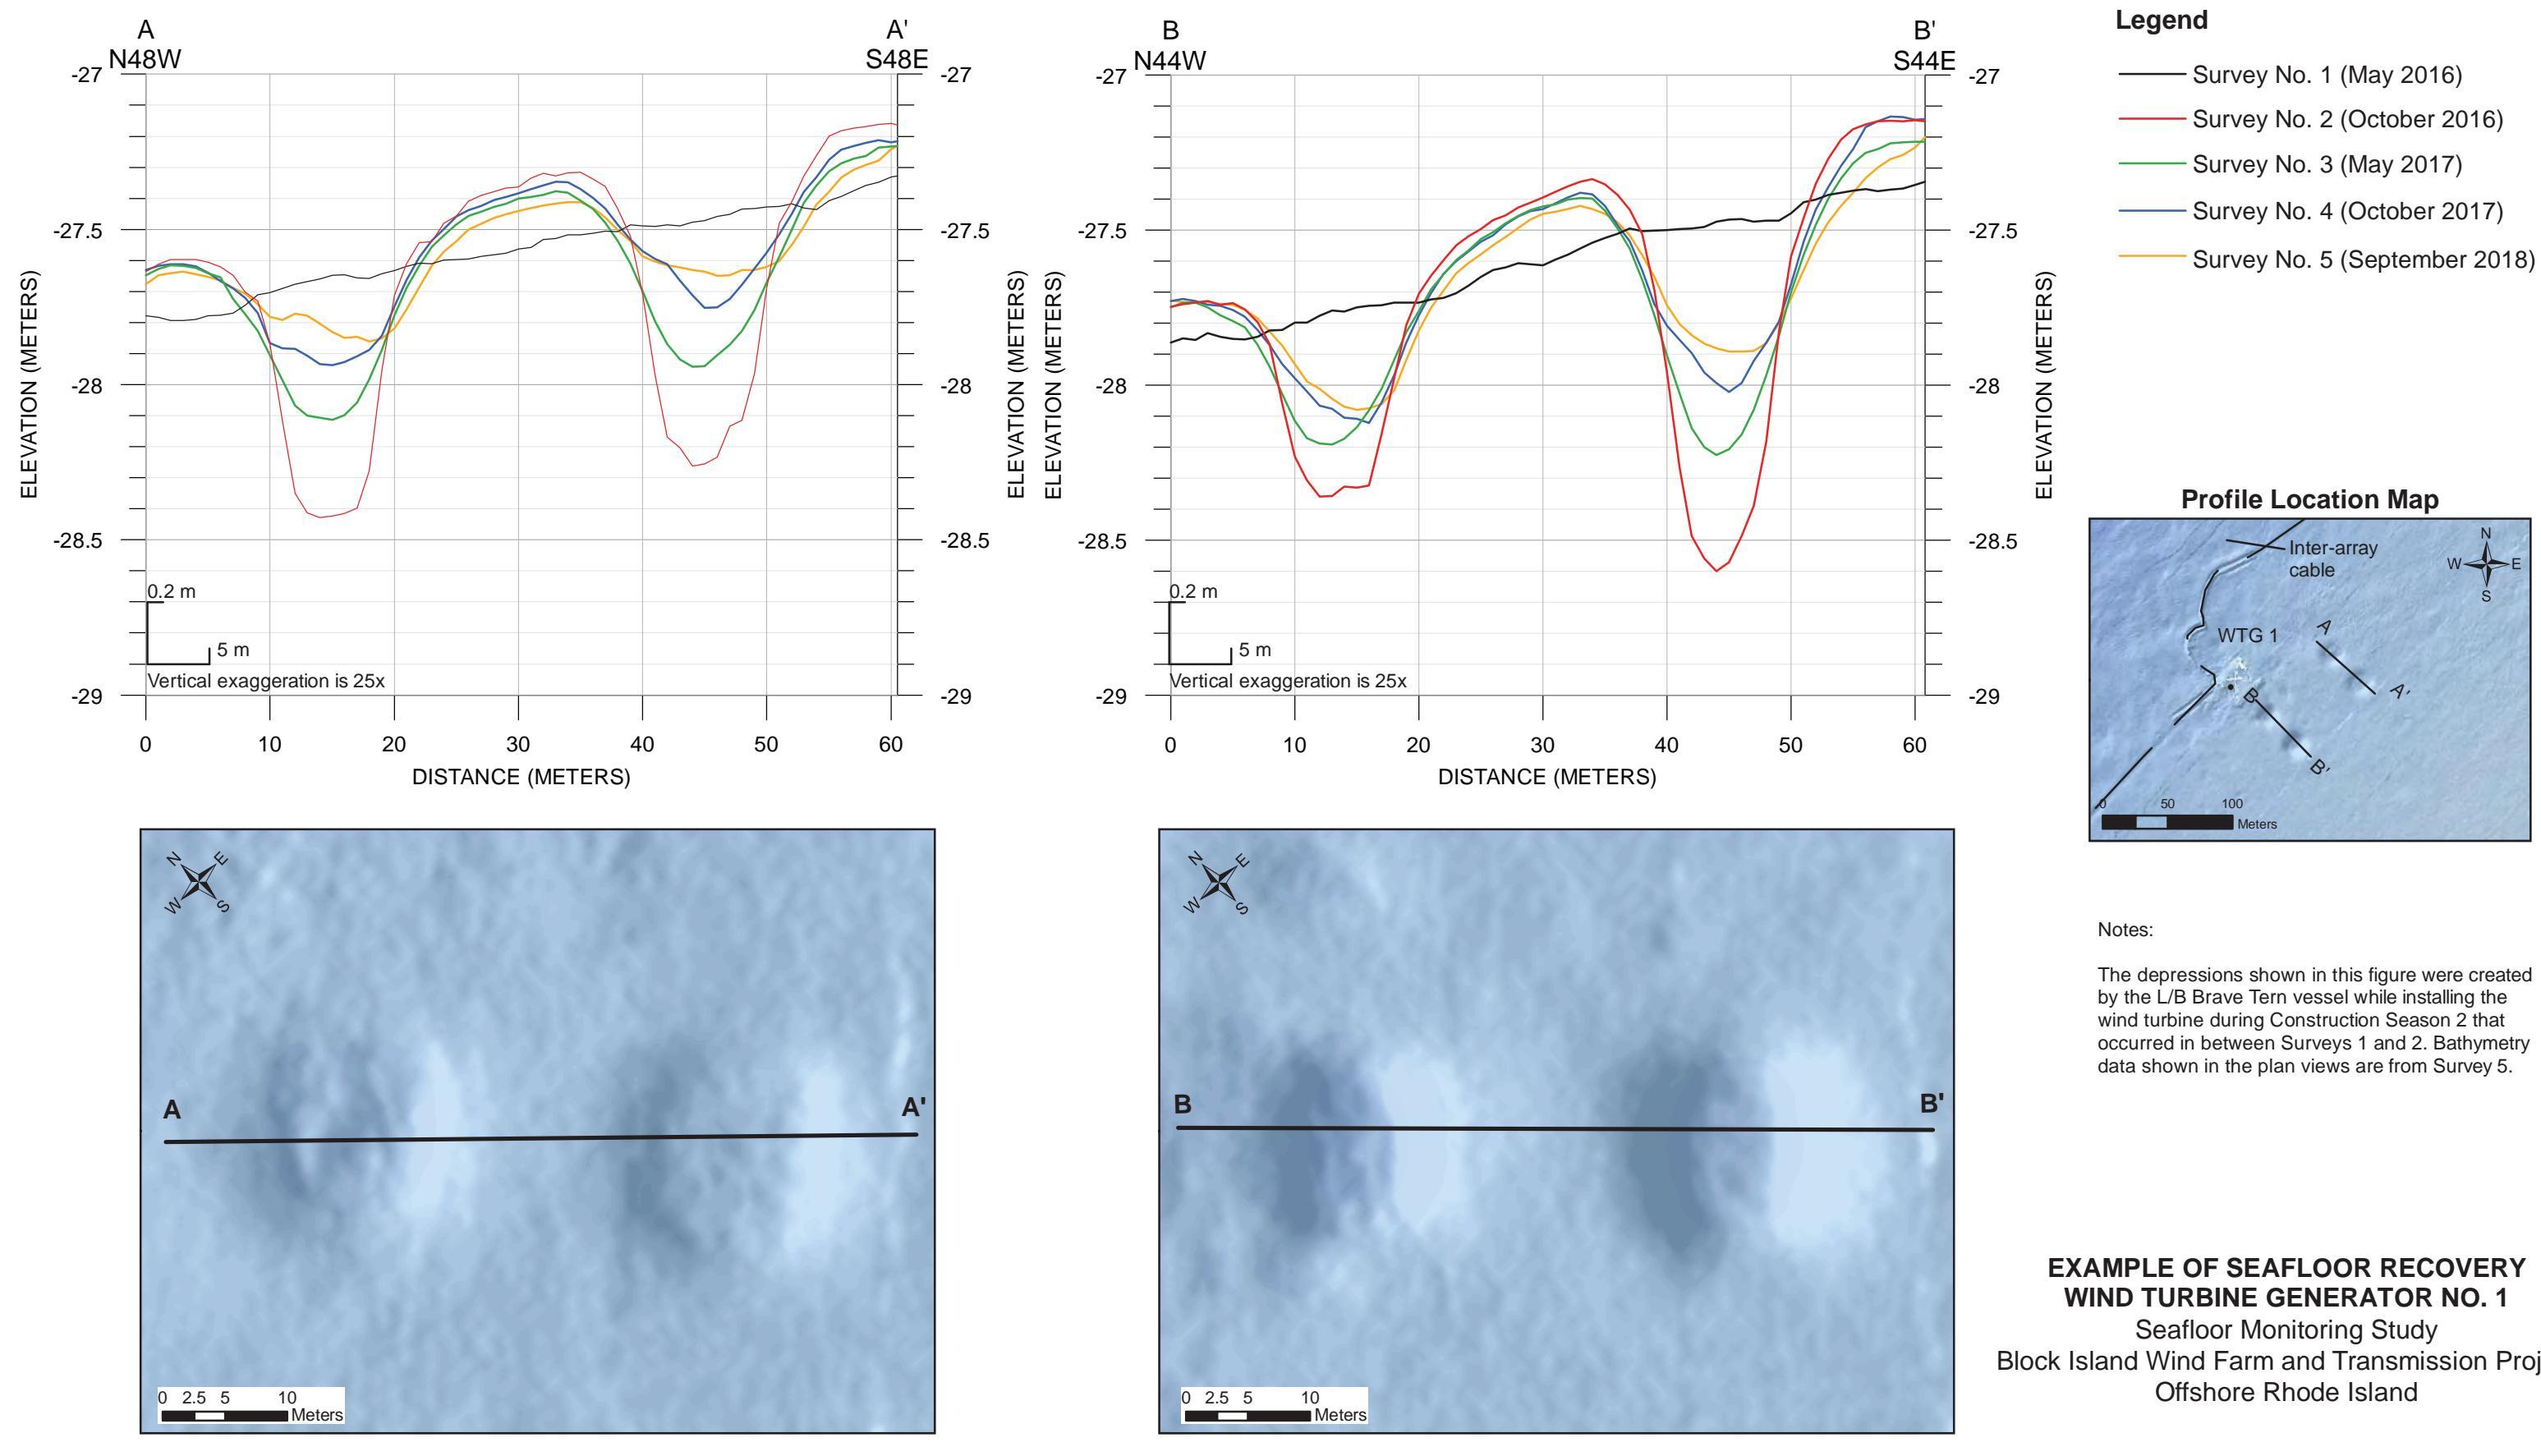
occurred in between Surveys 1 and 2. Bathymetry

EXAMPLE OF SEAFLOOR RECOVERY

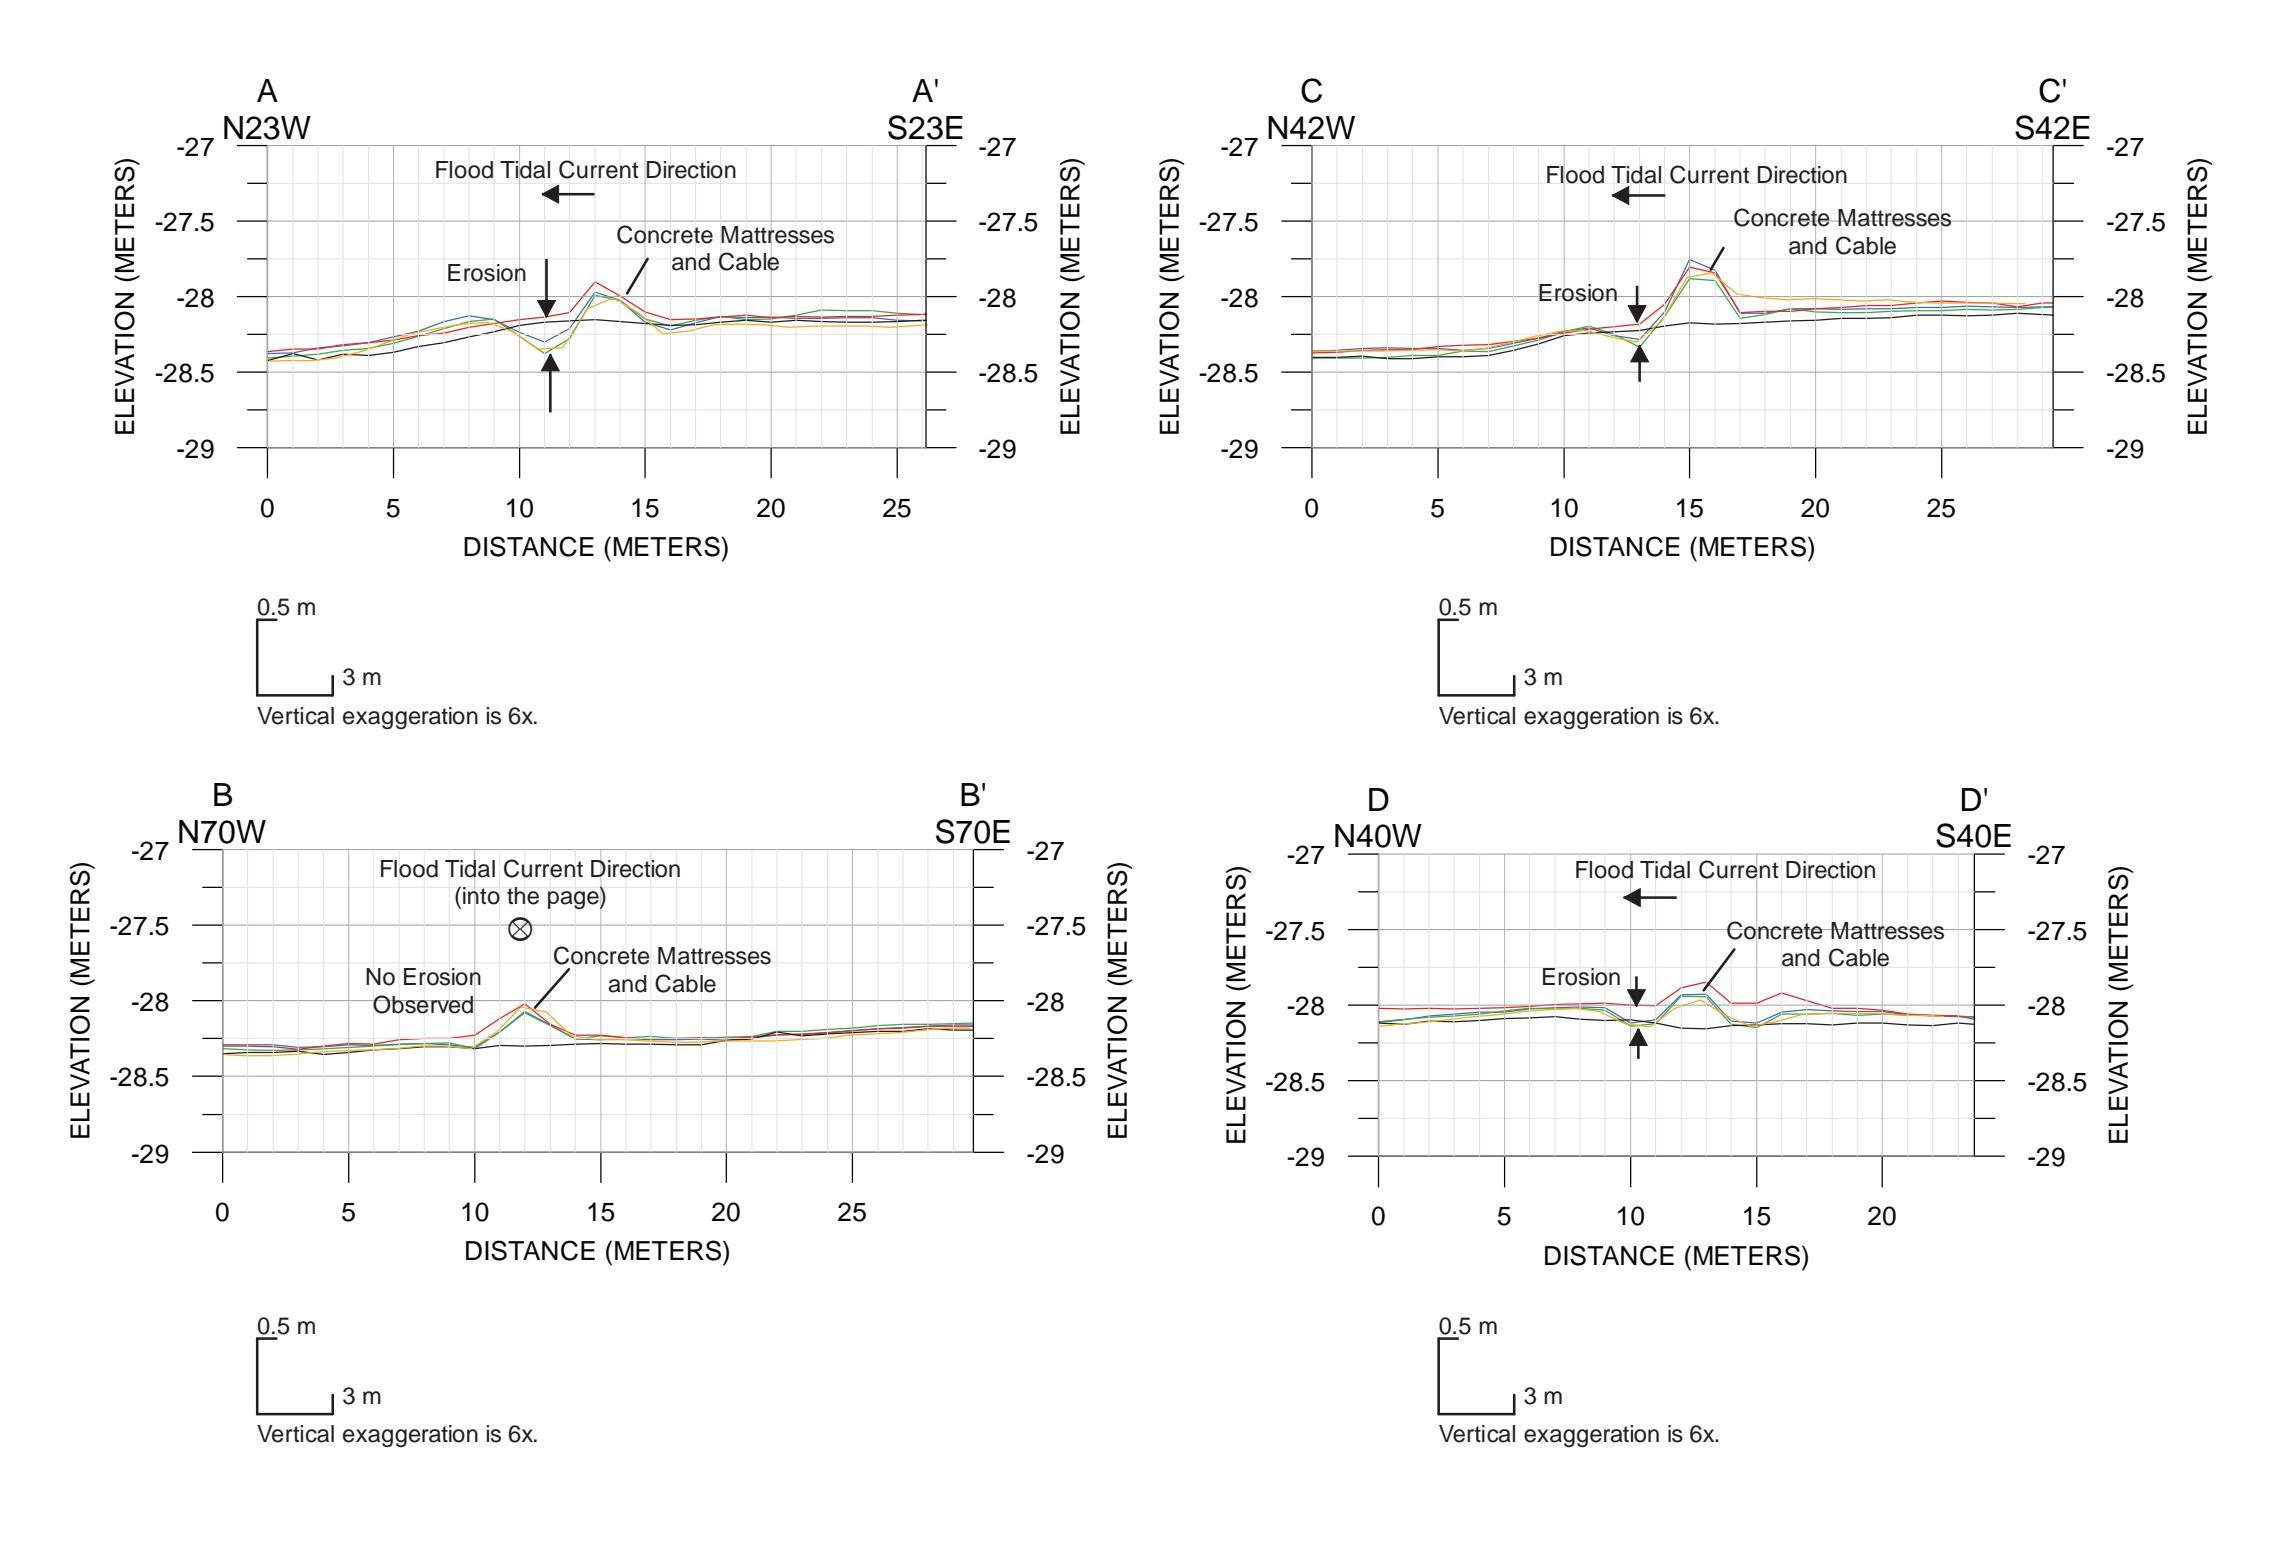
> EXAMPLE OF SEAFLOOR RECOVERY WIND TURBINE GENERATOR NO. 1

Principle tidal axis is aligned in the NNW-SSE direction. Cable segment in Profile B is nearly aligned with the principle tidal axis and shows the least amount of scour. Cable segments shown in Profiles A, C, and D are oriented perpendicular to the principle tidal axis. Scour is most prevalent on the northern side of the cable/concrete mattresses which indicates the dominant tidal current flow at this location is likely to the NNW (flood tidal current direction).
