Field Observations During Wind Turbine Foundation Installation at the Block Island Wind Farm, Rhode Island

Appendix E3: Seafloor Monitoring Survey 3 Report

**Seafloor Disturbance and Recovery Monitoring Program
Survey 3 May 2017
Block Island Wind Farm, USA**

**Seafloor Disturbance and
Recovery Monitoring Program
Survey 3 May 2017**
Block Island Wind Farm, USA

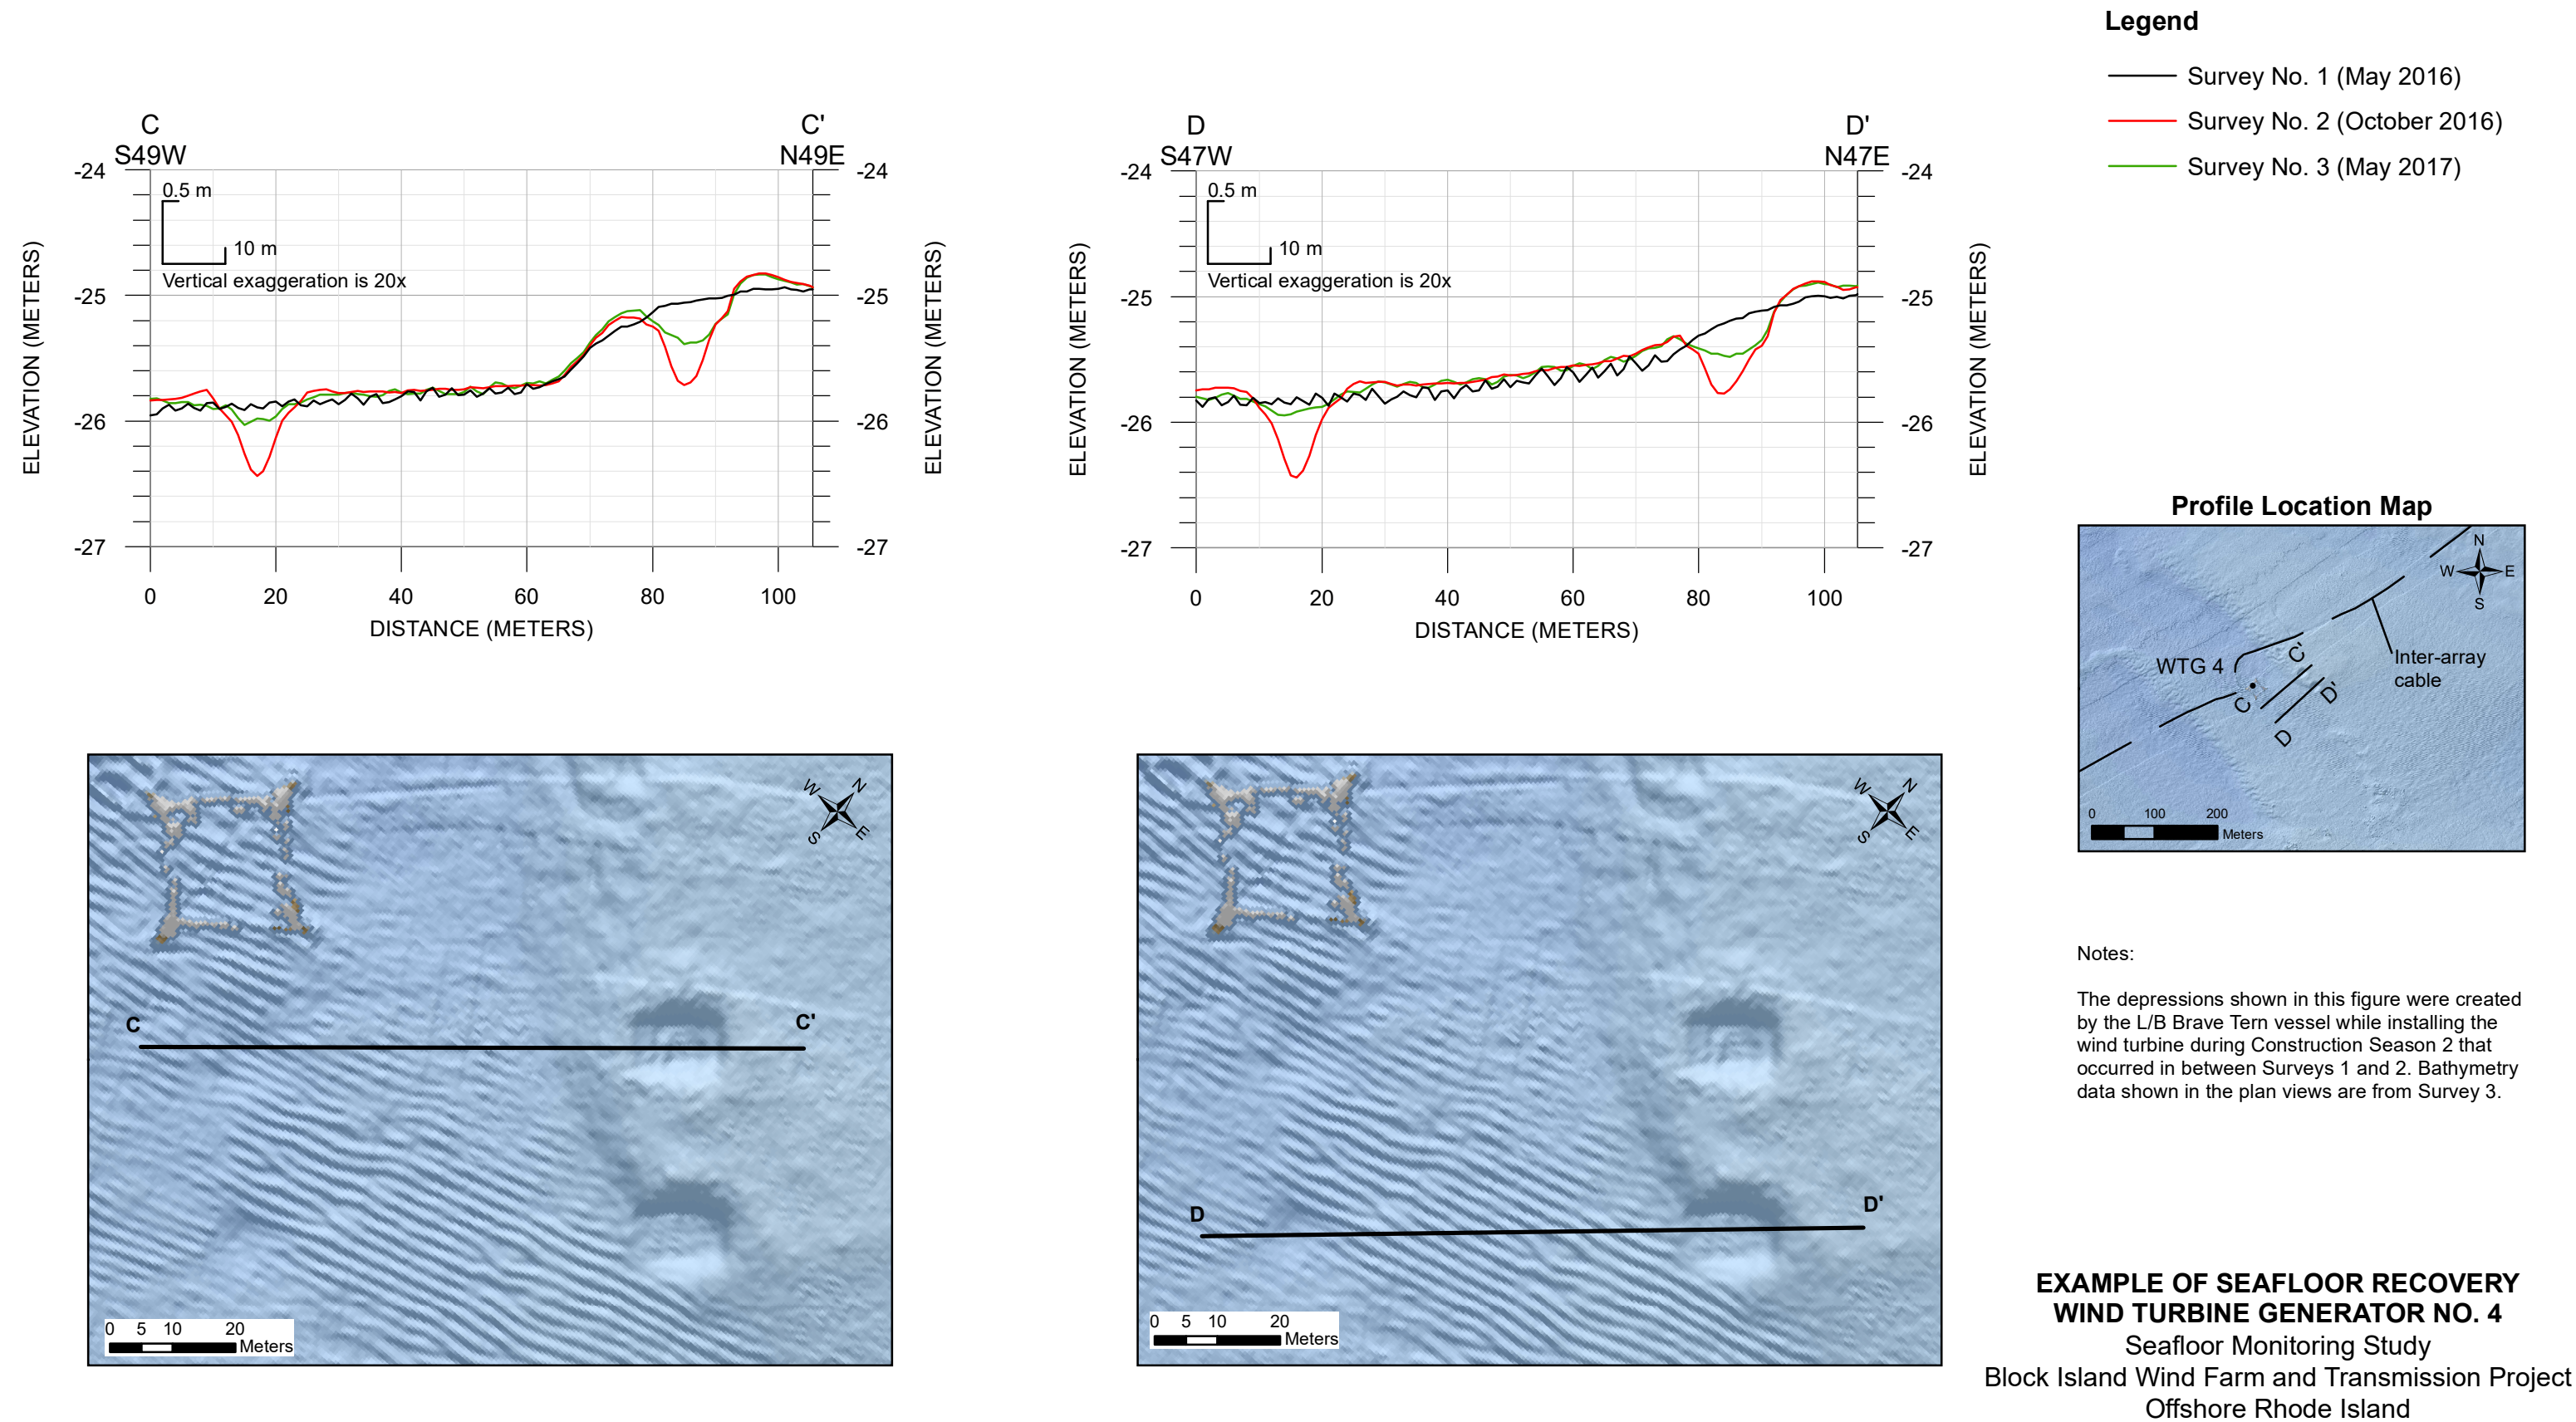
Bathymetric data collected during October 2016 and May 2017 indicate that the prominent leg depressions from the L/B Brave Tern appear to be recovering at different rates. The two southwestern depressions are barely visible in the May 2017 survey data and have infilled (recovered) by 65 to 75 percent. Bathymetry data also reveal a prominent ripple field where the two southwestern leg depressions are located. The two northeastern leg depressions are clearly visible in the May 2017 data and have only infilled (recovered) by about 30 to 45 percent.
