# Observing Cable Laying and Particle Settlement During the Construction of the Block Island Wind Farm

US Department of the Interior  
Bureau of Ocean Energy Management  
Office of Renewable Energy Programs

**March 2017**

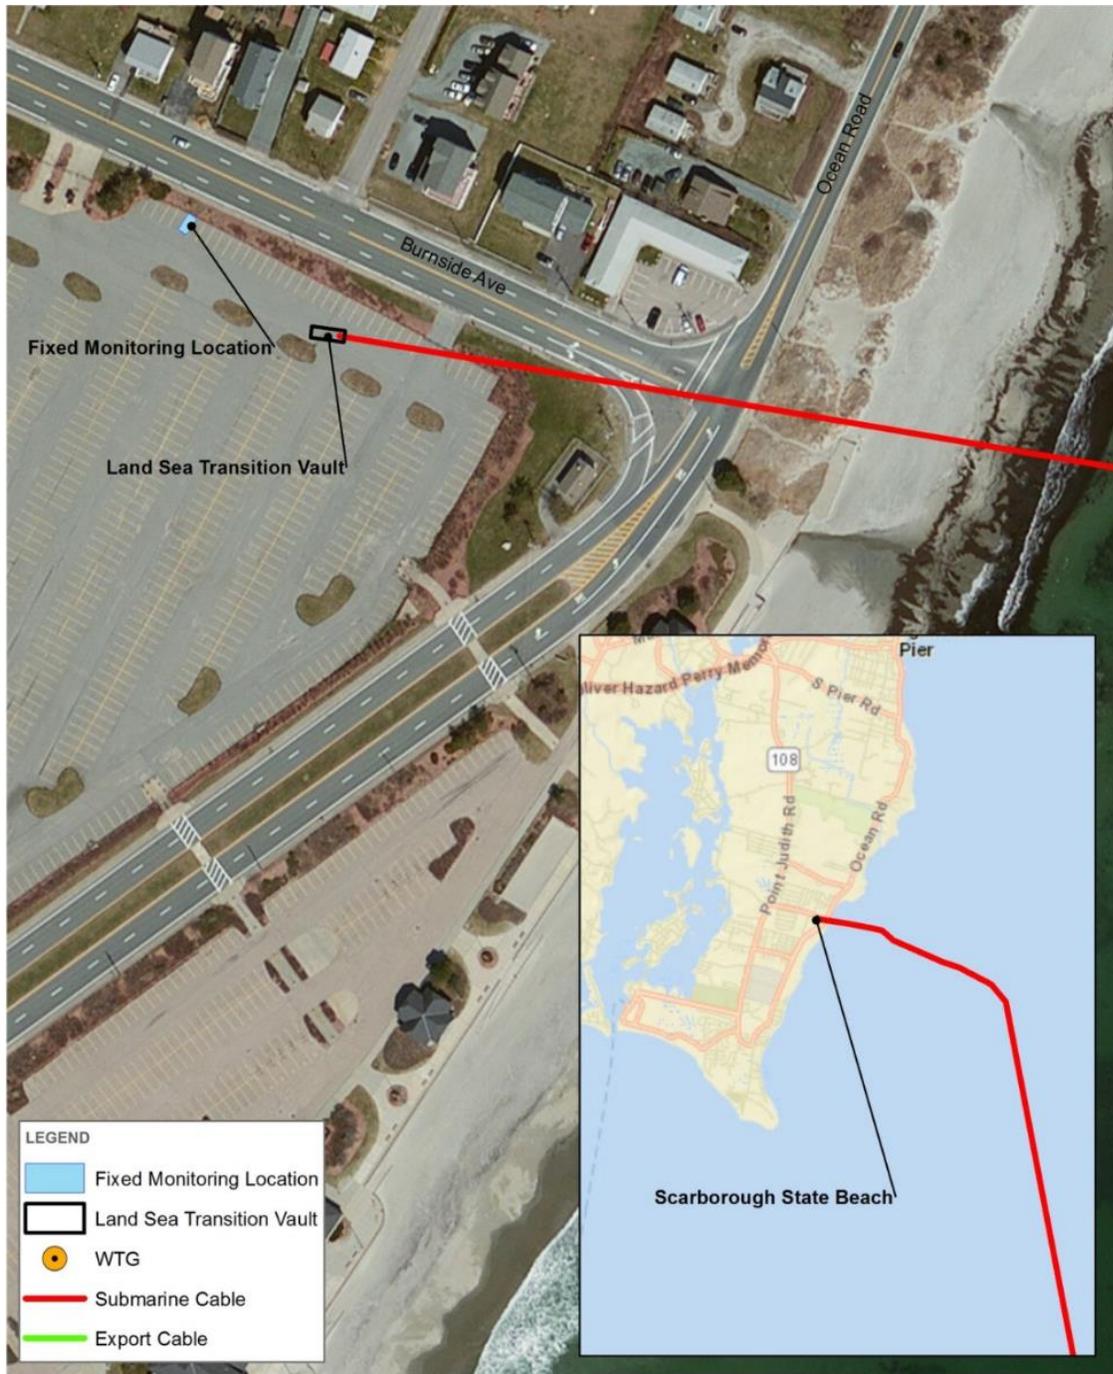
Figure 7. Onshore Monitoring Scarborough State Beach

**Figure 7** below shows monitoring position on the mainland at Scarborough State Beach parking lot utilized for monitoring and the cable transition to land. The land sea transition vault was a rectangle shaped hole dug in the parking lot used to connect the BITS cable to the terrestrial cable. An underground conduit for the BITS cable at the beach and the intersection of Ocean Road and Burnside Avenue was already complete upon the team's arrival.

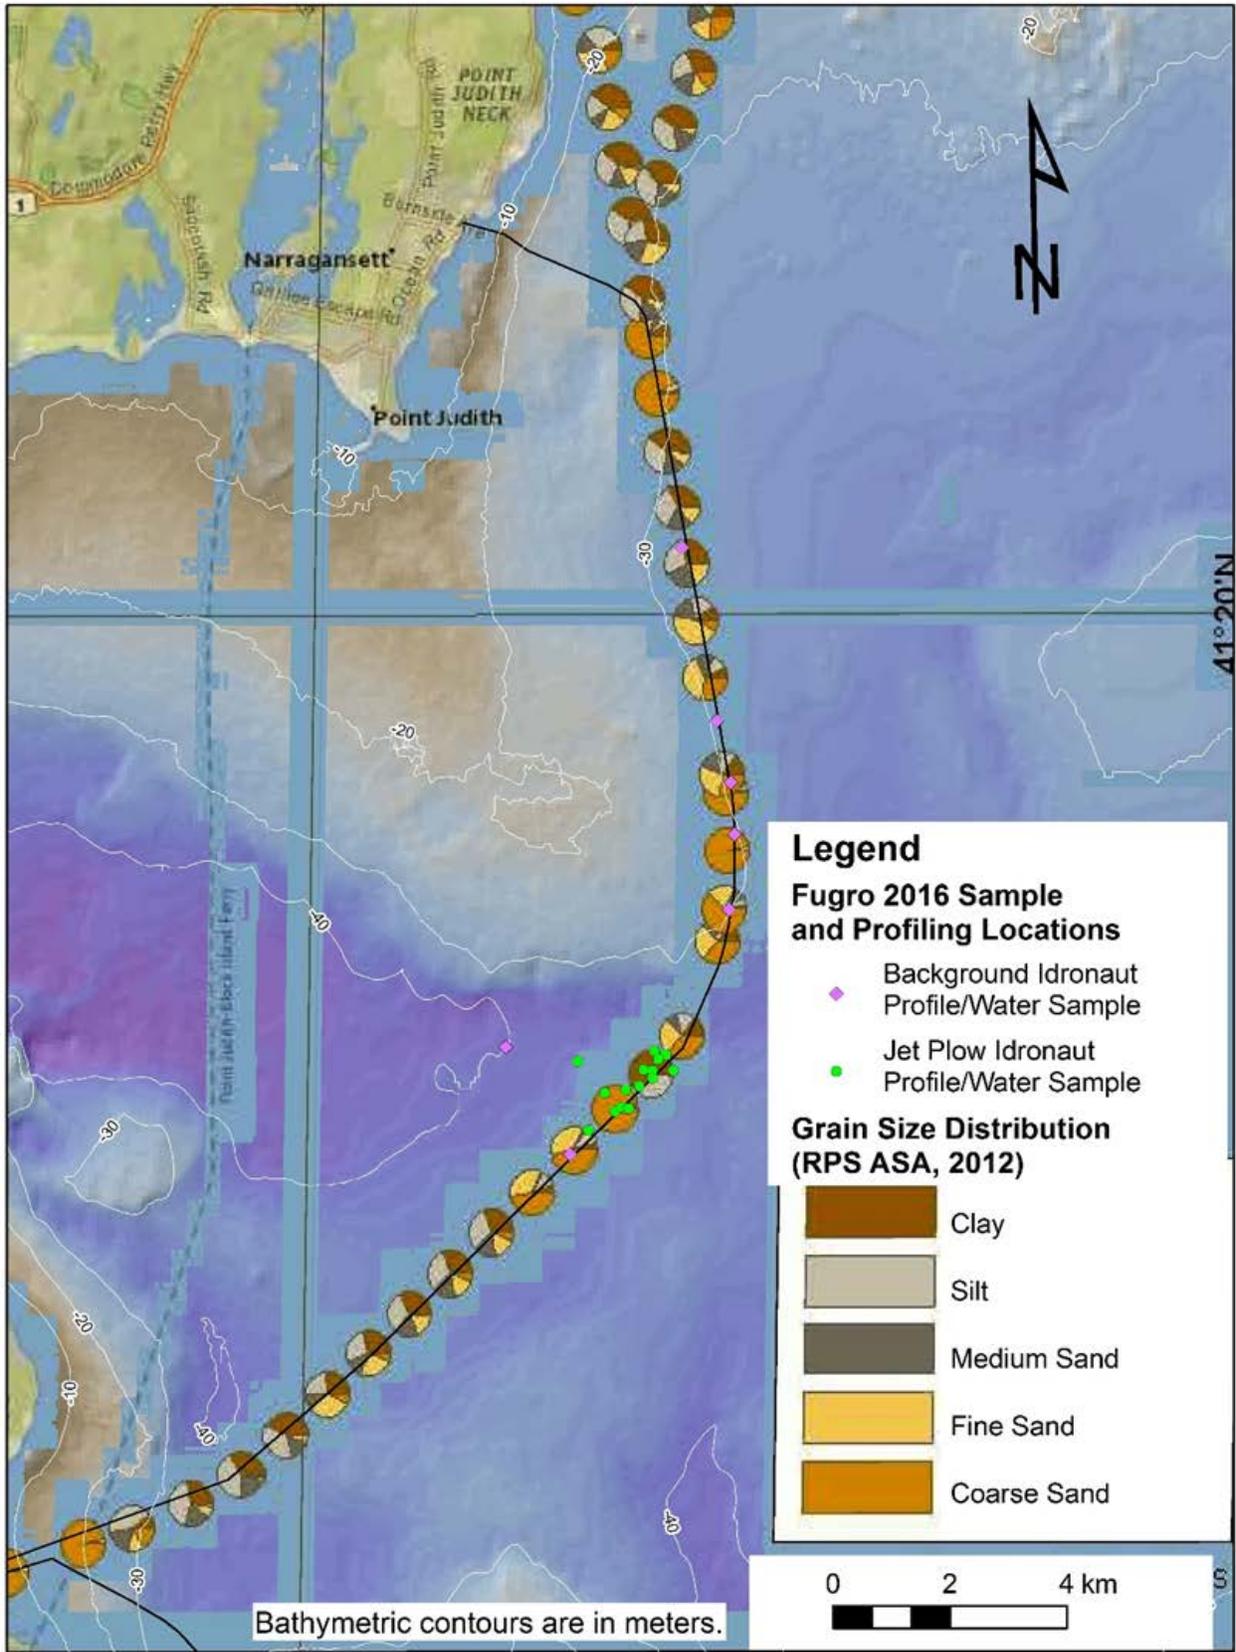
Figure 14. Seafloor sediment characteristics along cable route.

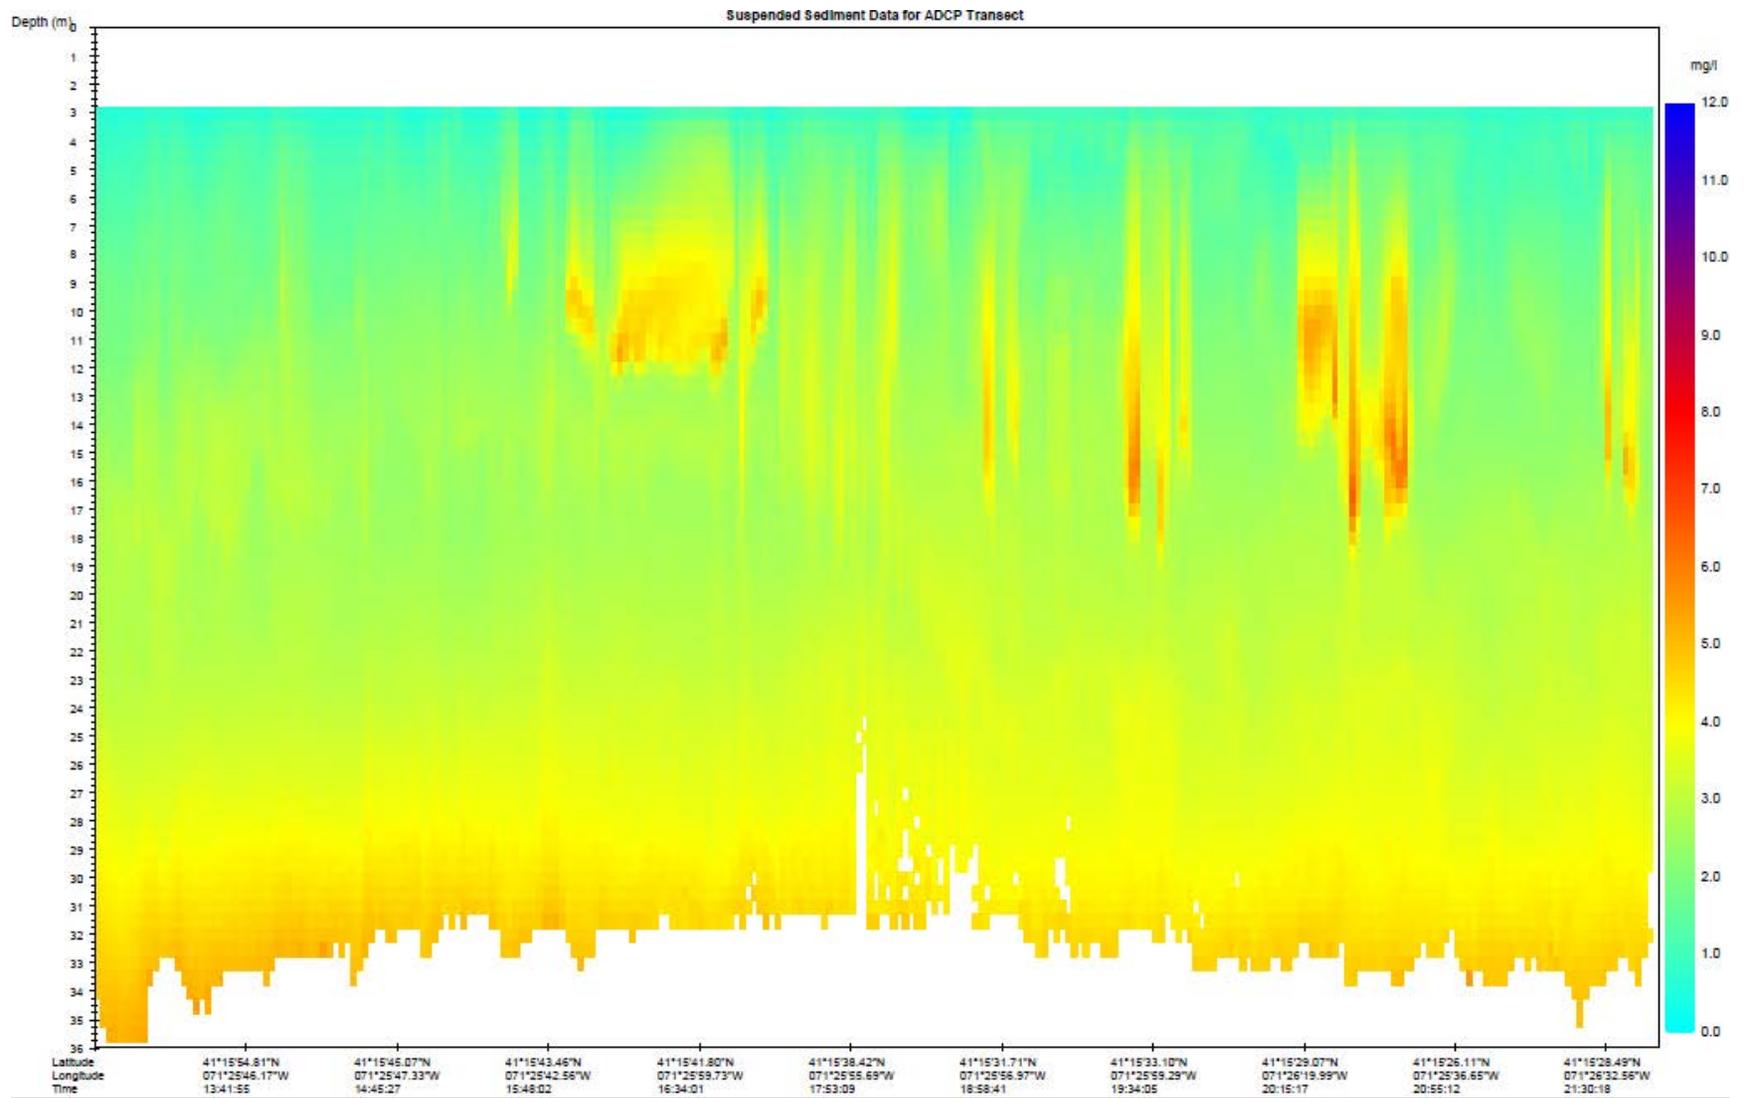
Elevated levels of acoustic signal return were observed in both the ADCP and multibeam echosounder (MBES) datasets down to approximately 16 m depth when the instruments passed by the dynamic positioning thrusters from the Big Max. The ADCP data shown in **Figure 23** illustrate this. Increased suspended sediment concentrations were not observed in the Idronaut profiles suggesting that this acoustic return was caused by bubbles rather than sediment. This turbulence on site was photographed and is displayed in **Figure 24**.

**Figure 23. ADCP data showing increased turbidity as a result of instrumentation passing vessel thrusters**

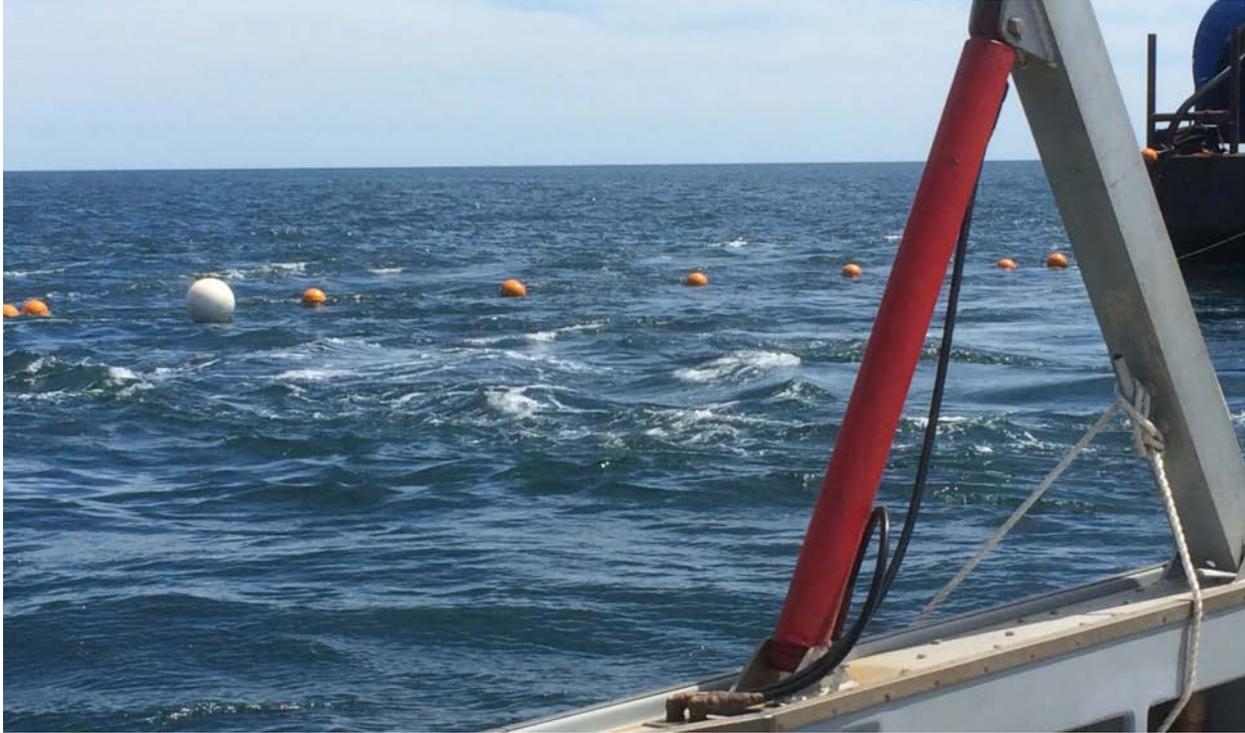
**Figure 24. Turbulence around the jet plow caused by vessel thrusters**

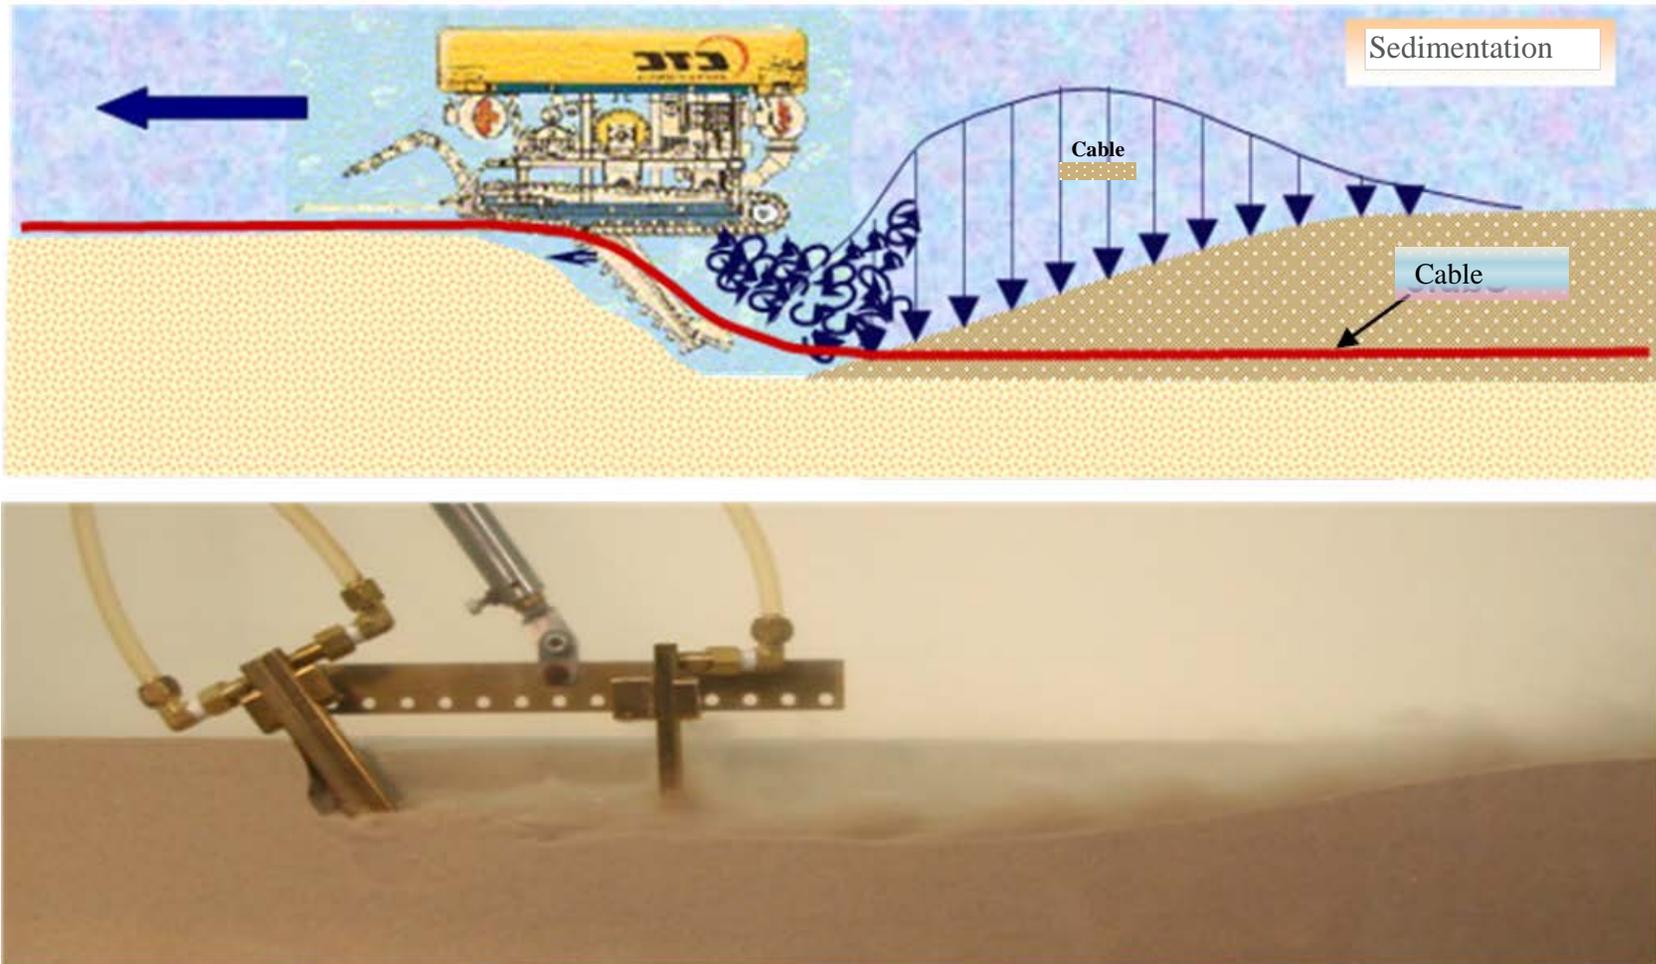
Figure 27. Schematic Illustration of a jet-trencher during operation (Van den Berghe et al., 2008)

2. Lateral Processes. Lateral processes include erosion by the breaching and collapse of the trench side walls. This will occur to a greater extent in looser sediments and those with lower fines contents. Overspill occurs beyond the internal hydraulic jump once the upper boundary of the turbid current exceeds the trench wall. Once the turbid water rises above the trench wall, the plume expands laterally, and some sediment will redeposit outside the trench. The amount of sediment that deposits outside the trench will largely depend on the sediment particle sizes,

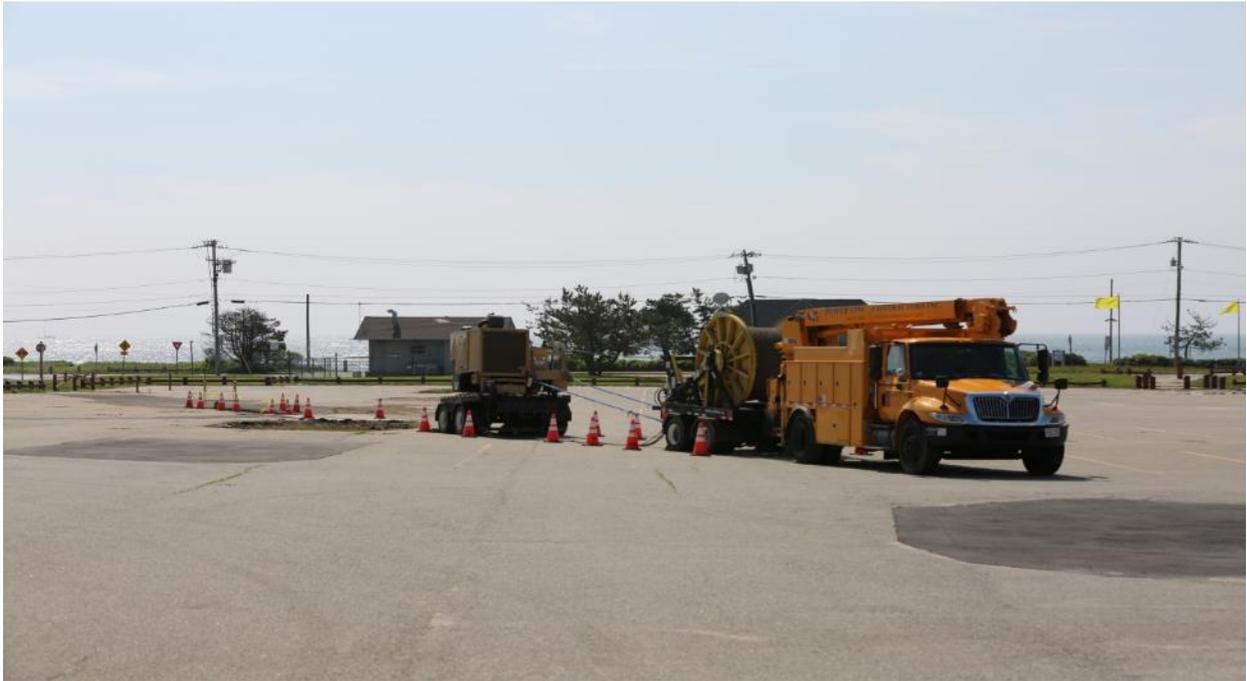
6/6/2016 Scarborough Beach State Park – Photo 0074: Utility truck, winch spool, and winch prepared for BITS cable pull to shore. The land sea transition vault is surrounded by cones.

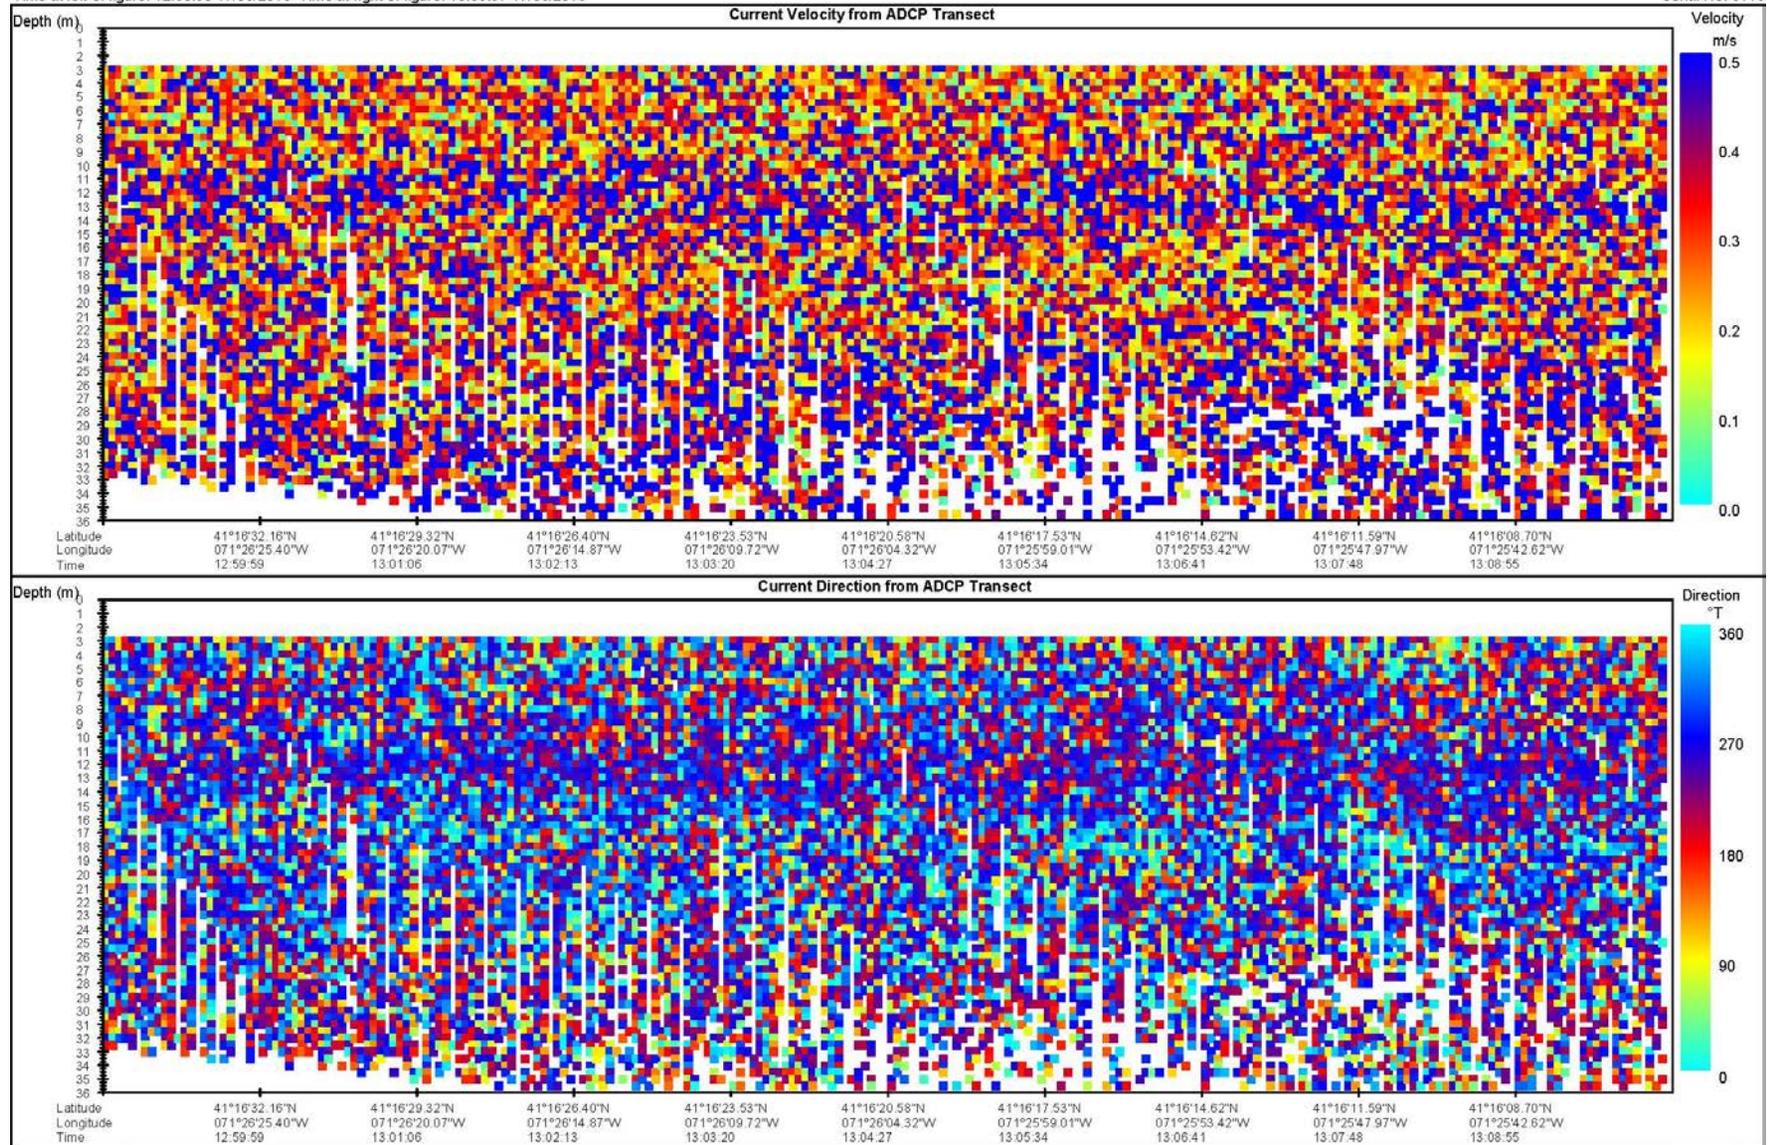
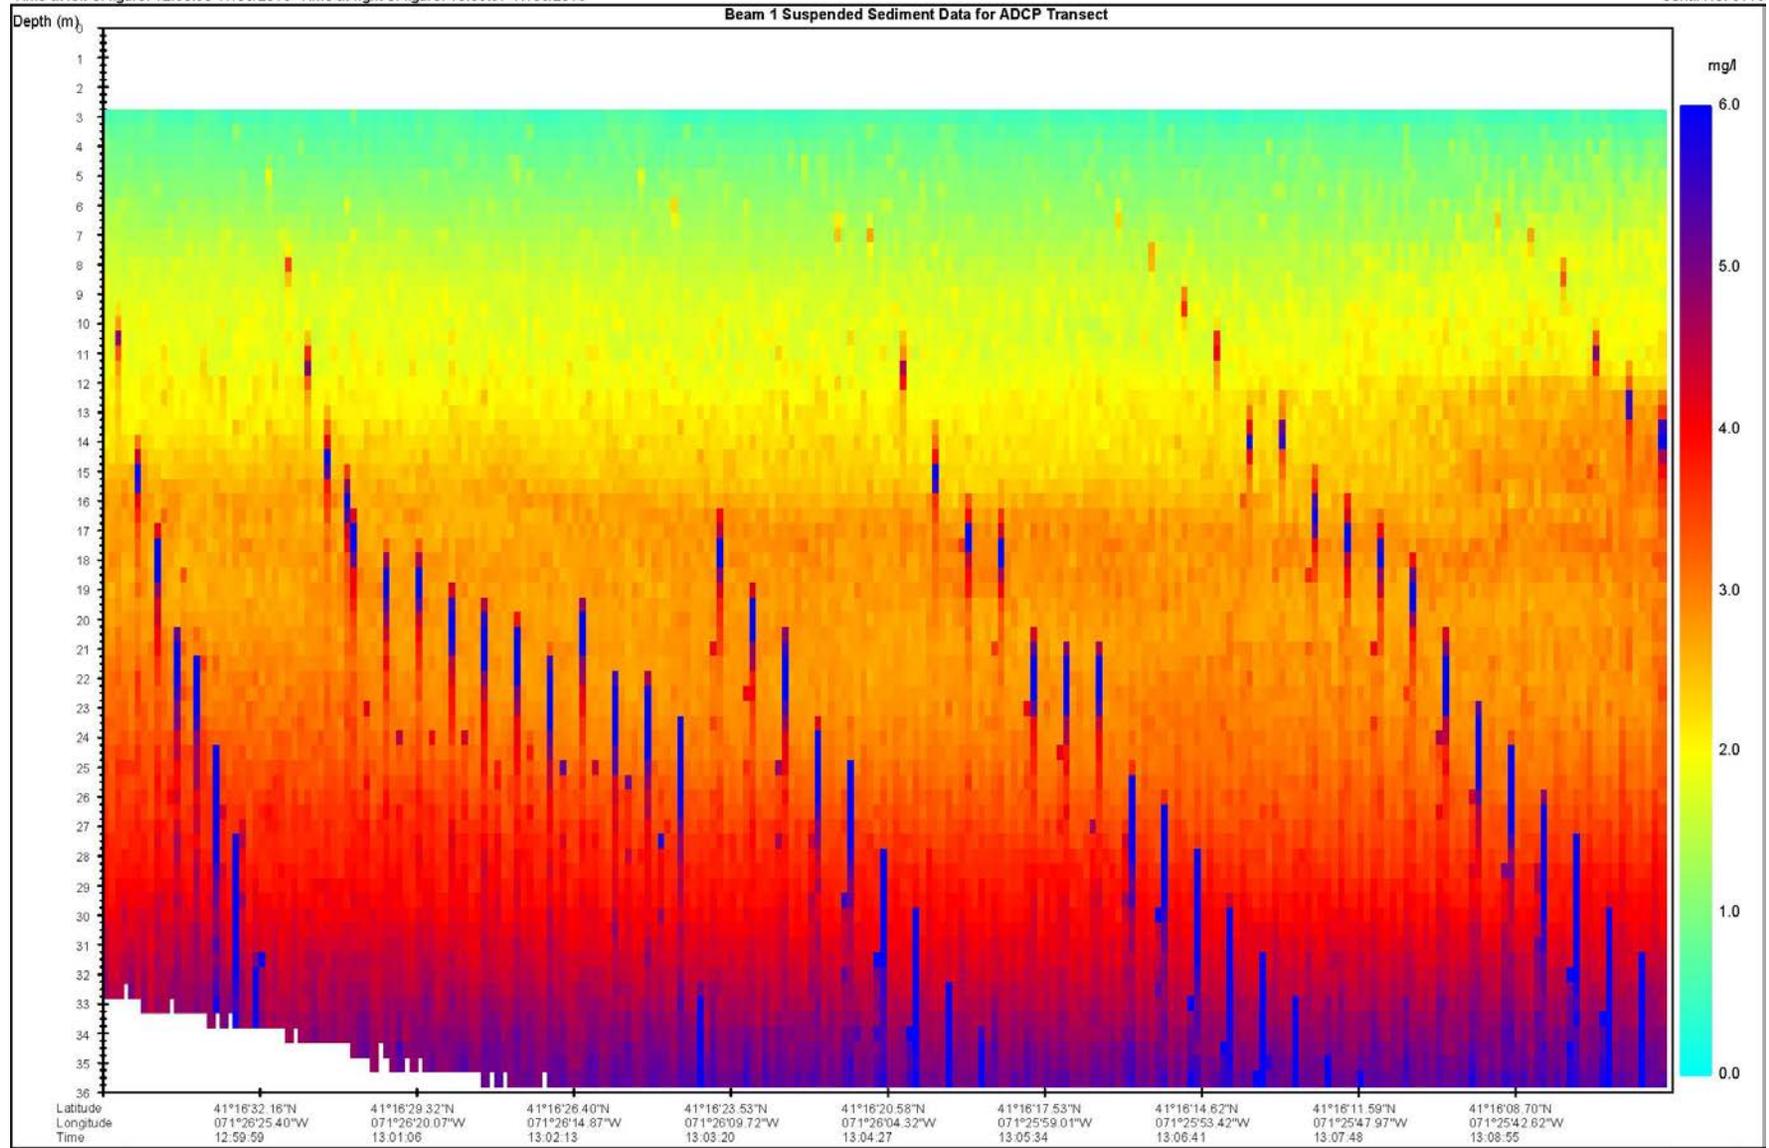
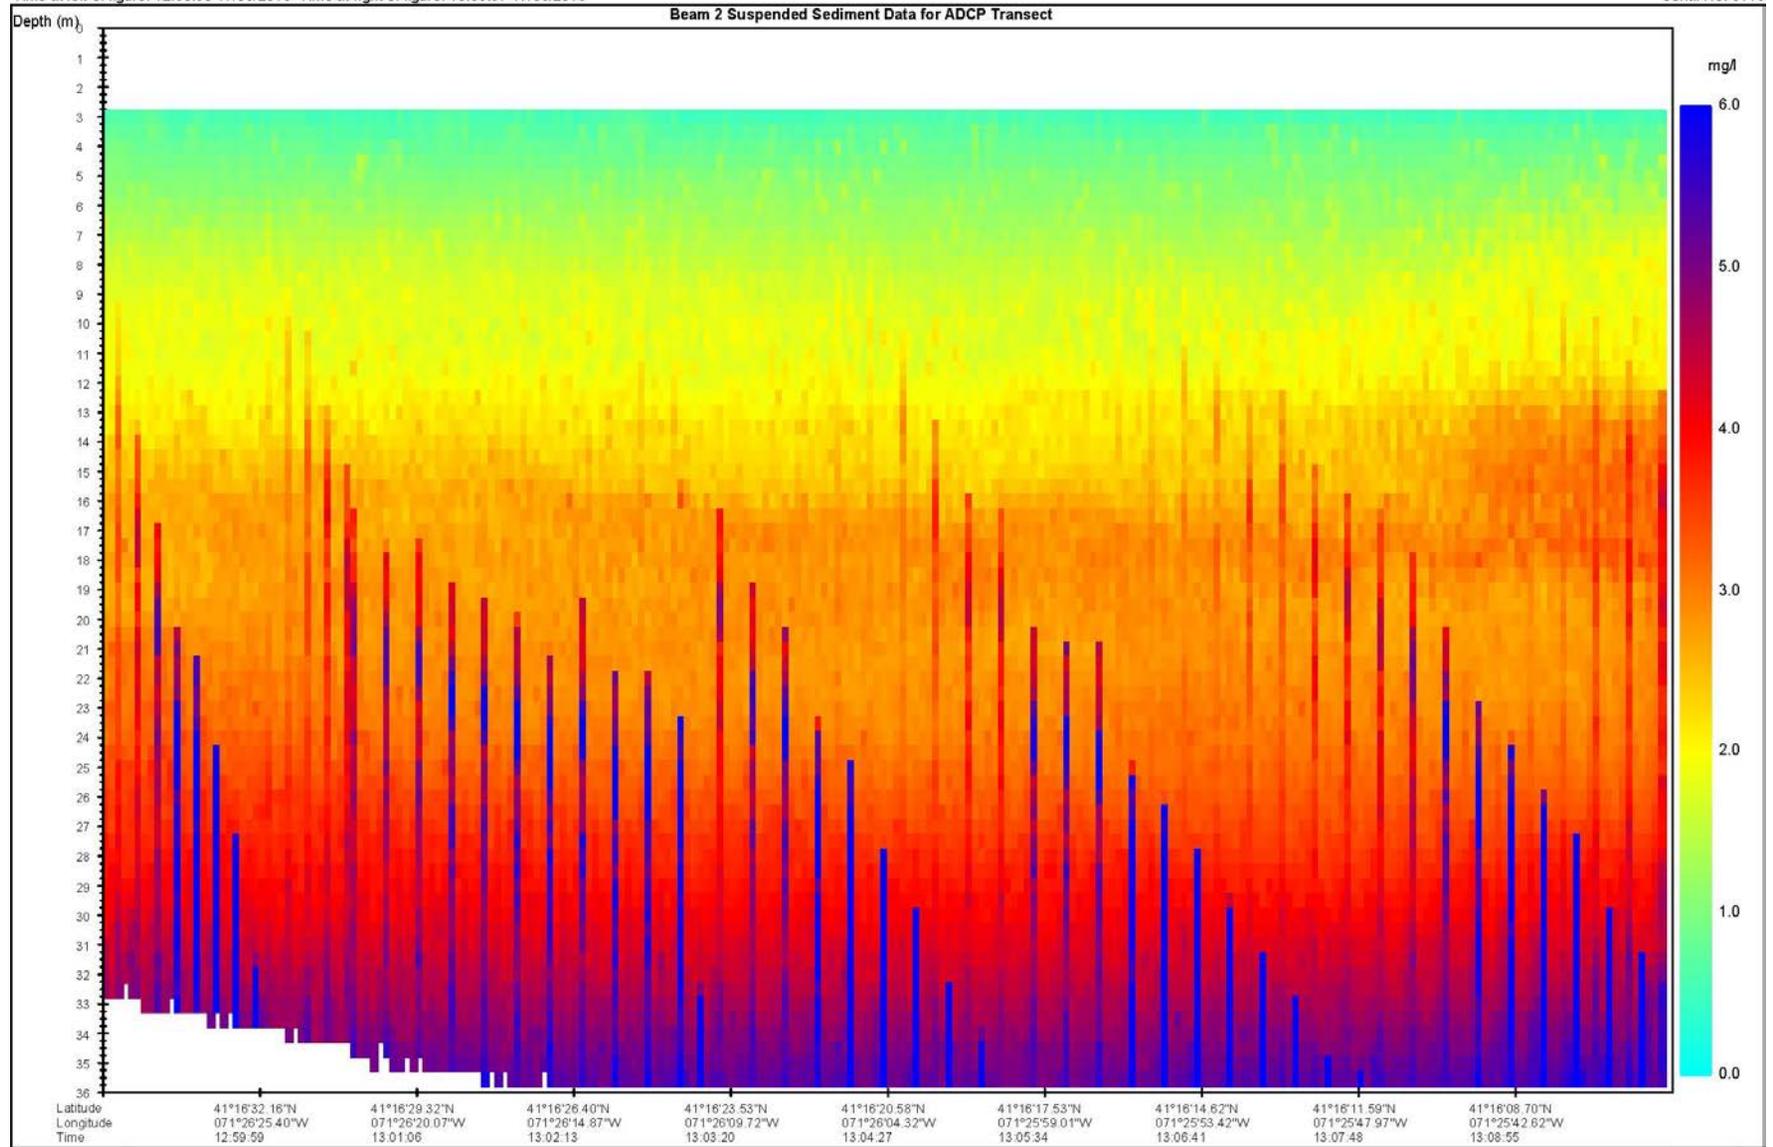
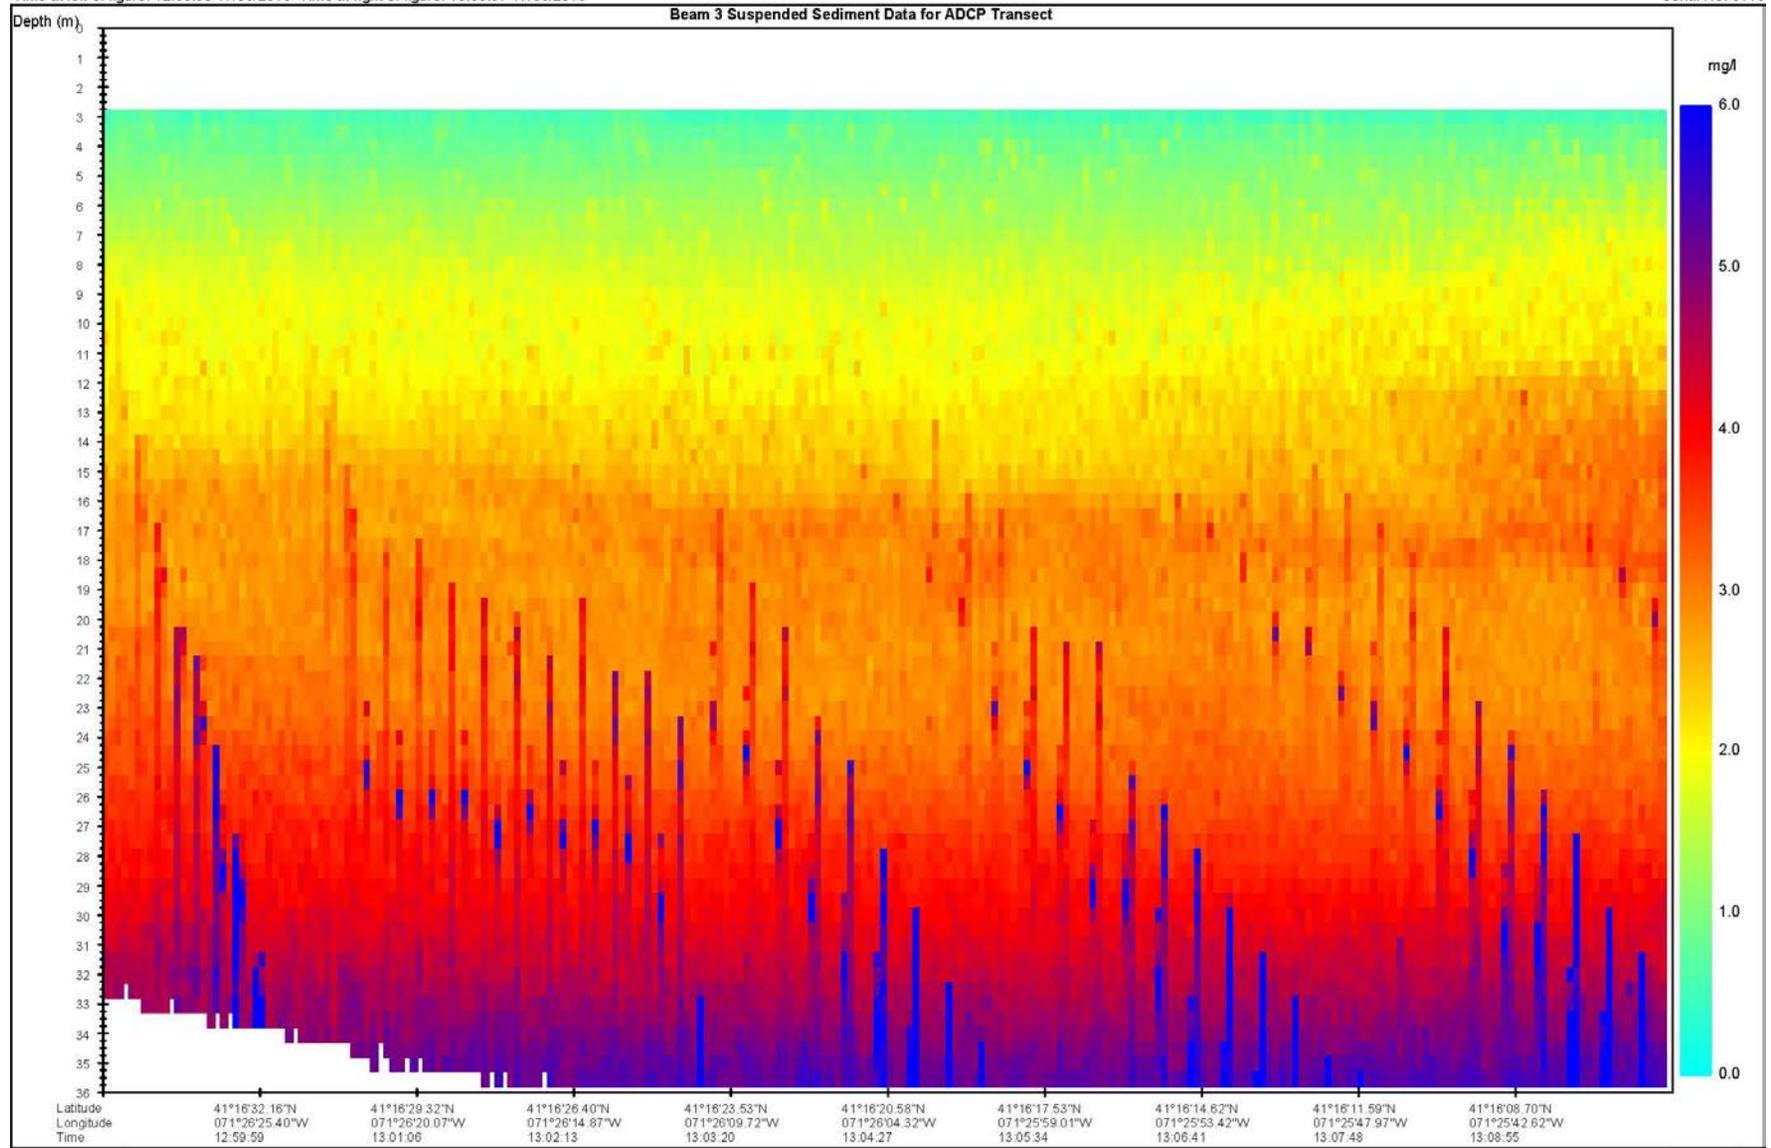
Colour Contour Plots of Current Speed and Direction  
Block Island Sediment Plume Monitoring, Jet Plow 1

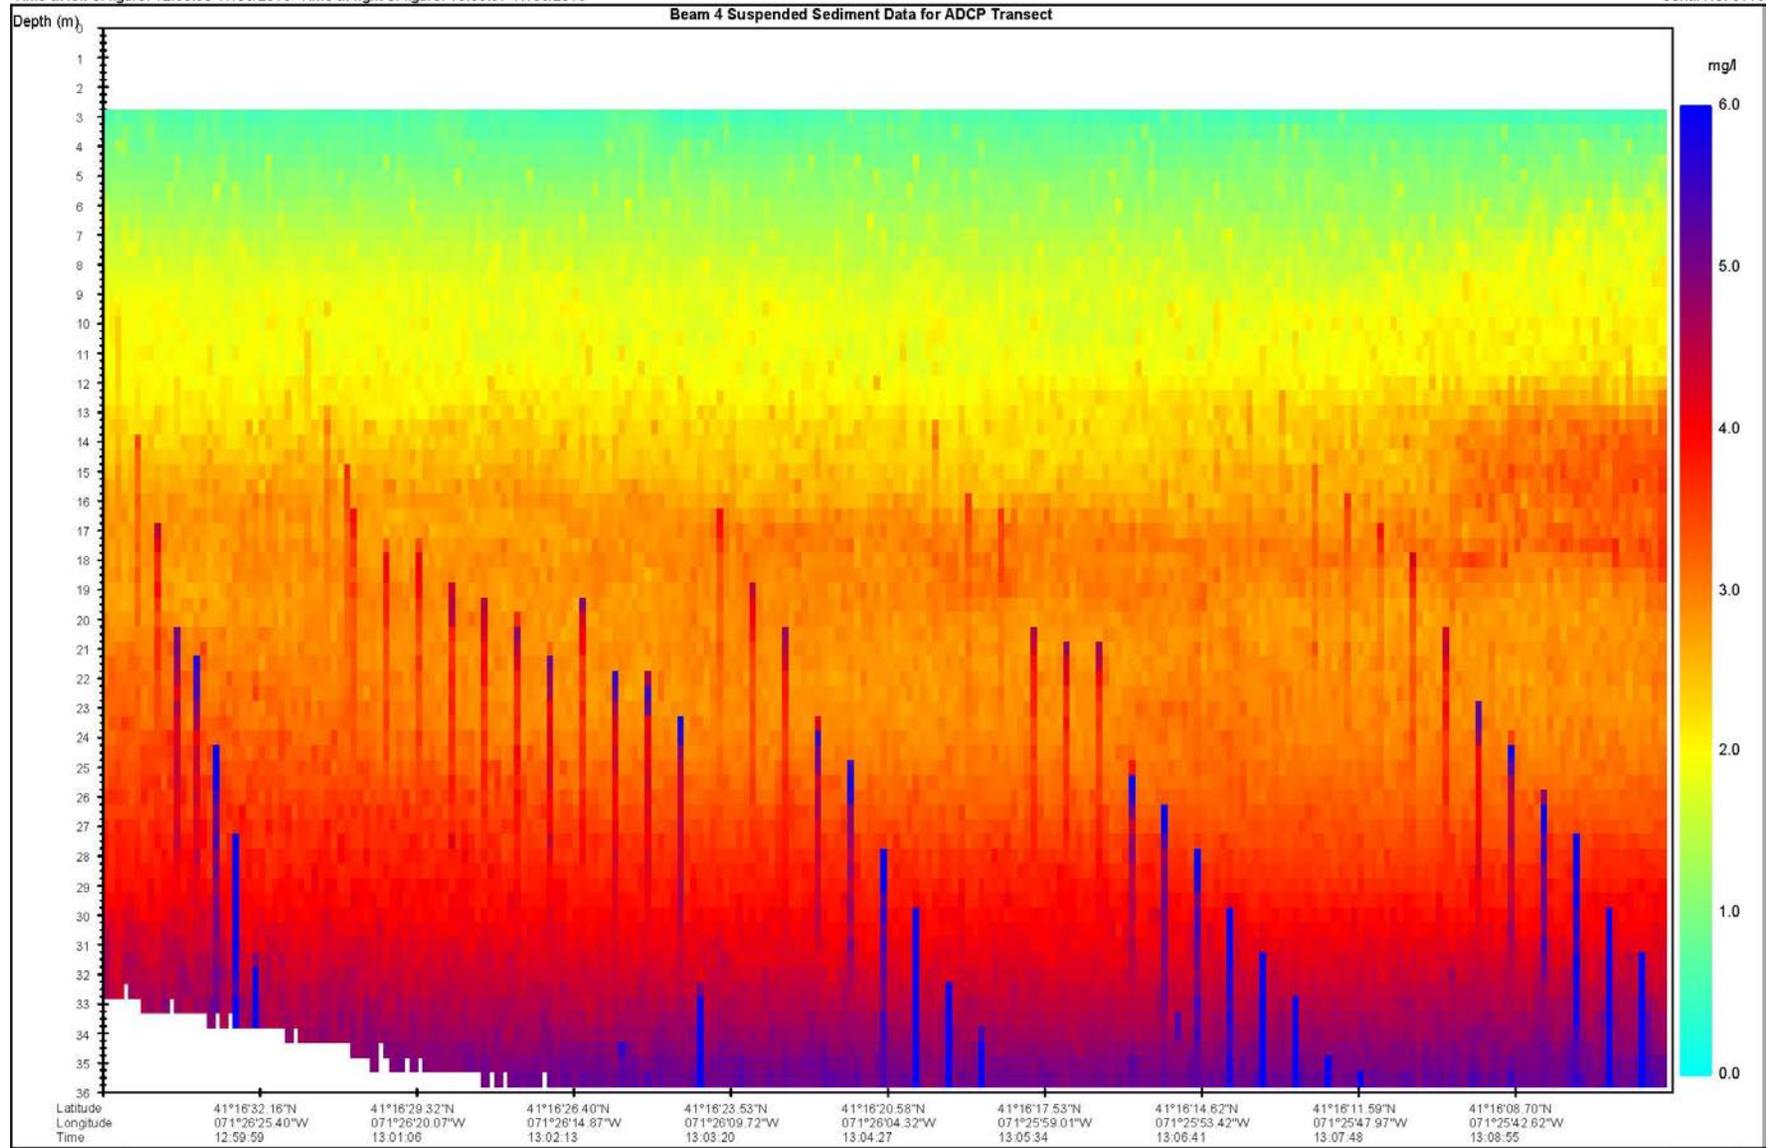
Colour Contour Plots of Current Speed and Direction  
Block Island Sediment Plume Monitoring, Jet Plow 2
