# Observing Cable Laying and Particle Settlement During the Construction of the Block Island Wind Farm

US Department of the Interior  
Bureau of Ocean Energy Management  
Office of Renewable Energy Programs

**March 2017**

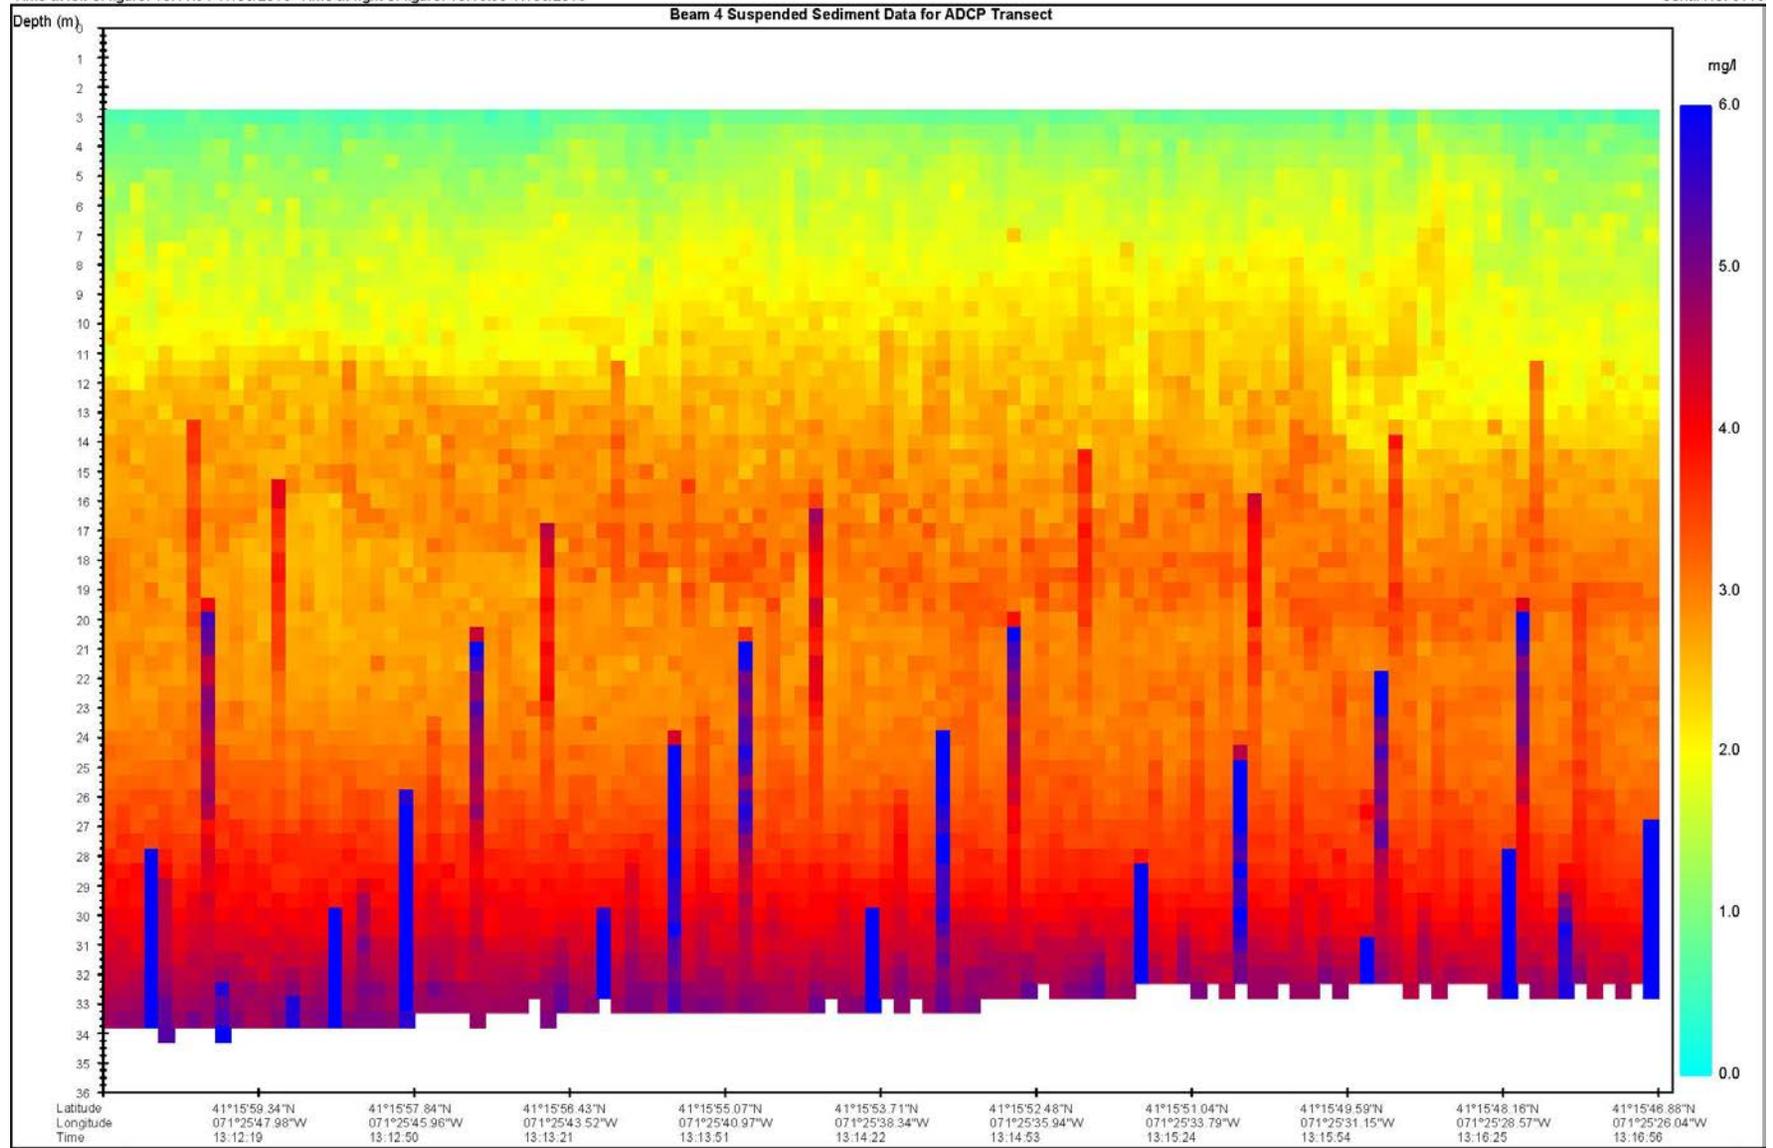
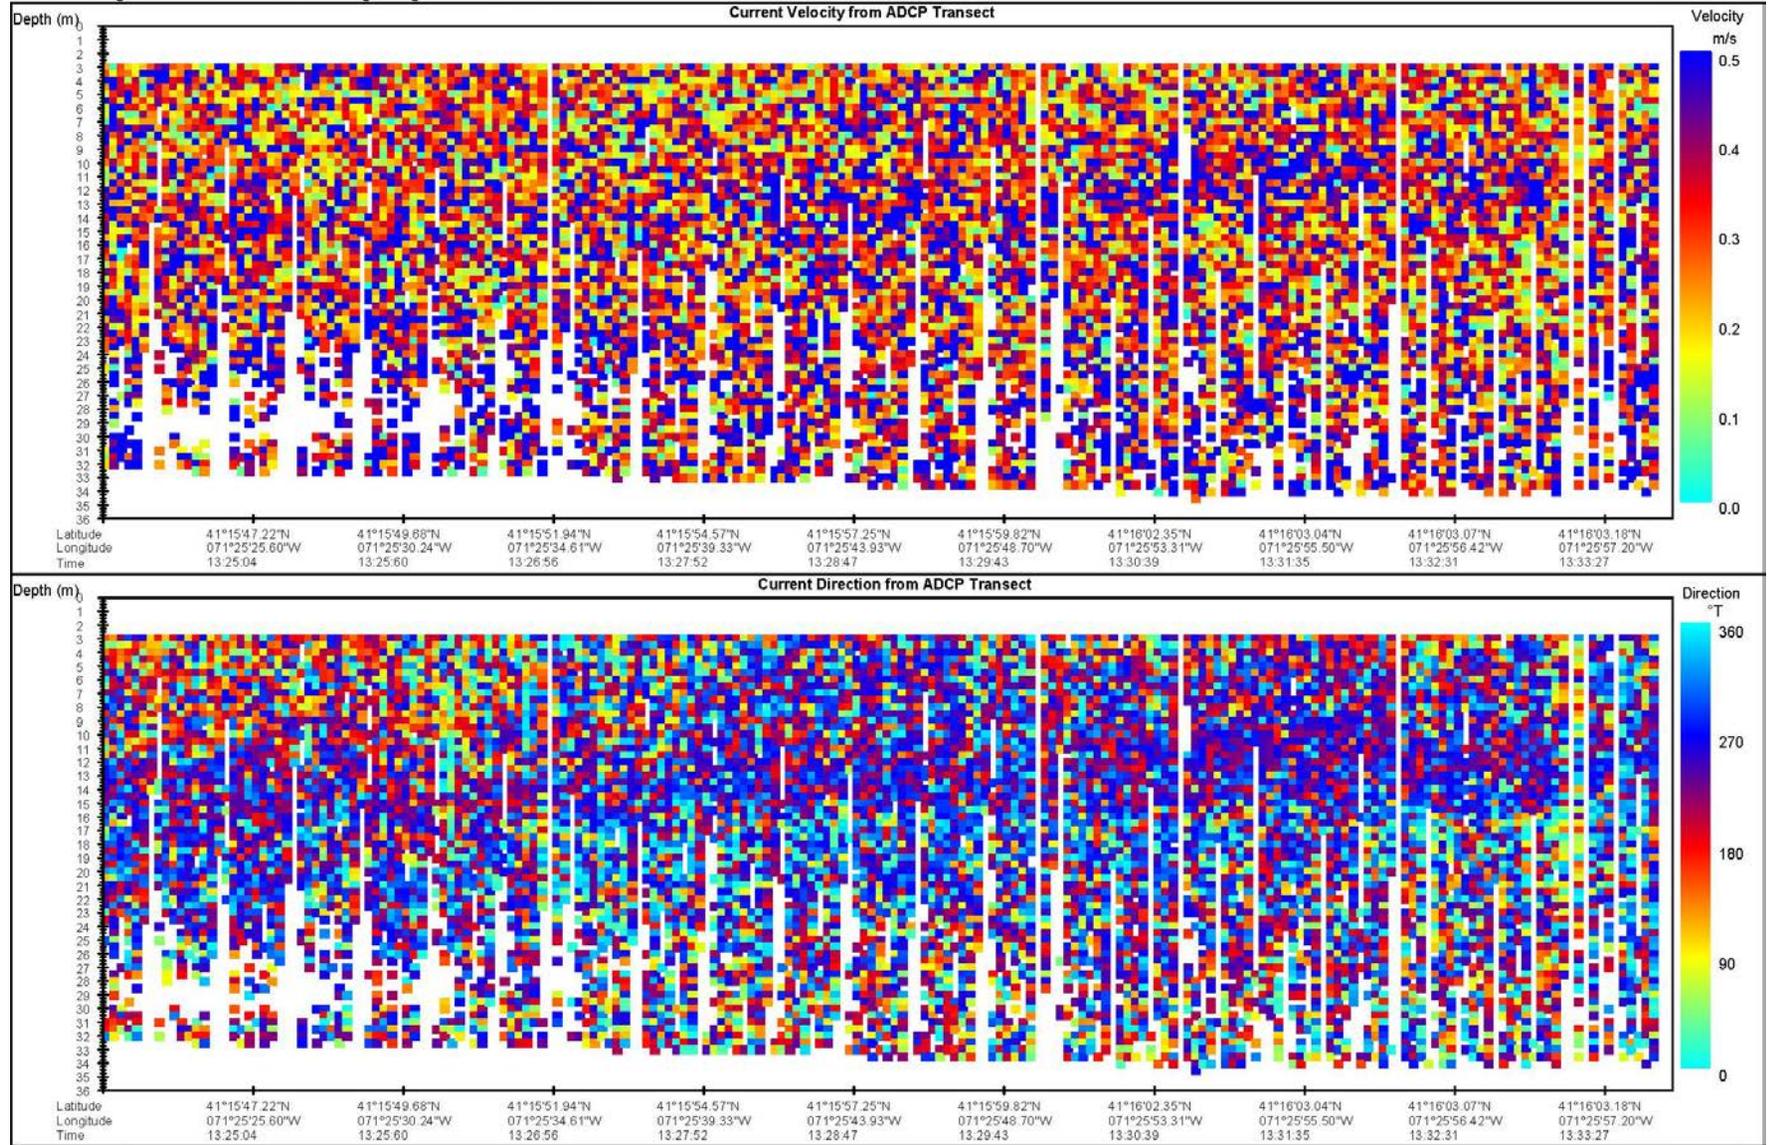
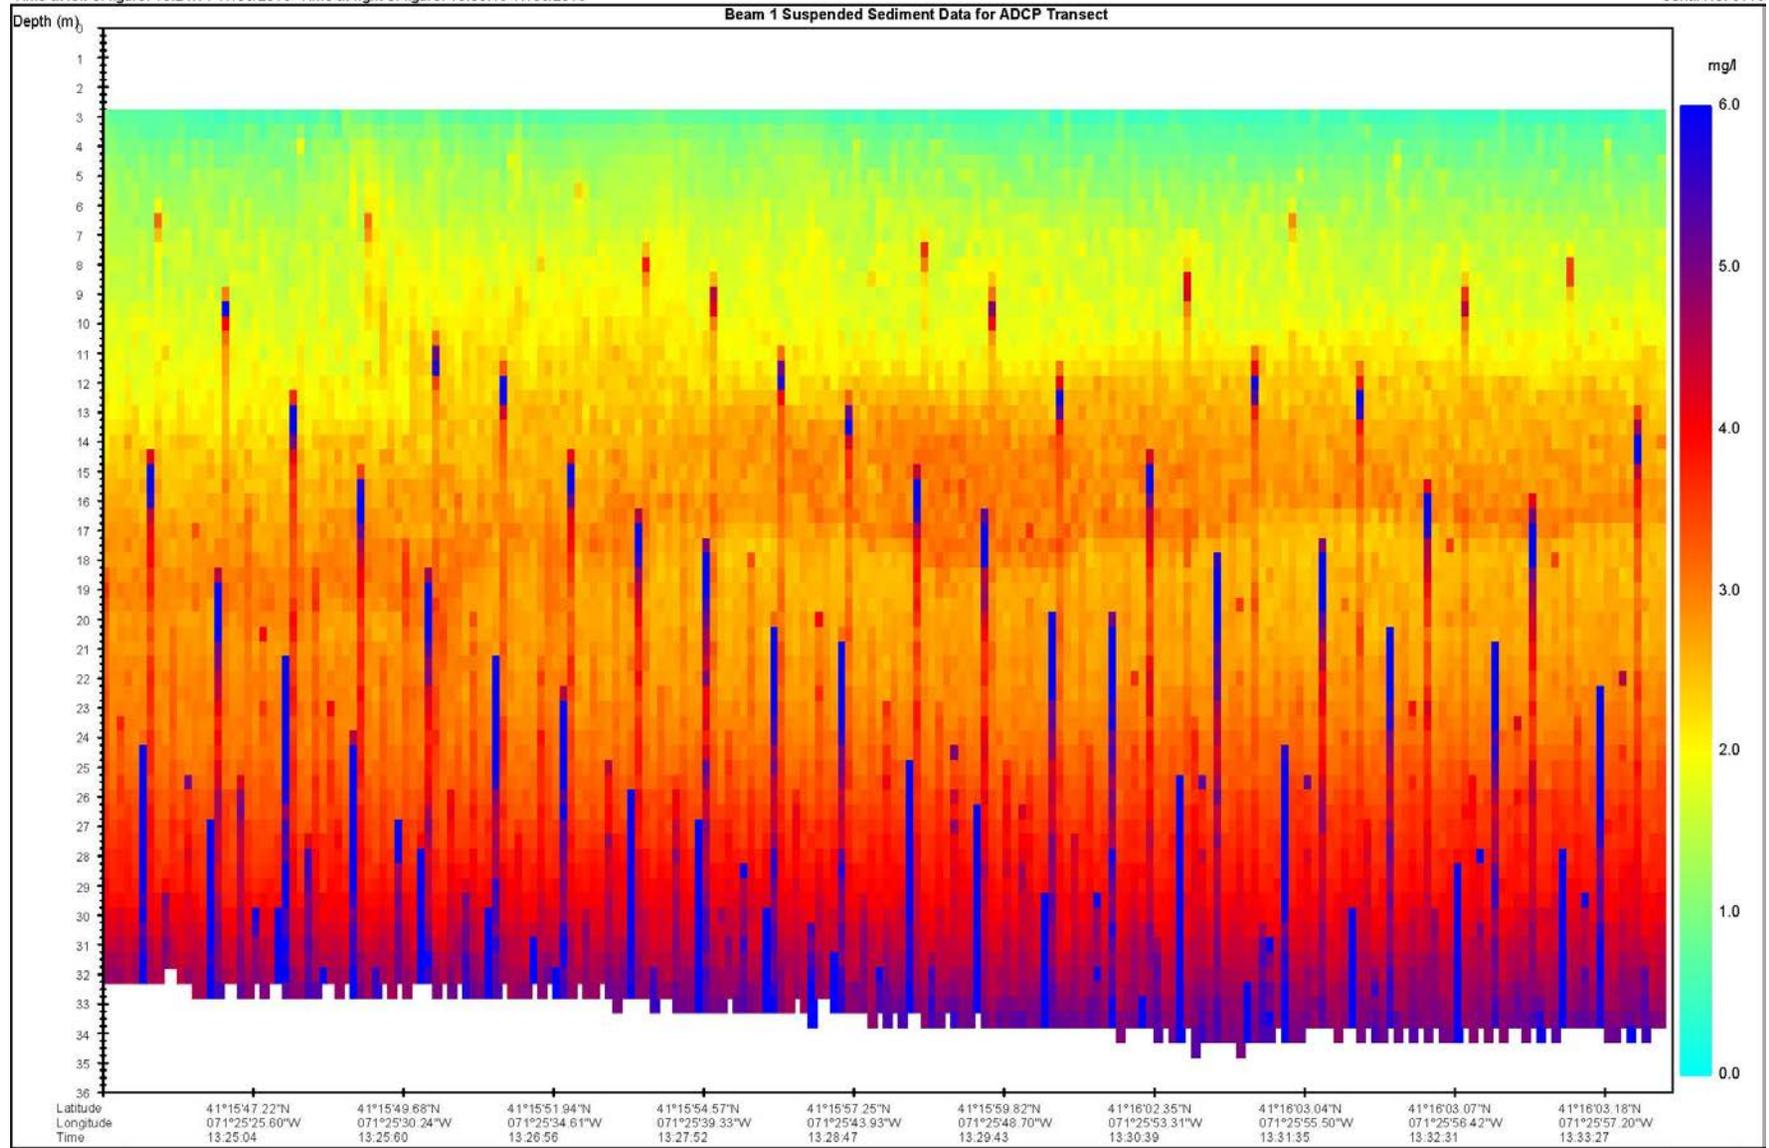
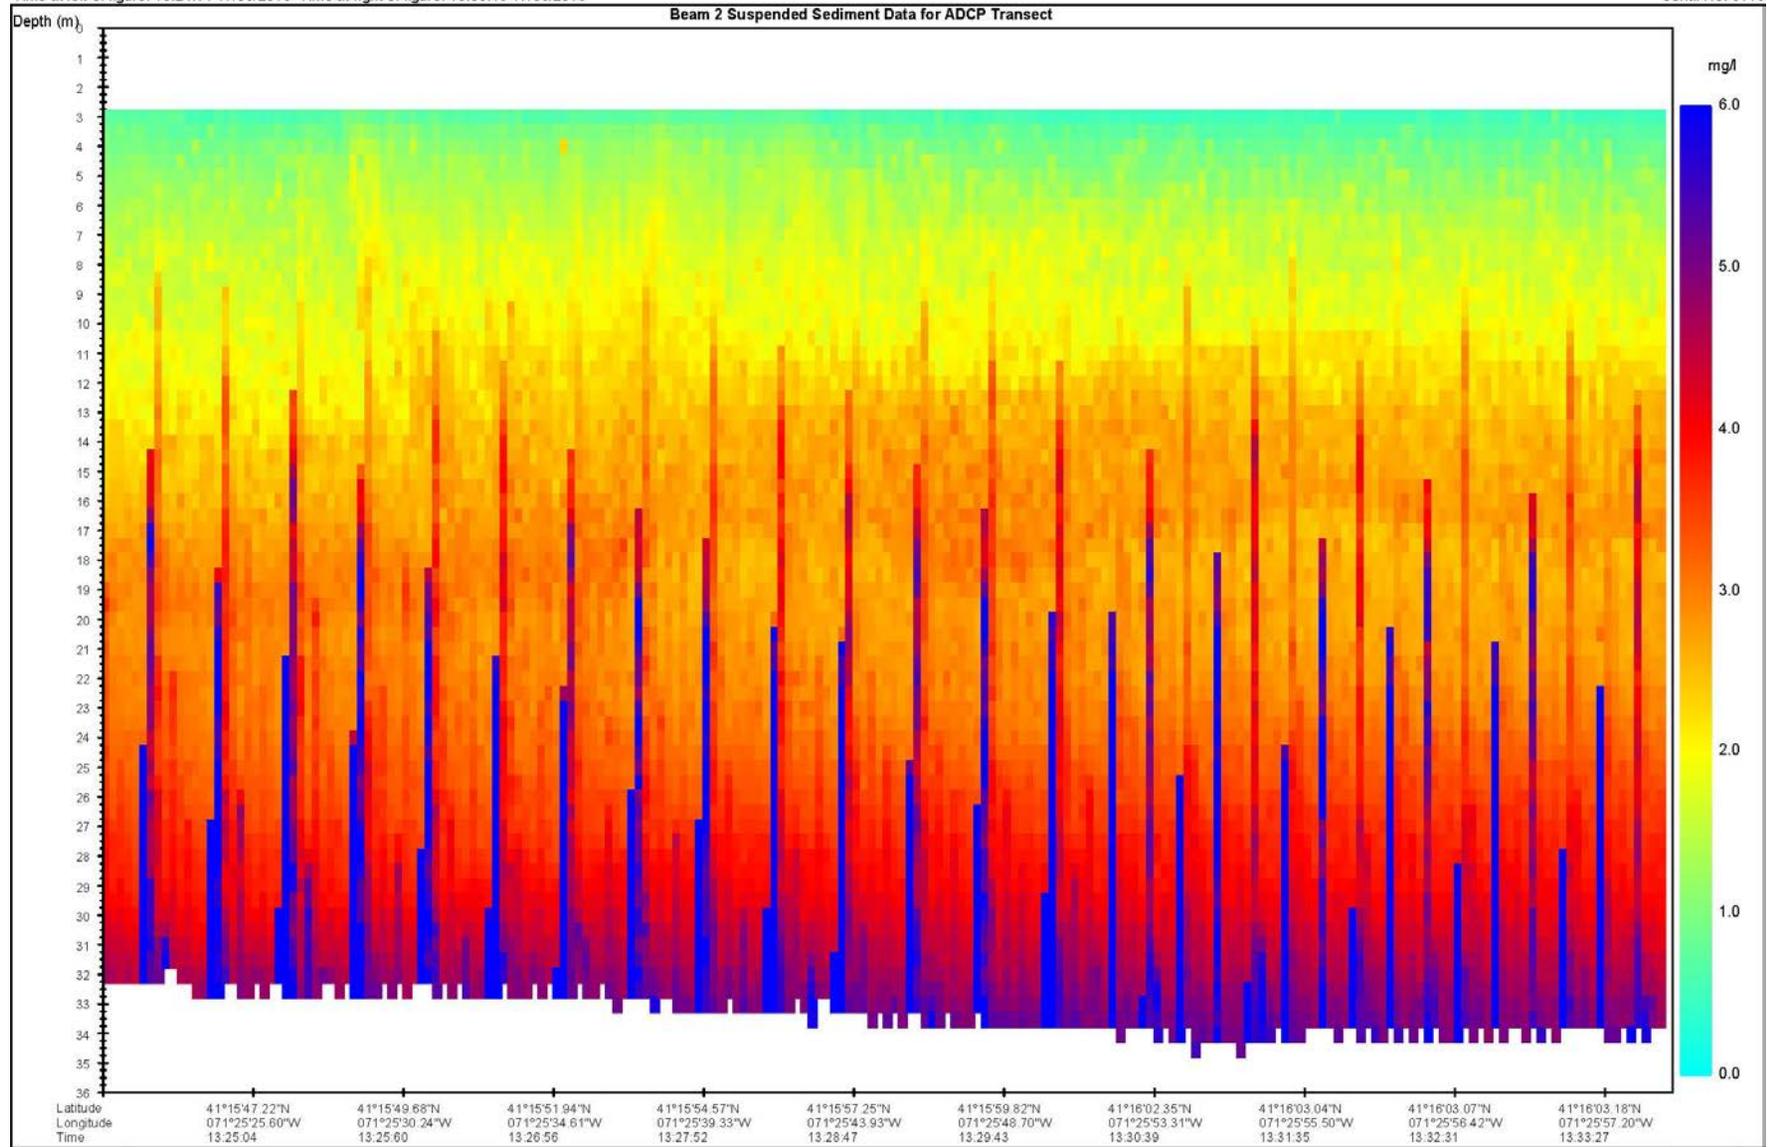
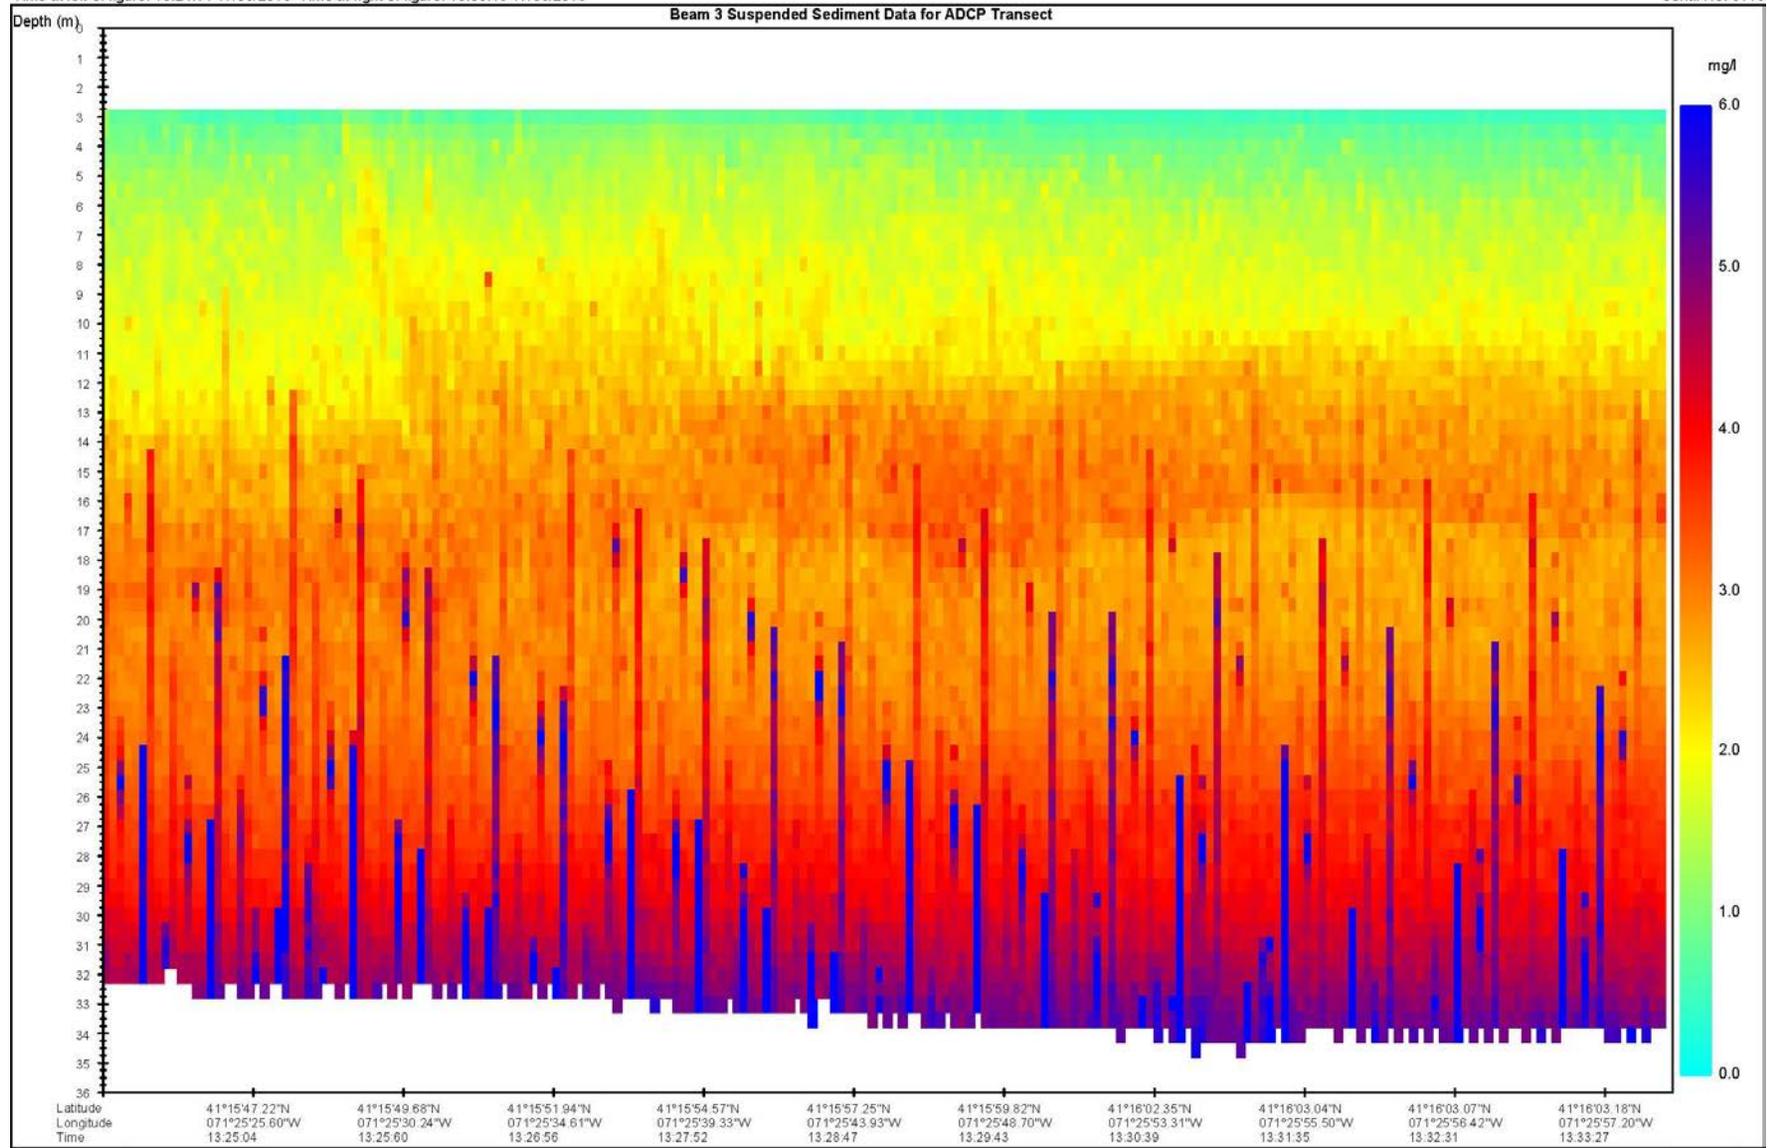
**Colour Contour Plots of Current Speed and Direction**  
**Block Island Sediment Plume Monitoring, Jet Plow 3**

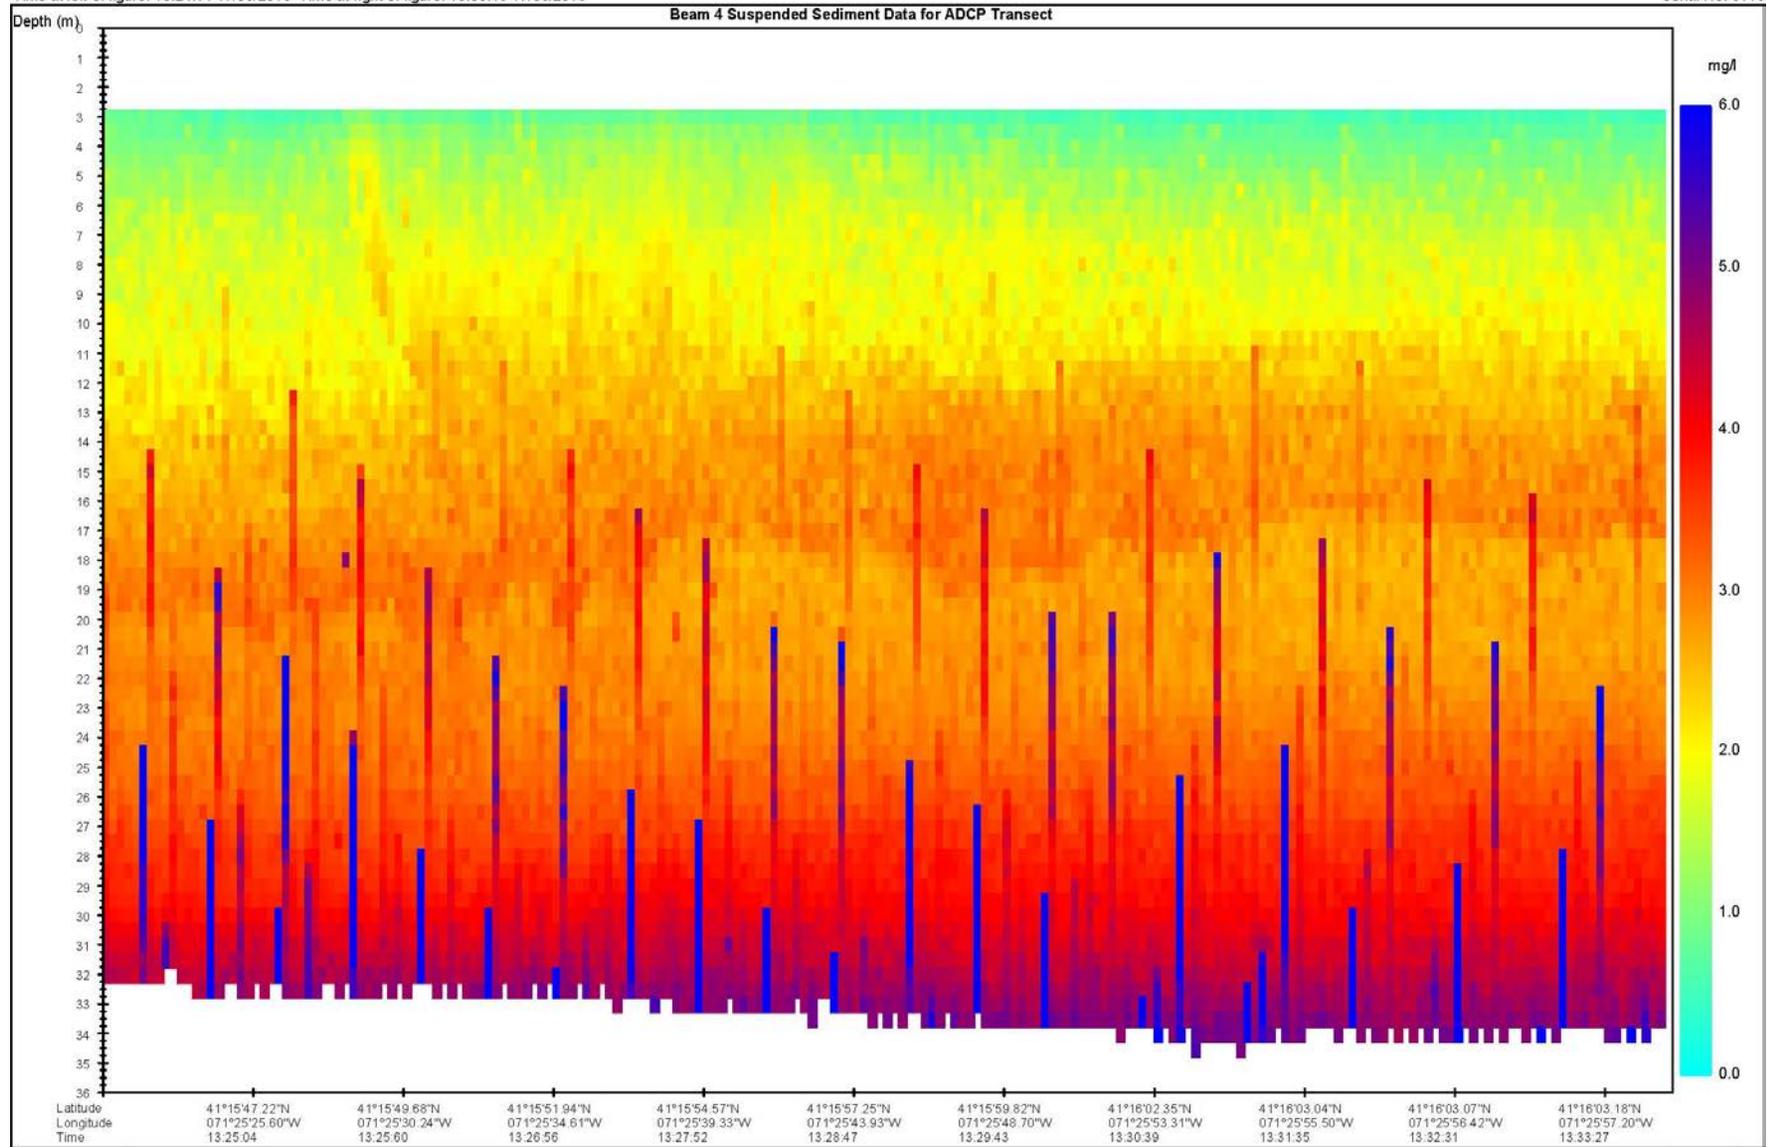
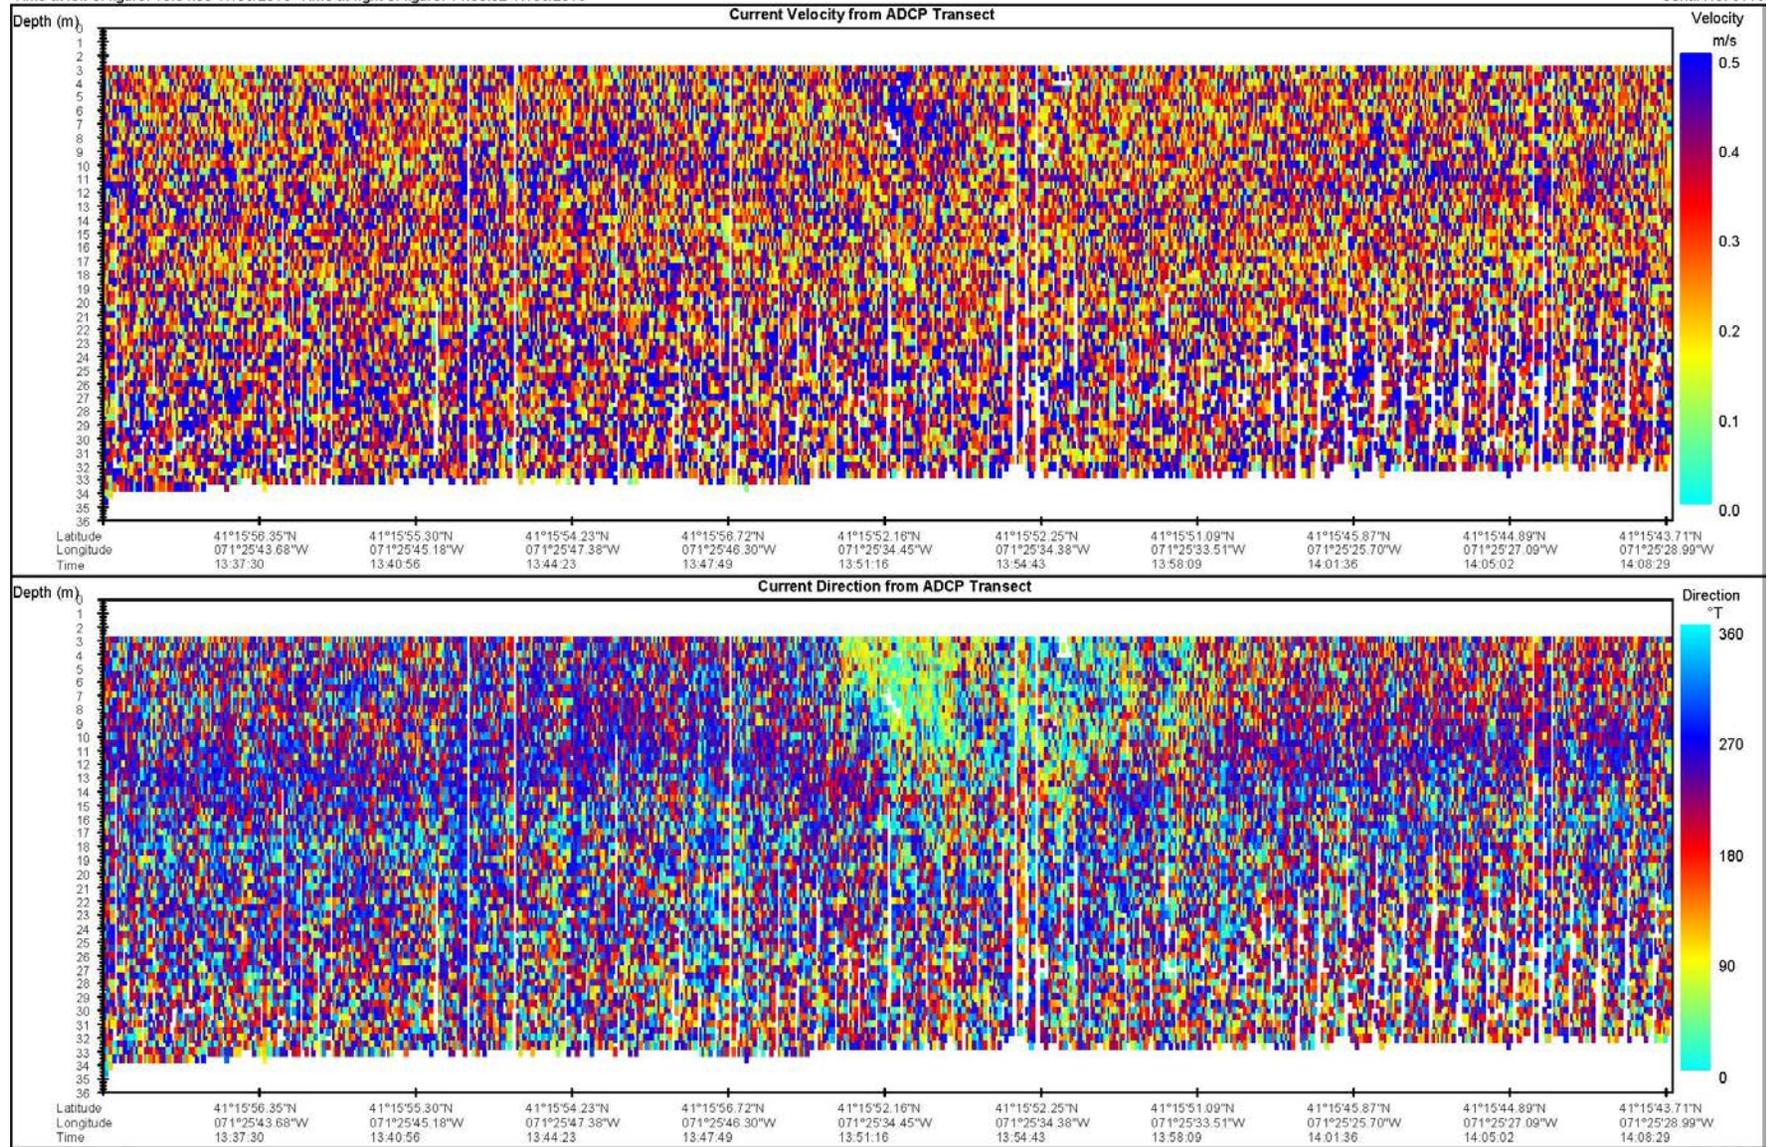
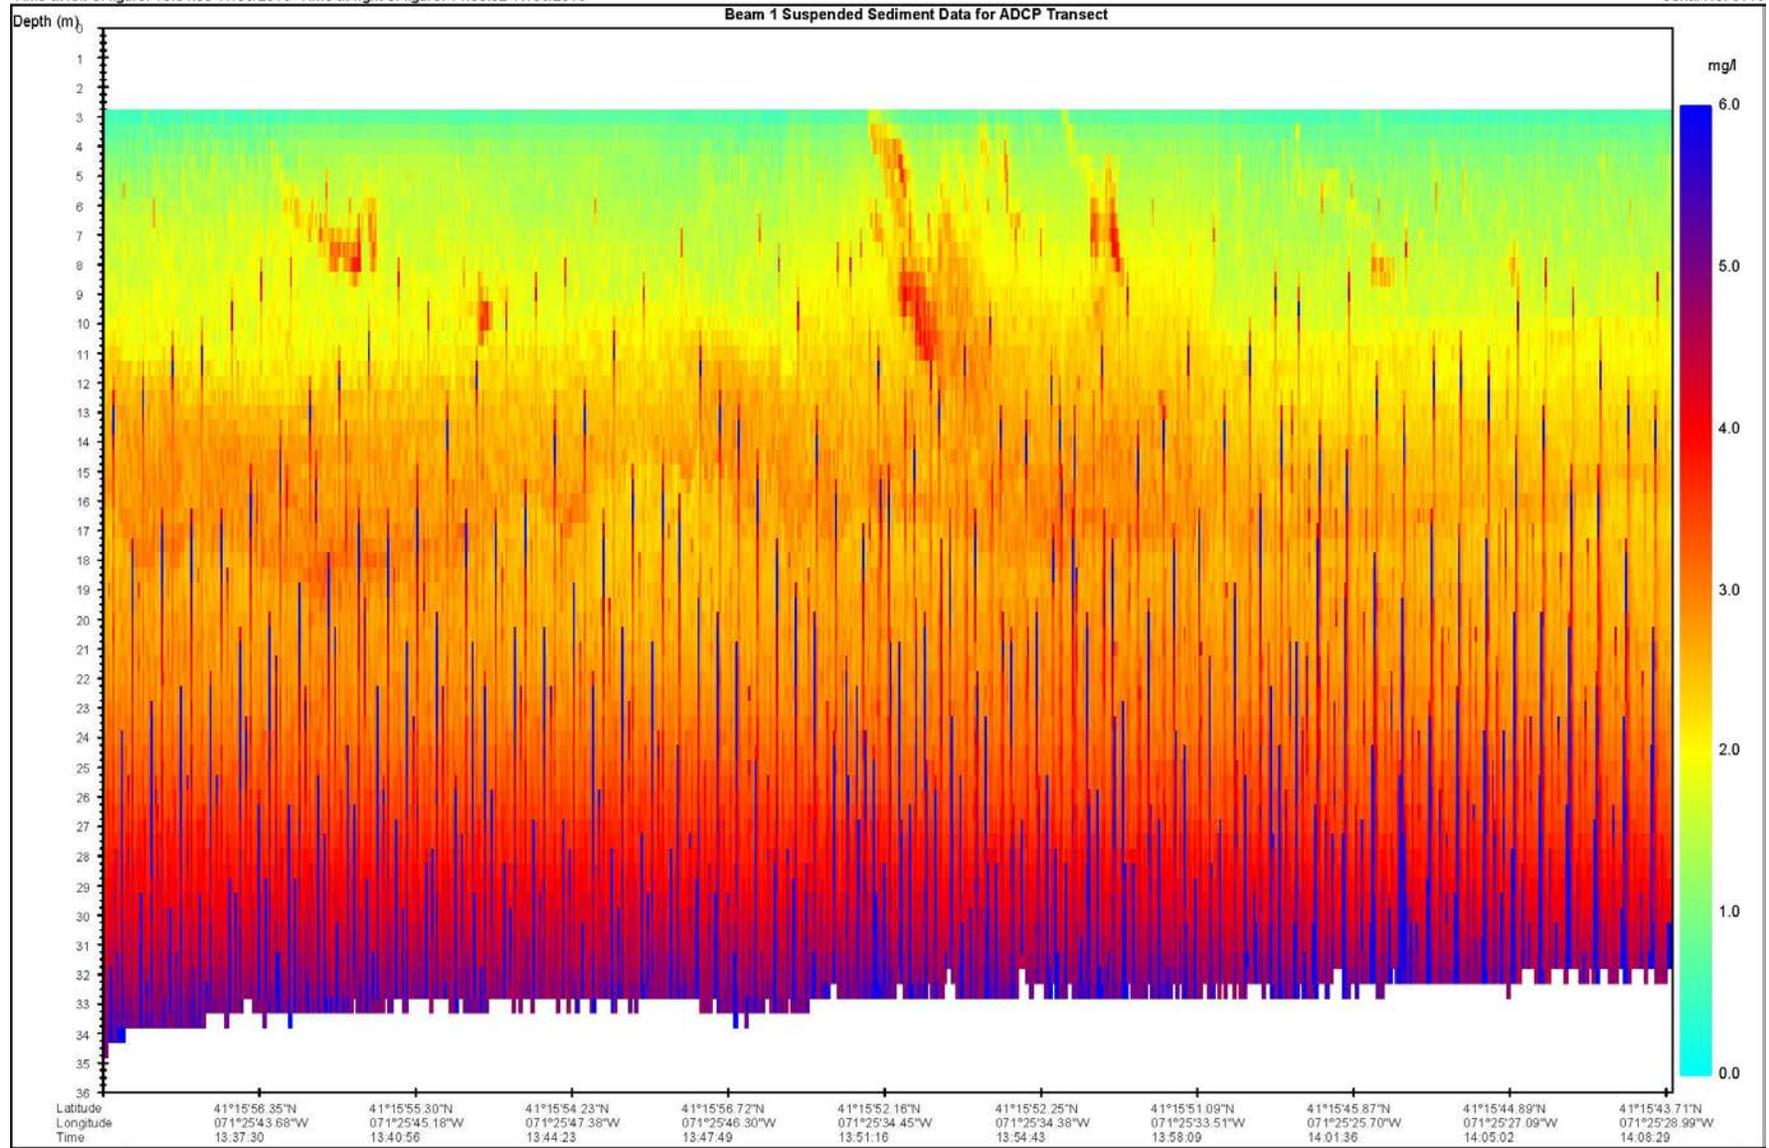
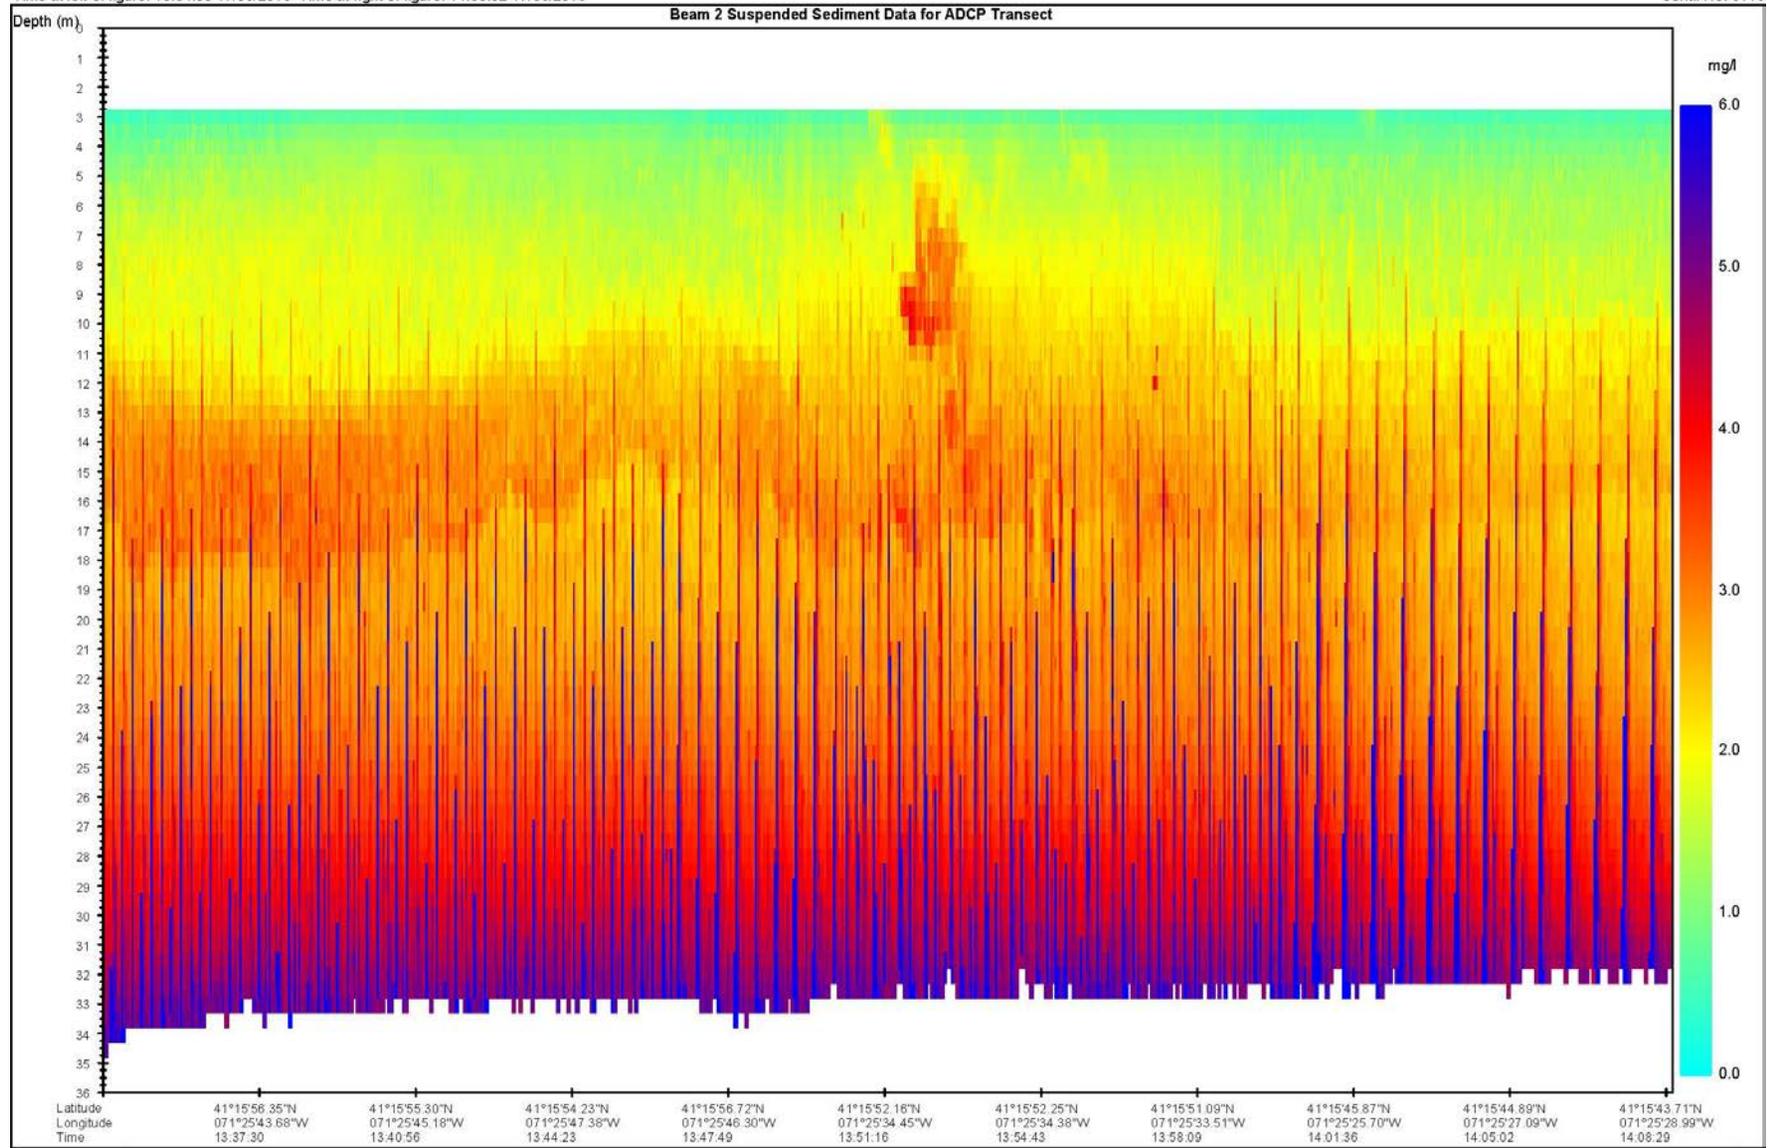
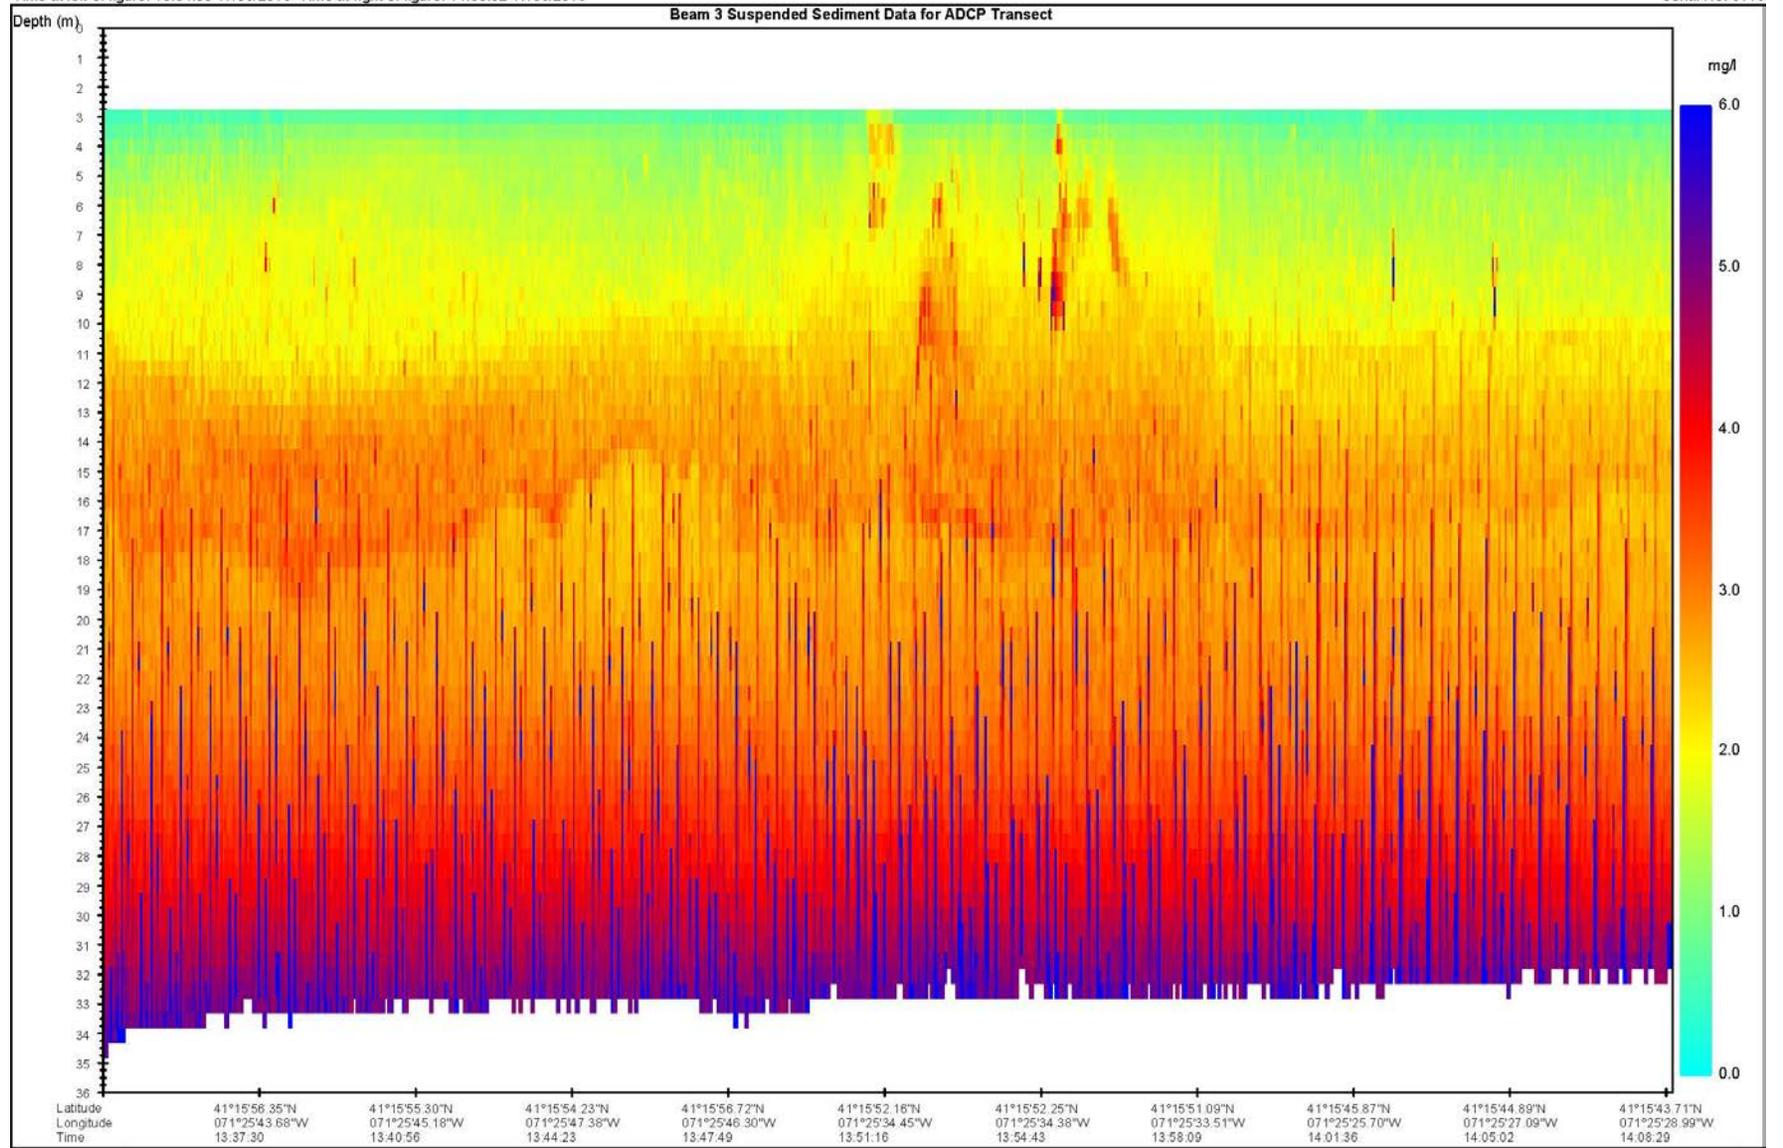
Colour Contour Plots of Current Speed and Direction  
Block Island Sediment Plume Monitoring, Jet Plow 4
