Field Observations During Wind Turbine Installation at the Block Island Wind Farm, Rhode Island

May 2019

HDR. 2019. Field Observations During Wind Turbine Installation at the Block Island Wind Farm, Rhode Island. Final Report to the U.S. Department of the Interior, Bureau of Ocean Energy Management, Office of Renewable Energy Programs. OCS Study BOEM 2019-027. 292 pp.

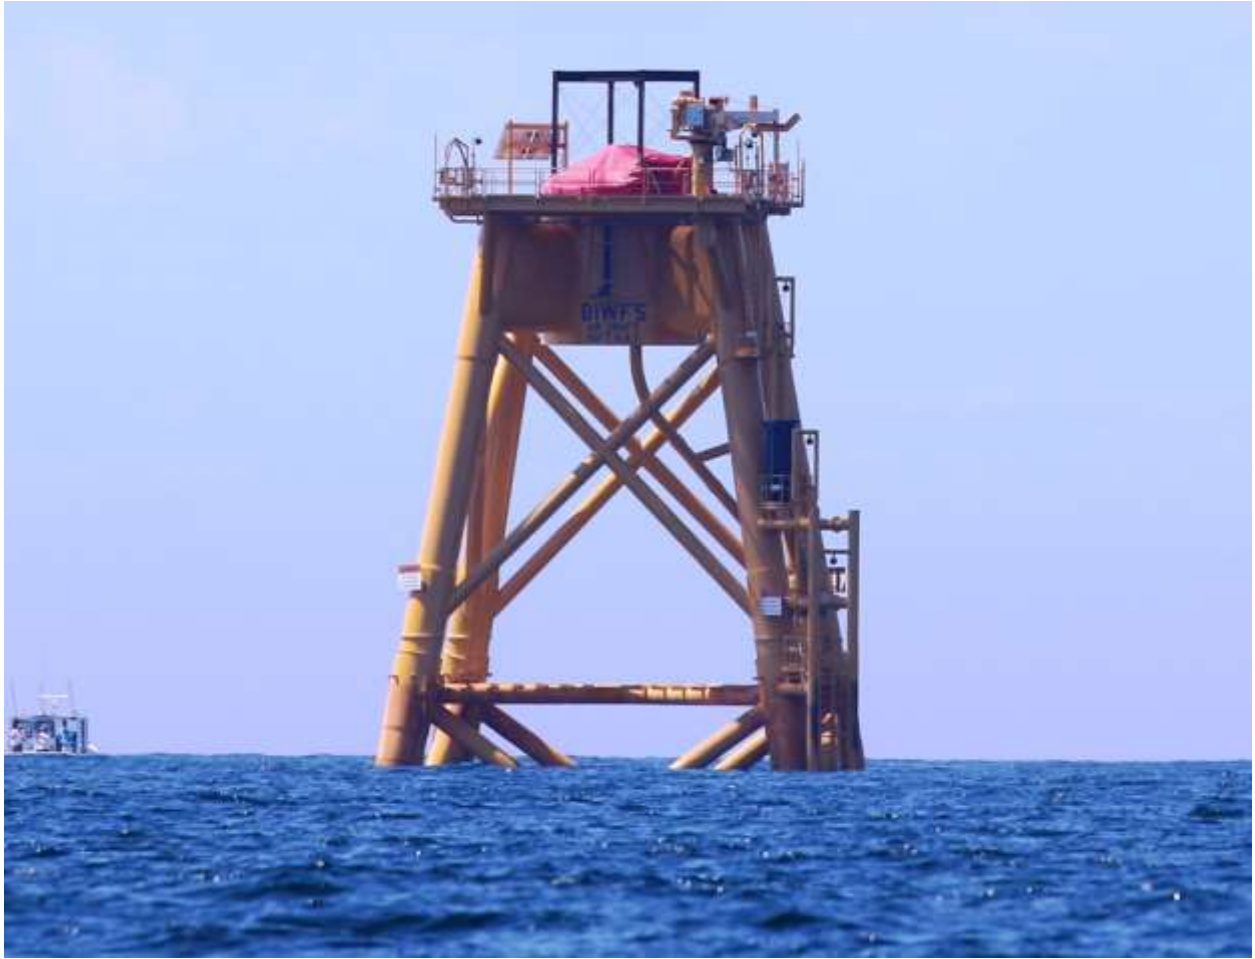
Figure 3. Fully assembled WTG 5 foundation

A transition deck was then placed on top of the jacket and bolted in place to complete the foundation. **Figure 2** shows a schematic of a fully assembled WTG foundation; a photograph of the assembled WTG 5 foundation is shown in **Figure 3**. Key observations from the RODEO Program environmental monitoring conducted during construction Phase 1 are presented a separate report entitled “*Field Observations during Wind Turbine Foundation Installation at the Block Island Wind Farm, Rhode Island*” (HDR 2018).

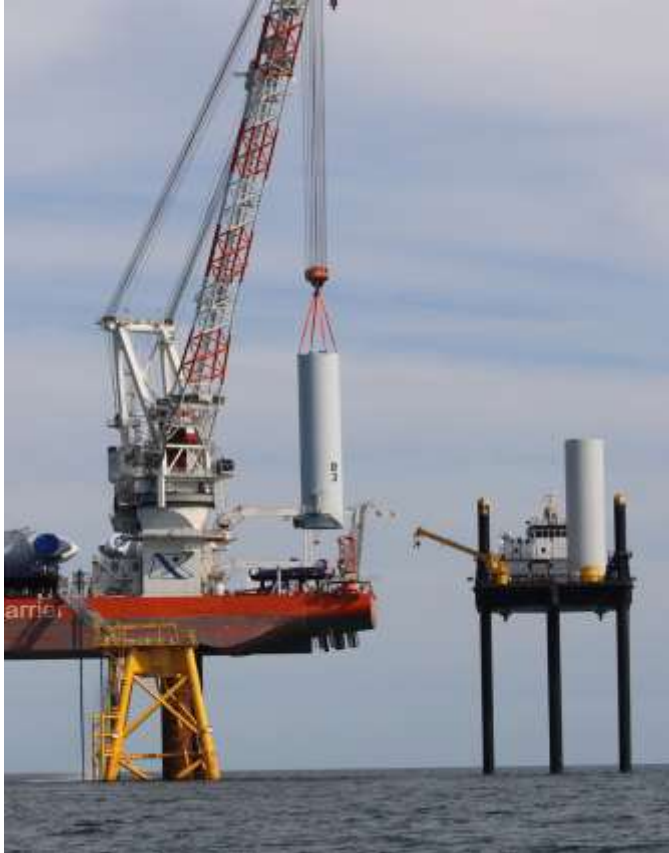
Figure 12. Placing the tower section at WTG 3.

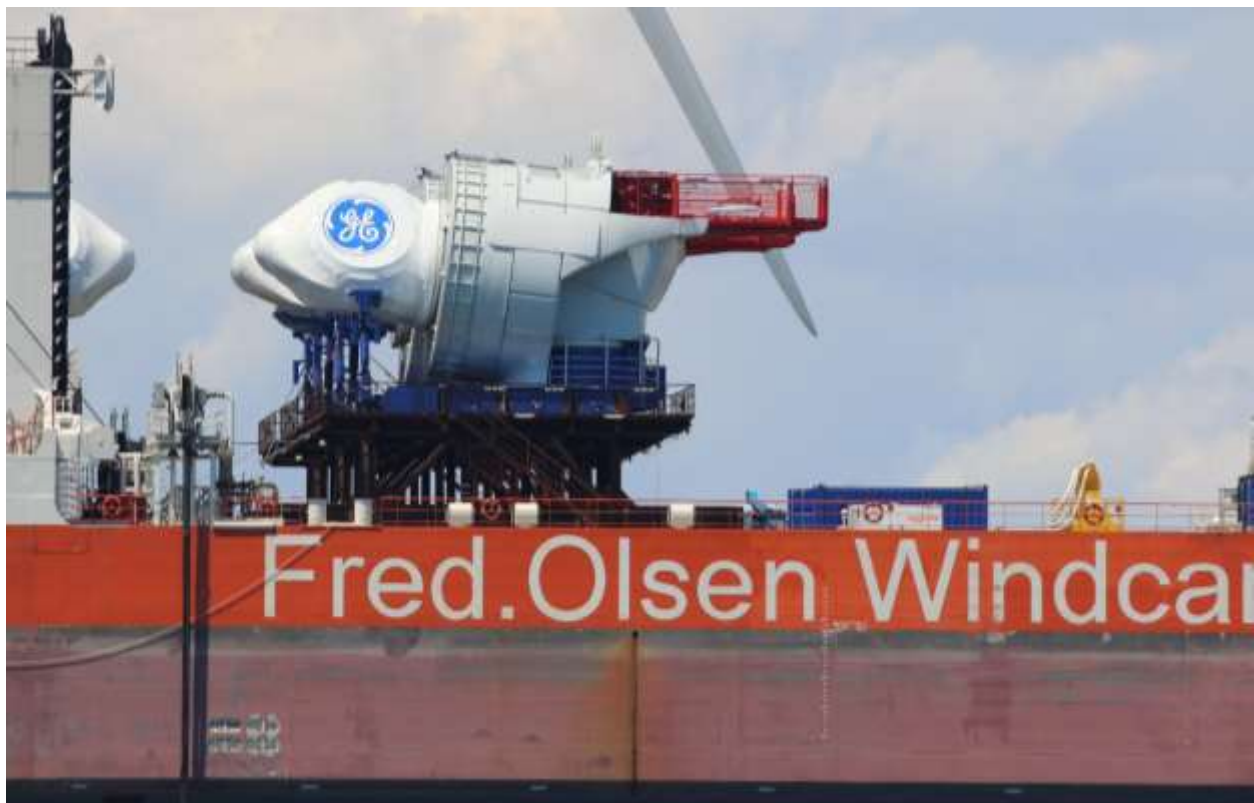
Figure 15. Nacelles stored on the deck of L/B Brave Tern.

Figure 15 shows a nacelle prior to it being lifted off the deck of the L/B *Brave Tern*. Lifting and placement of the nacelle on WTG 4 is shown in **Figures 16 and 17**. The worker positioned in the blade opening of the nacelle can be used as a scale for **Figure 17**. All three turbine blades to be installed on a given tower were stored and transported to the site on the L/B *Paul* (**Figure 18**). Each blade was 73 m (240 ft) in length and weighs 29 tons (58,000 pounds). The blades were lifted from L/B *Paul* using a specially designed cradle, which was attached to the crane (**Figure 18**). Placement of the blade into the nacelle at WTG 4 using the specialized cradle is shown in **Figures 19 and 20**. Fully assembled WTG 1, 2 and 3 are seen in **Figure 21**. Significant events that occurred during Phase 2 construction are summarized in **Table 4**, and approximate installation times for the various components are listed in **Table 5**.

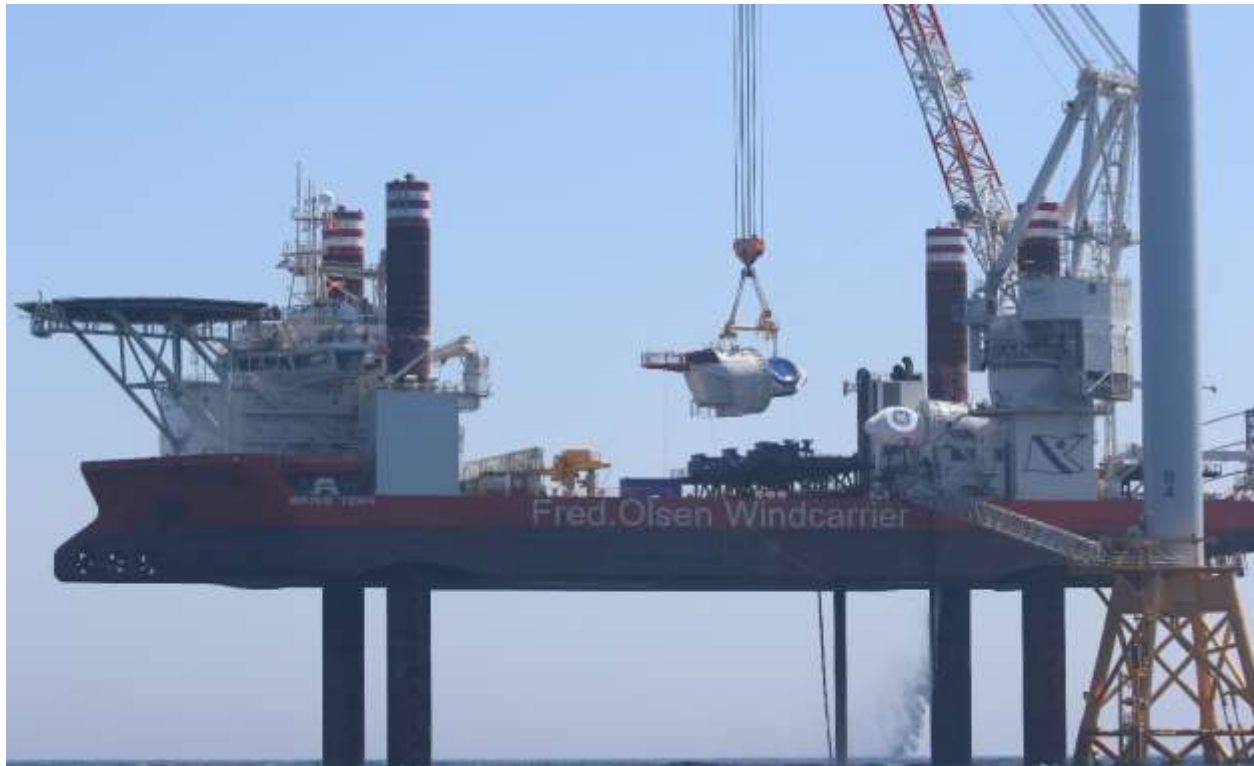
Figure 16. Lifting nacelle off the deck of L/B Brave Tern.

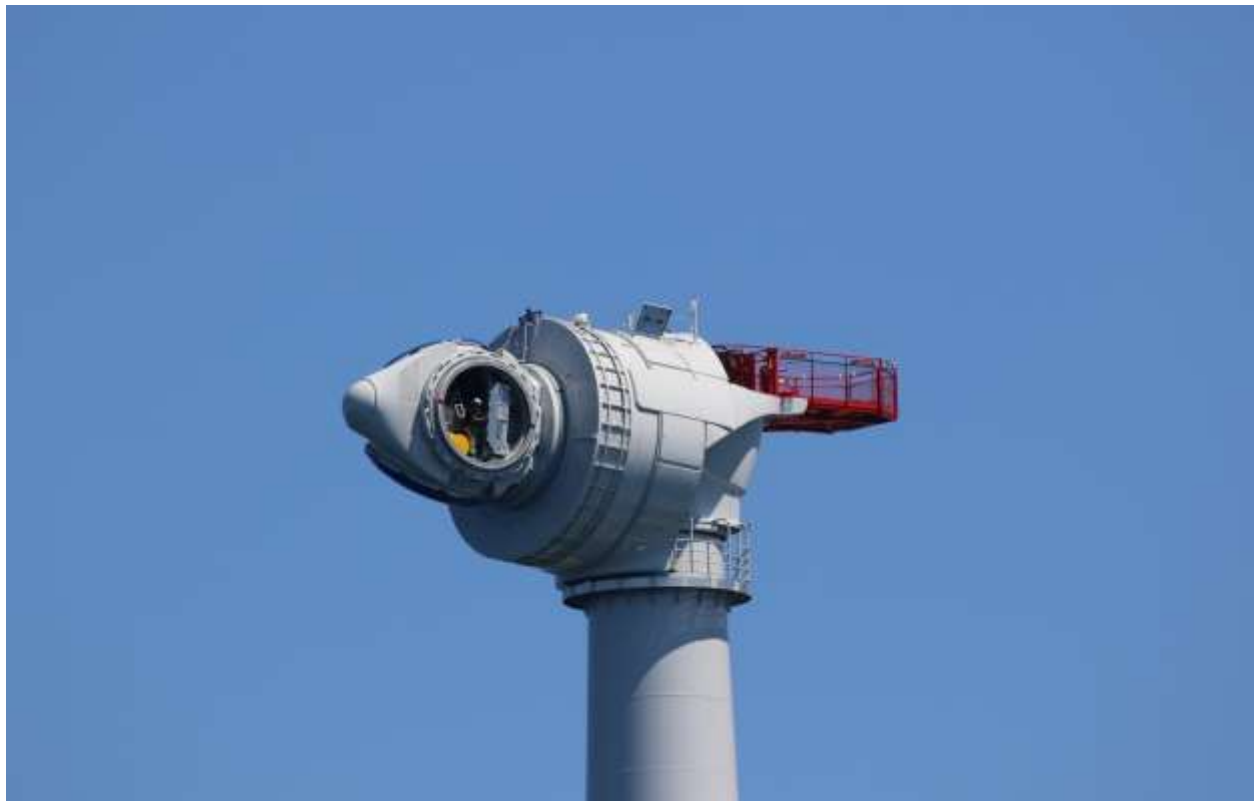
Figure 17. Nacelle placed on top of tower section.

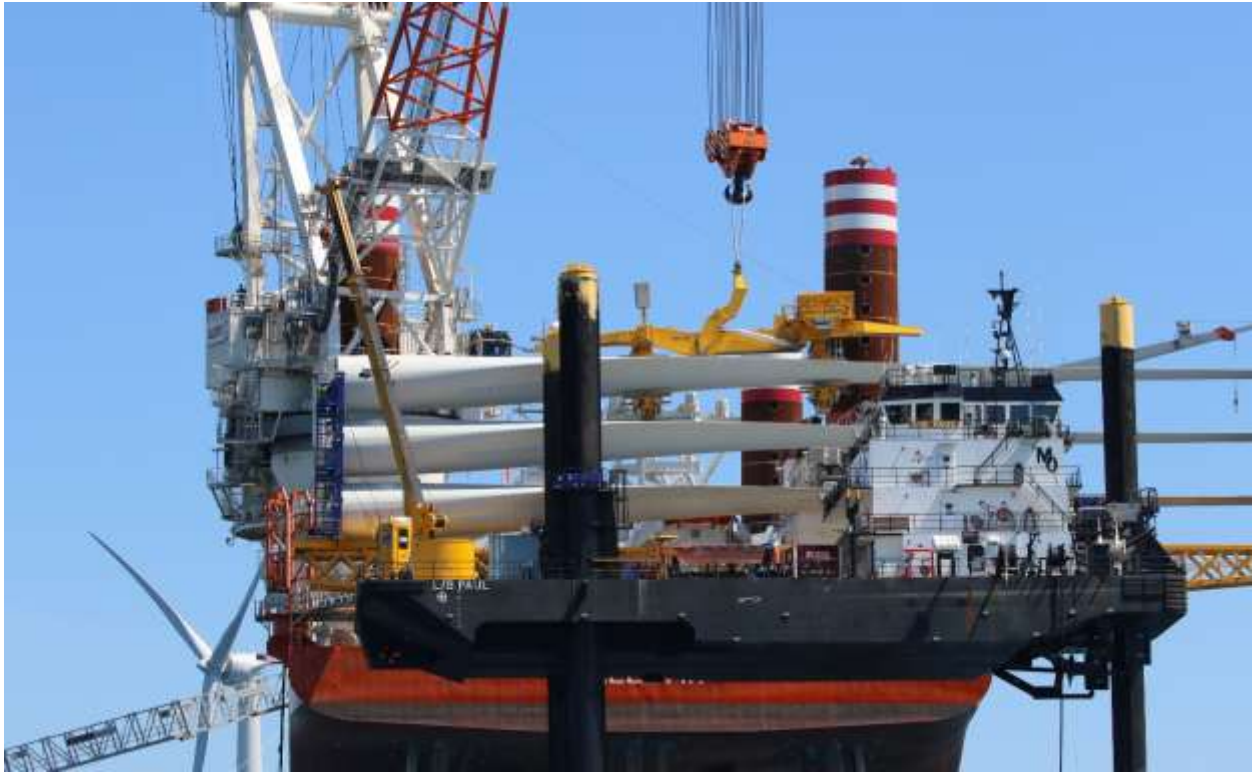
Figure 18. L/B Brave Tern lifting turbine blades from L/B Paul.

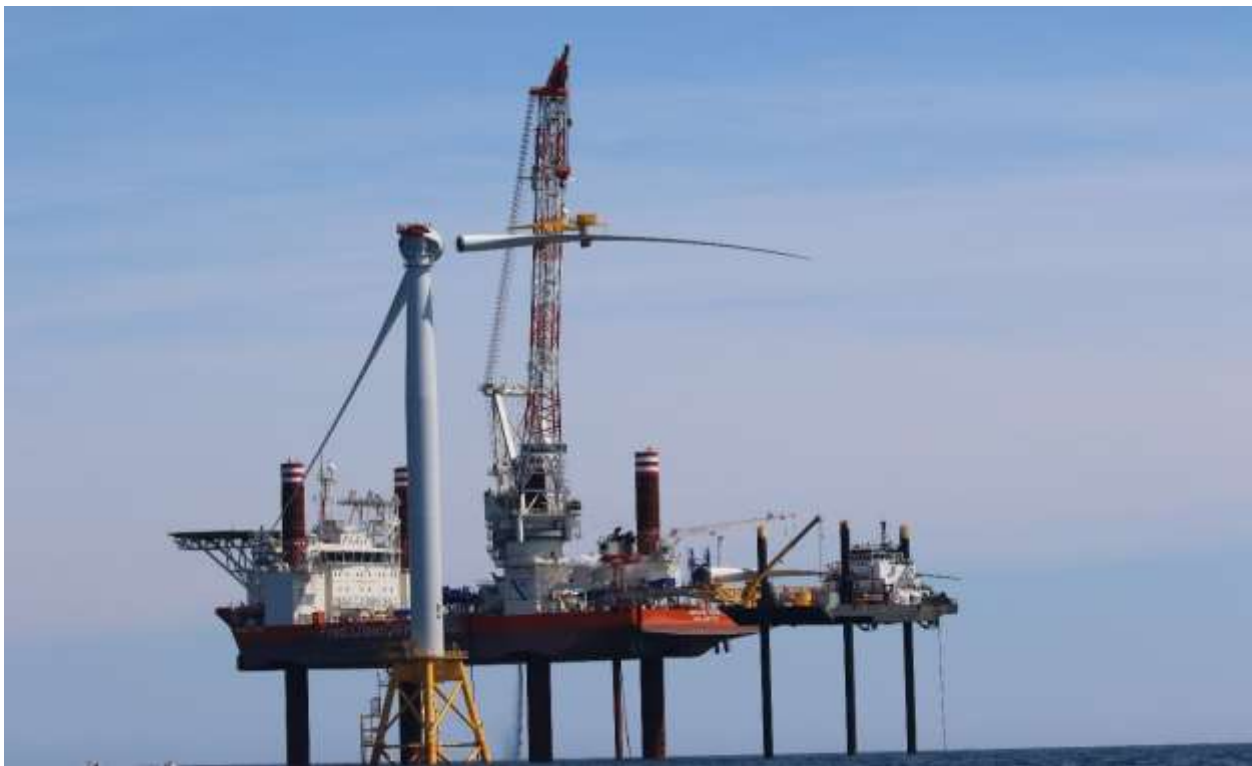
Figure 19. Attaching blade to nacelle at WTG 4.

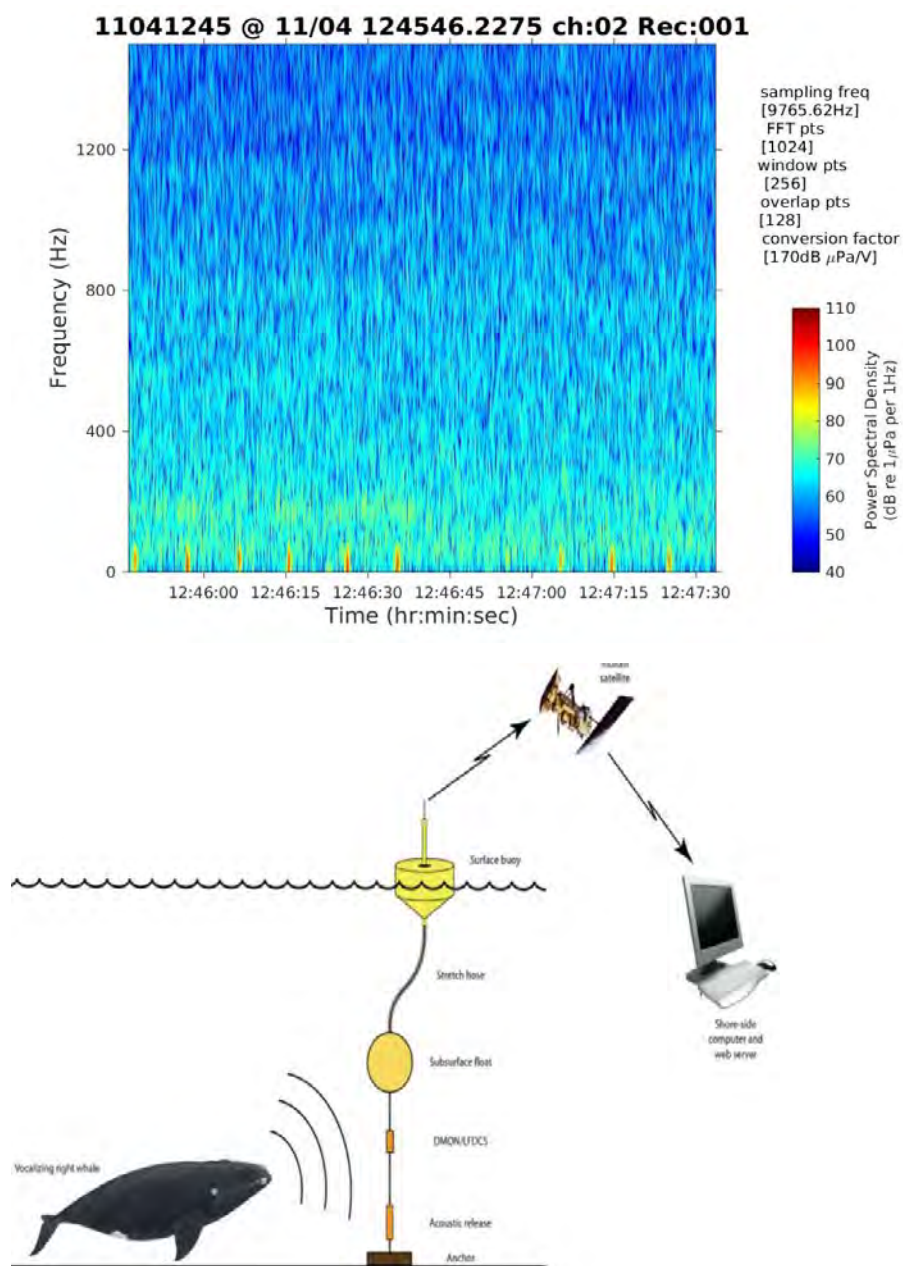
Figure 8. Spectrogram of the acoustic data recorded on the 15-km vertical array mooring on November 4, 2015 showing fin whale calls centered at 20 Hz.

A fin whale was detected on the 15 km SHRU mooring on November 4, 2015, as shown in **Figure 8**. The data shown at <http://dcs.who.edu/nomans0315/nomans0315.shtml> for the Nomans Land Island DMON also detected fin whales call during the same period, showing the potential of joint detection and hence the possibility for localization.

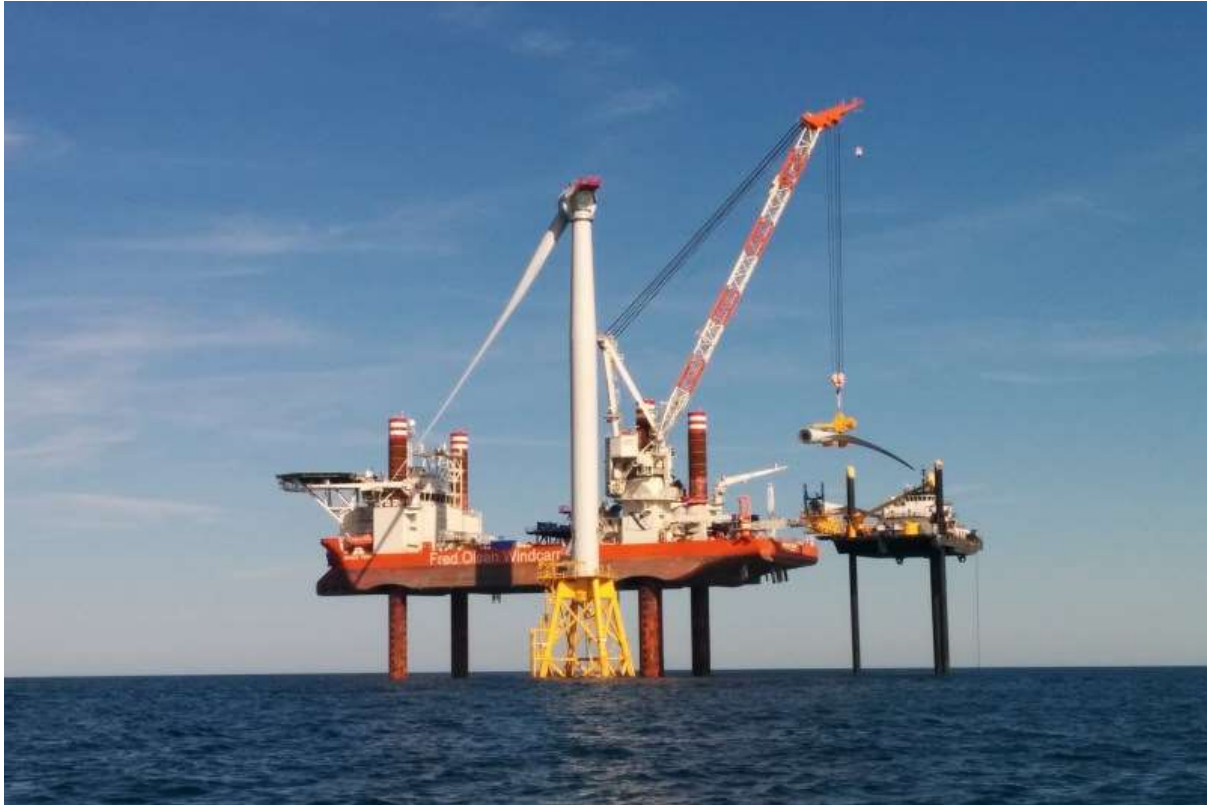
Figure 1-1 Jacket with four driven piles under construction

The tower under construction can be seen in Figure 1-1.

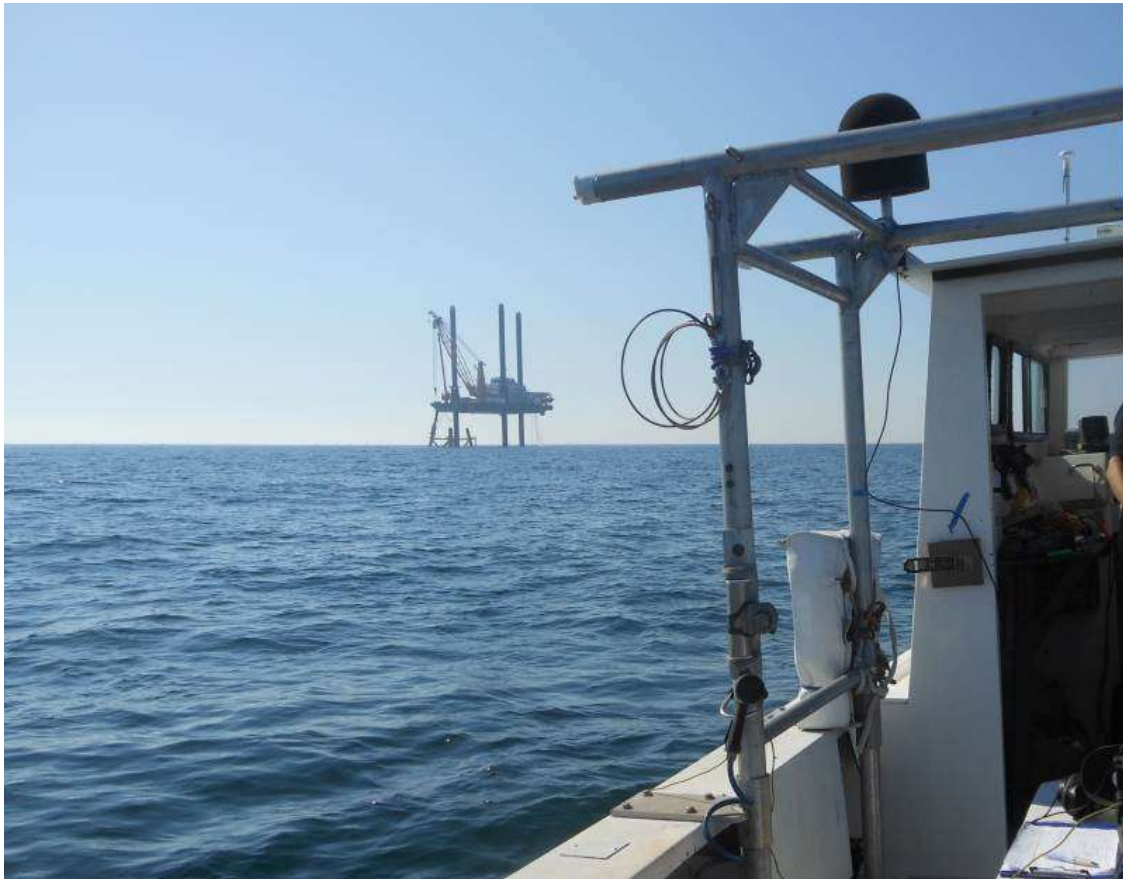
Figure 2-2 McMaster deck showing microphone positioning and high performance windscreen (jack-up barge for piling in background)

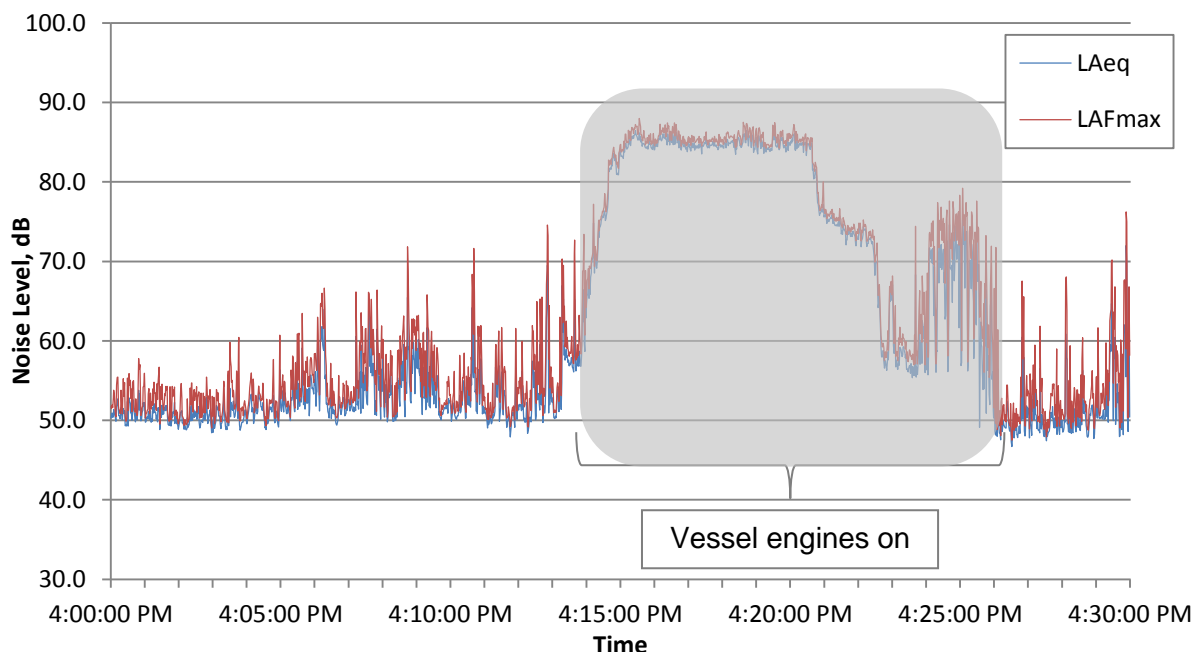
Figure 3-1 Typical sample background noise level measured offshore, August 25, 2015
