Seafloor Disturbance and Recovery Monitoring at the Block Island Wind Farm, Rhode Island - Summary Report (Year 6)

February 2022

CSA Ocean Sciences Inc.
8502 SW Kansas Ave
Stuart, Florida 34997

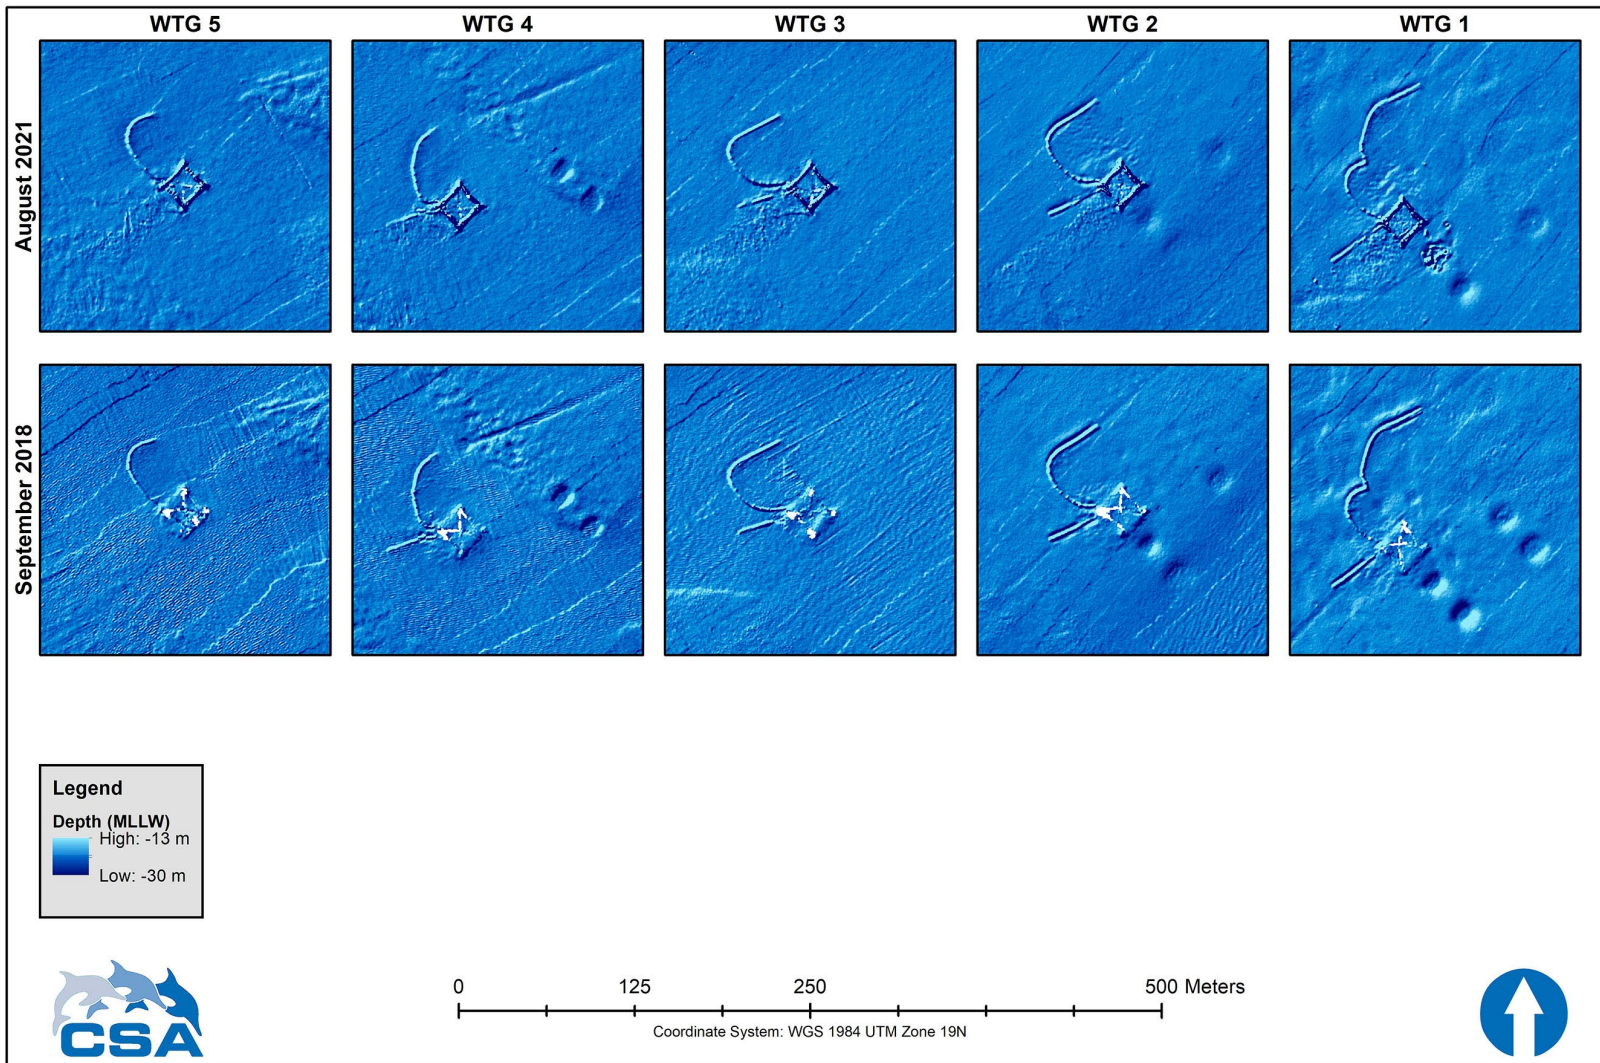
Figure 5 provides a comparison of the 2018 survey data and the 2021 survey data around each WTG. As can be observed, many of the smaller features identified in the 2018 survey have continued to recover and the larger spud features are continuing to recover. This is most noticeable in **Figure 5** as seen by in the large spud depressions near WTGs 1, 2, and 4 are significantly less prominent in the 2021 survey results compared to the 2018 survey, with infilling occurring, with at least one spud depression near WTG 1 completely recovered. In addition, the depressions created by the spud legs in the southwest adjacent to WTG1 appears to be accumulating cobble and boulders or marine debris within the depression.

Figure 5. Side-by-side comparison of the seabed disturbance and recovery monitoring data from the 2018 and 2021 surveys
