# Analyzing the Potential Impacts to Cultural Resources at Significant Sand Extraction Sites

## Volume I: Technical Report

**U.S. Department of the Interior  
Bureau of Ocean Energy Management  
Gulf of Mexico OCS Region**

**New Orleans, LA  
June 2019**

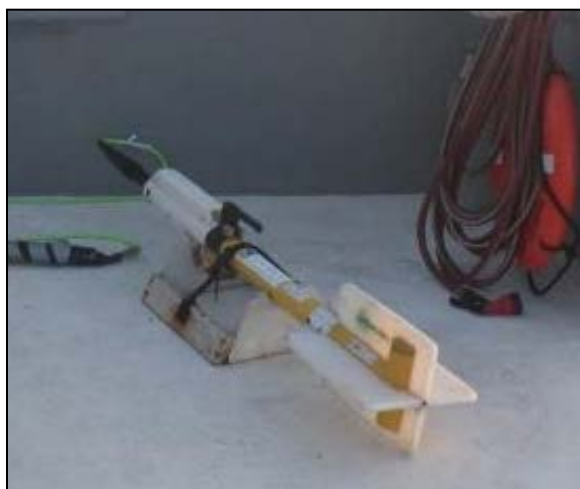
**Figure 18. Geometrics G-882 Digital Cesium Marine Magnetometer used to identify magnetic anomalies within the survey areas.**

High-resolution magnetic remote sensing was used to identify ferrous objects that could represent potential cultural resources or shallow hazards. A Geometrics G-882 Digital Cesium Marine Magnetometer, capable of a  $\pm 0.1$  gamma resolution, was used to perform an investigation of magnetic anomalies within the survey areas (Figure 18). The Hypack 2013® software recorded magnetic anomalies directly from the magnetometer. The G-882 was floated between 175 and 200 ft. (53 to 61 m) behind the survey vessel to minimize recording magnetic signatures from the survey vessel. To produce a magnetic record of sufficient resolution, the sensor was deployed and maintained in the water column approximately 10 to 20 feet above the seafloor. A computer recorder provided a continuous record of the magnetic background and target signatures. Positioning data generated by the navigation system were tied to magnetometer records by regular annotations to facilitate target location and anomaly analysis. Annotations included line number, date and time of start and end of each line, and target identification.

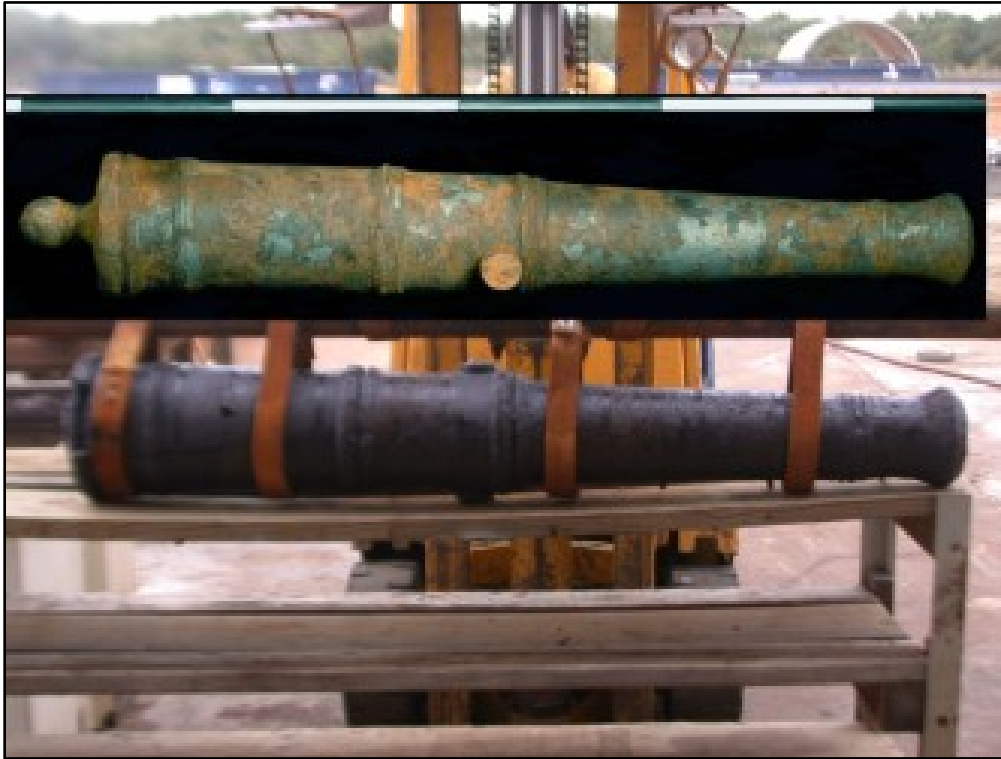
Figure 195. Comparison of *Queen Anne's Revenge* cannon (top) with one of the Chandeaur site's cannons recovered in 1989.

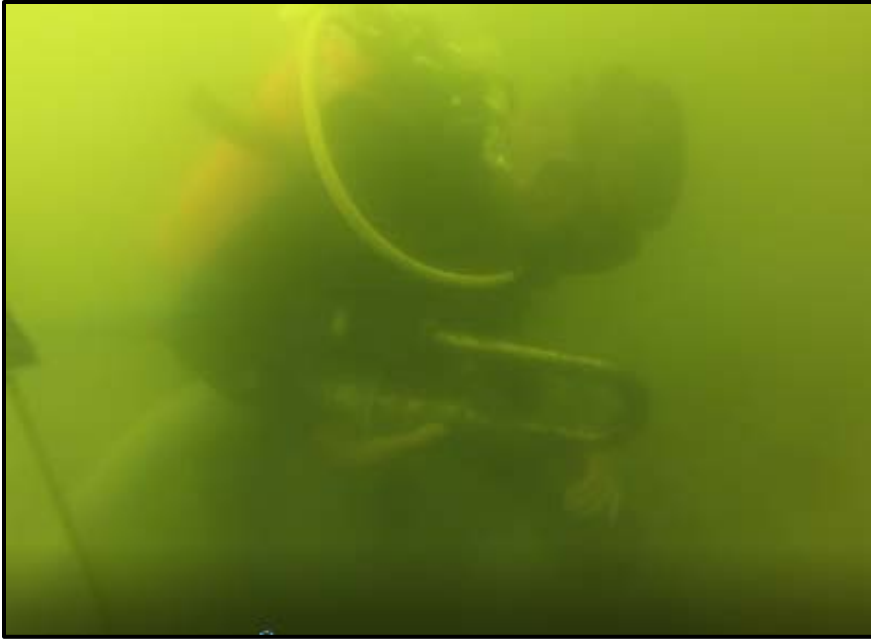
Figure 211. Excavating on the Center Priority magnetic anomaly cluster with an induction dredge.

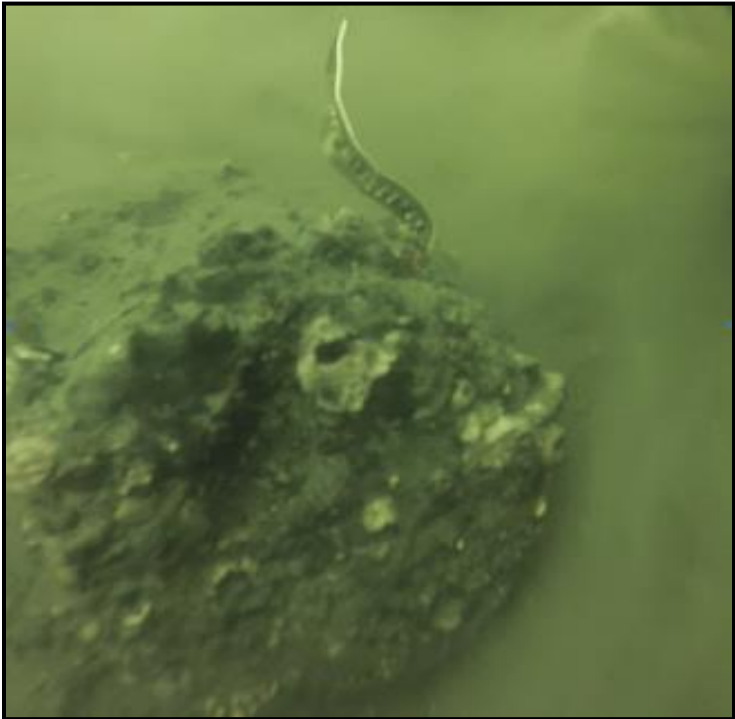
Figure 212. Stainless-steel hose clamp placed on trunnion by Jobling during the 1989 investigation.

In conjunction with the investigation of the Hewes Point sites, the high probability area for relocation of the ballast pile was investigated. That investigation included remote sensing and archaeological diver investigation of potentially significant magnetic anomalies. The first anomaly investigated by probing appeared to be a single metal object that could be a small cannon. At the second site, probing identified ballast, wood and metal objects. Subsequent excavation on one of the metal objects uncovered ballast and a cannon. A stainless steel hose clamp on one trunnion confirmed that the site was the one investigated in 1989.
