# Battle of the Atlantic: A Catalog of Shipwrecks off North Carolina's Coast from the Second World War

November 2021

NOAA Office of National Marine Sanctuaries Maritime Heritage Report Series:  
NUMBER 6

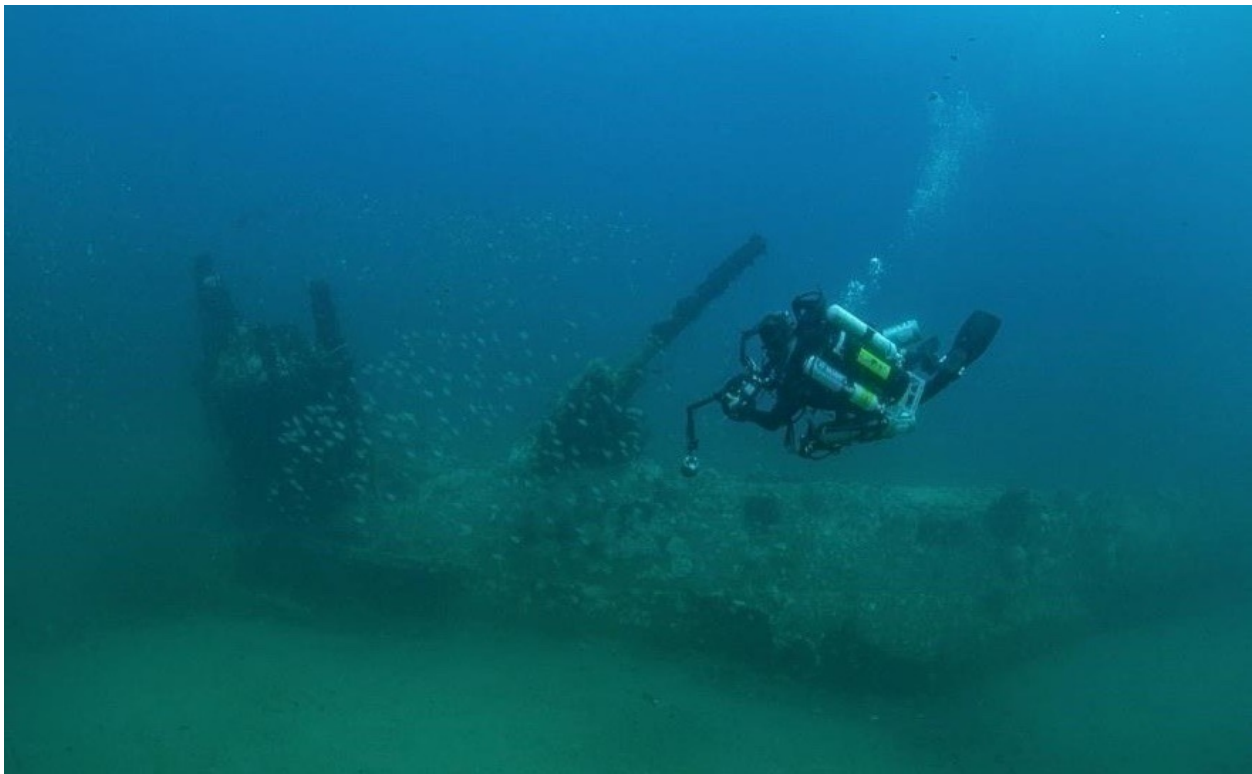
**Figure 3-2** Diver shooting photos of U-85 for a photogrammetric model.

Once a 3D model is created, accurate measurements of the site can be taken after producing a digital scale bar from a known measurement or a physical scale bar within the photos. The ability to take measurements and compare meshes between models made in different times allows one to track site change over time and is a valuable tool in site monitoring and management. 3D photogrammetric models also are valuable education and outreach tools, as they provide an accessible way for the public to experience the sites in an immersive and interactive 3 dimensional way. These models can be viewed with 3D software or online tools, and printed with a 3D printer. Online 3D modeling websites provide an intuitive interface for sharing models and for public access (Figure 3-2 through Figure 3-5).

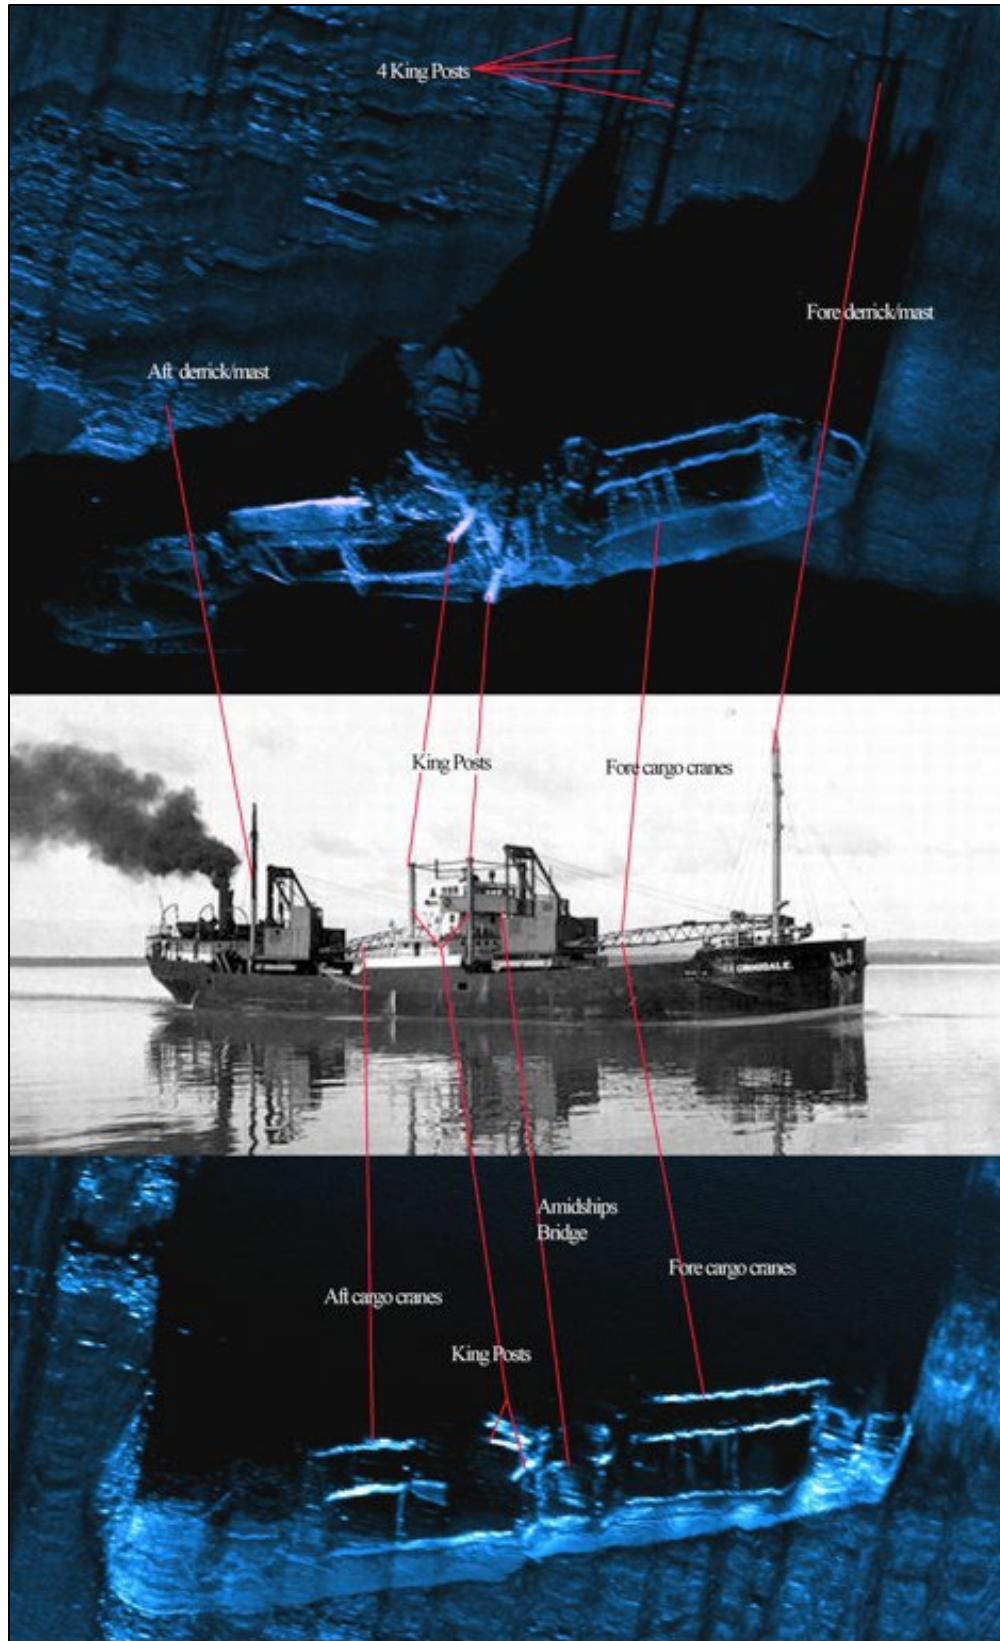
**Figure 7-50 Comparison of common features between historic photos and sonar imagery of *Bluefields*.**  
Source: Composite NOAA and Historical Collections of Bowling Green State University

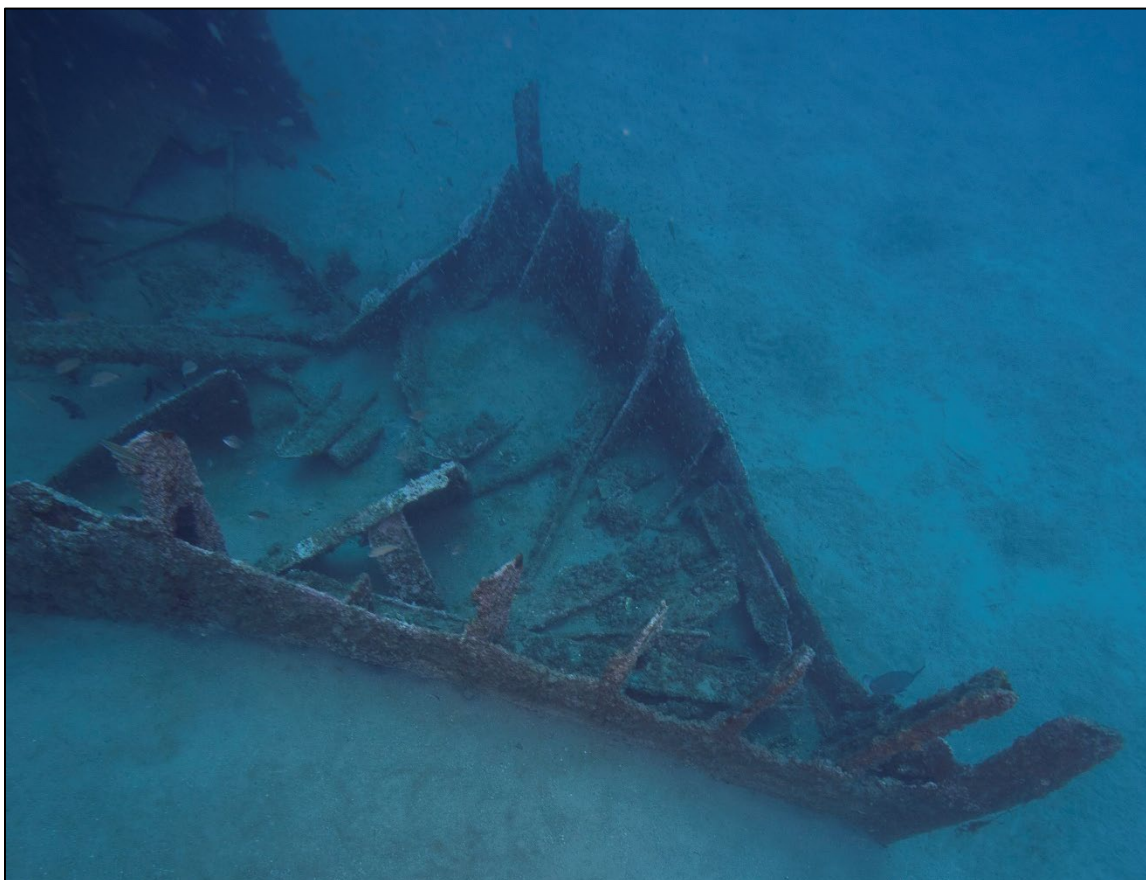
**Figure 7-68** Bow section of *British Splendour* in 2018 showing missing stem and keelson.

The site of *British Splendour* was visited again in 2018 for a more detailed site investigation in collaboration with the Battle of the Atlantic Research and Expedition Group. This survey was successful in conducting a comprehensive photogrammetric survey of the entire site. While the majority of the site appears relatively unchanged from 2011 to 2018, there is one prominent feature missing. The keelson and stempost assemblage that formed a distinctive arch shape in 2011 was now completely gone. A definitive reason for its disappearance is difficult to ascertain. It is possible that this is representative of damage from inadequate anchoring practices from fishing vessels or dive boats. Had the material degraded naturally some remnants of its collapse would be expected, however it appears the remains have been completely removed from the area (Figure 7-68).

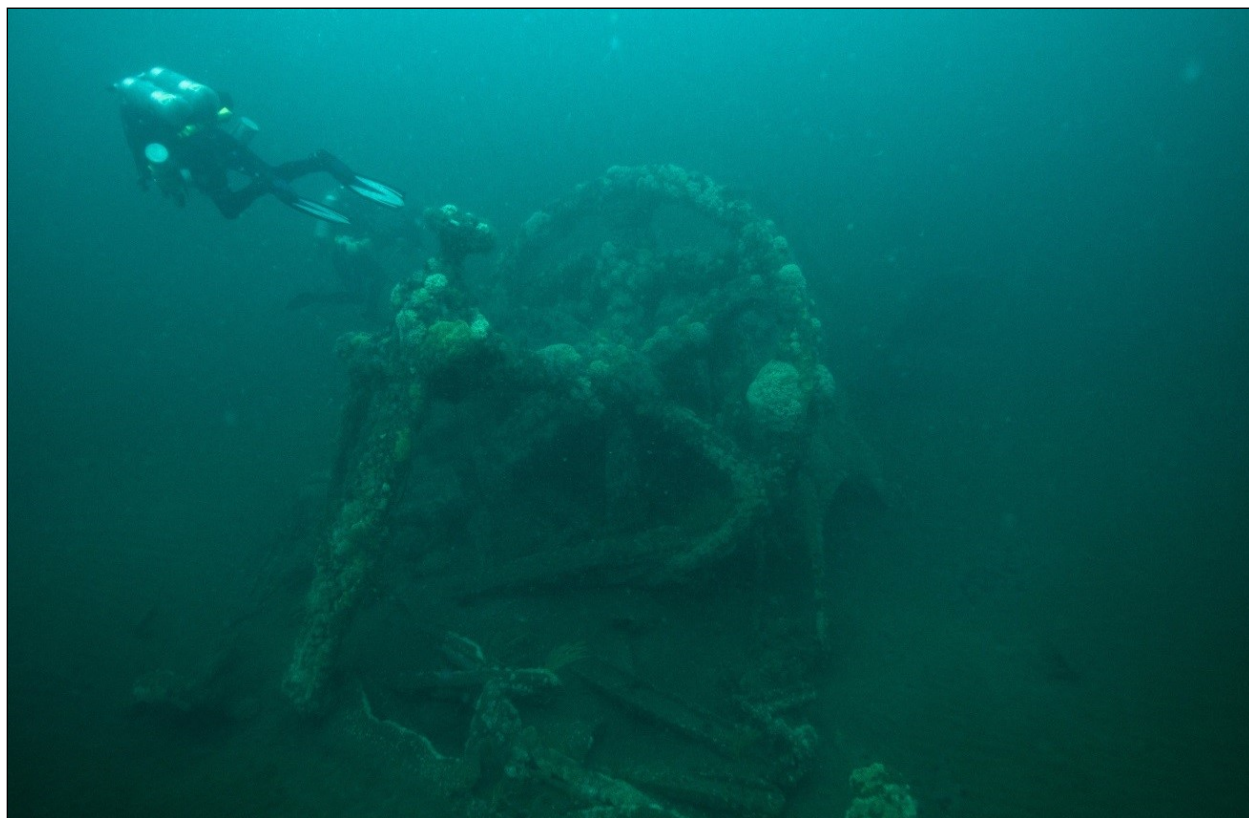
**Figure 7-118** Stern section of *City of Atlanta* as seen in 2010, with part of the steering gears visible.

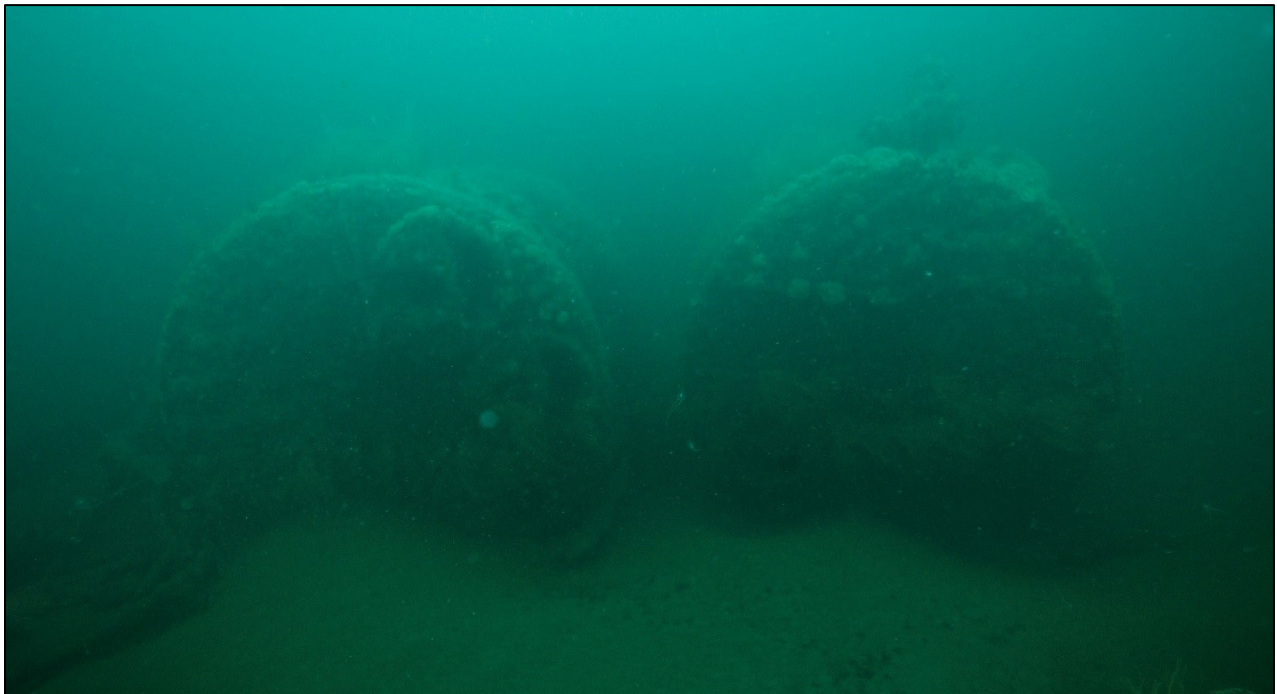
**Figure 7-120 Boilers found amidships on *City of Atlanta*.**

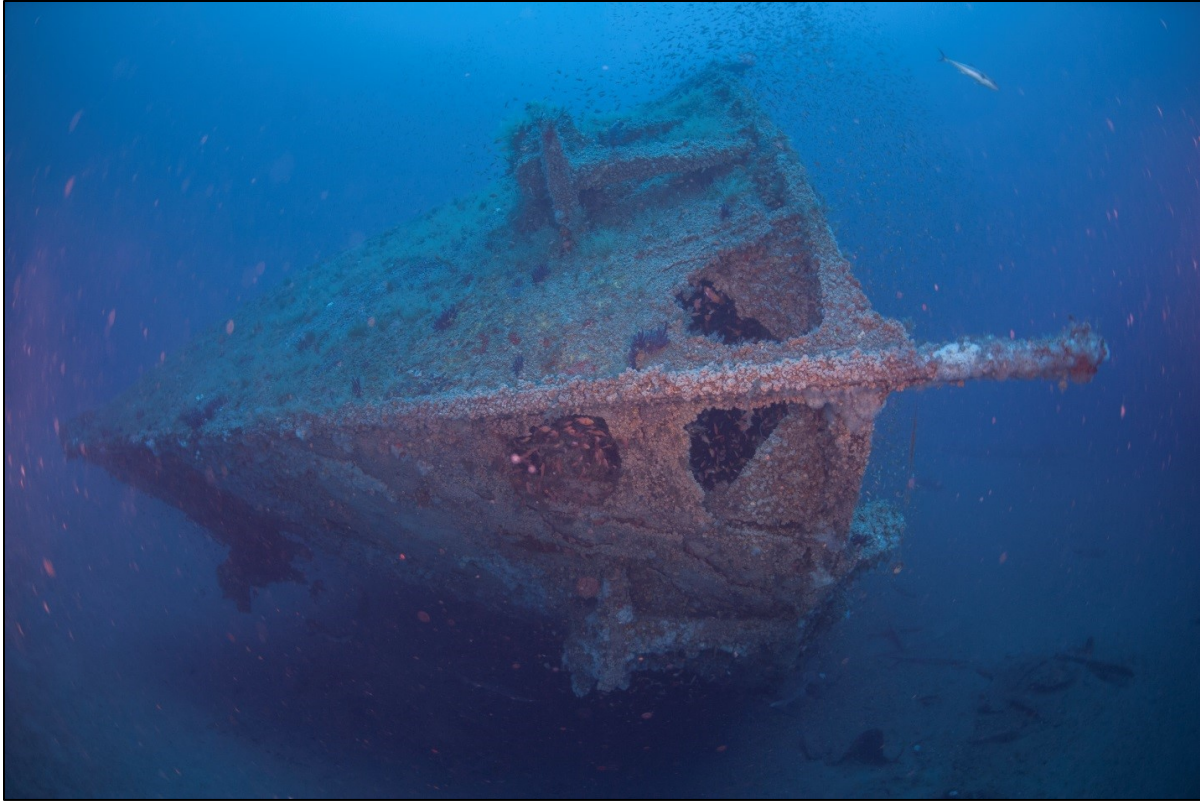
**Figure 7-153** Bow of the *E.M. Clark*.

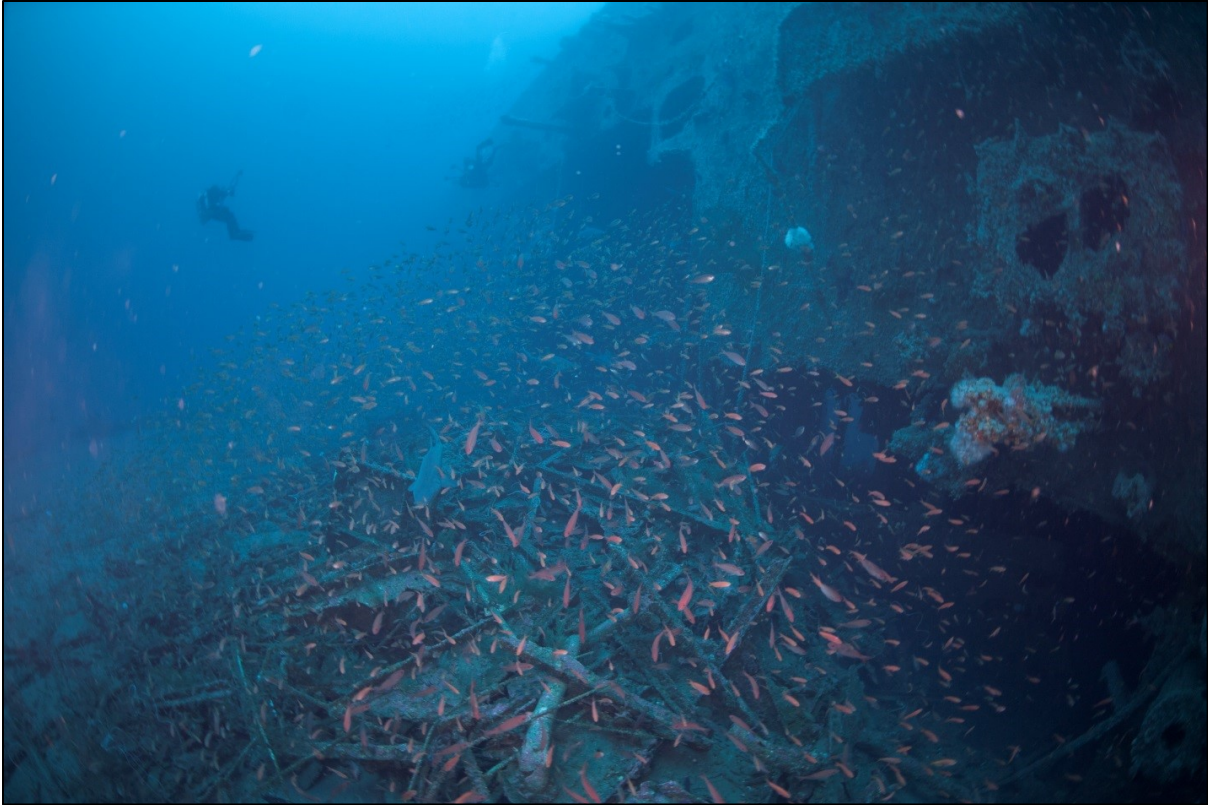
**Figure 7-155 Forward deck structure debris field on *E.M. Clark*.**

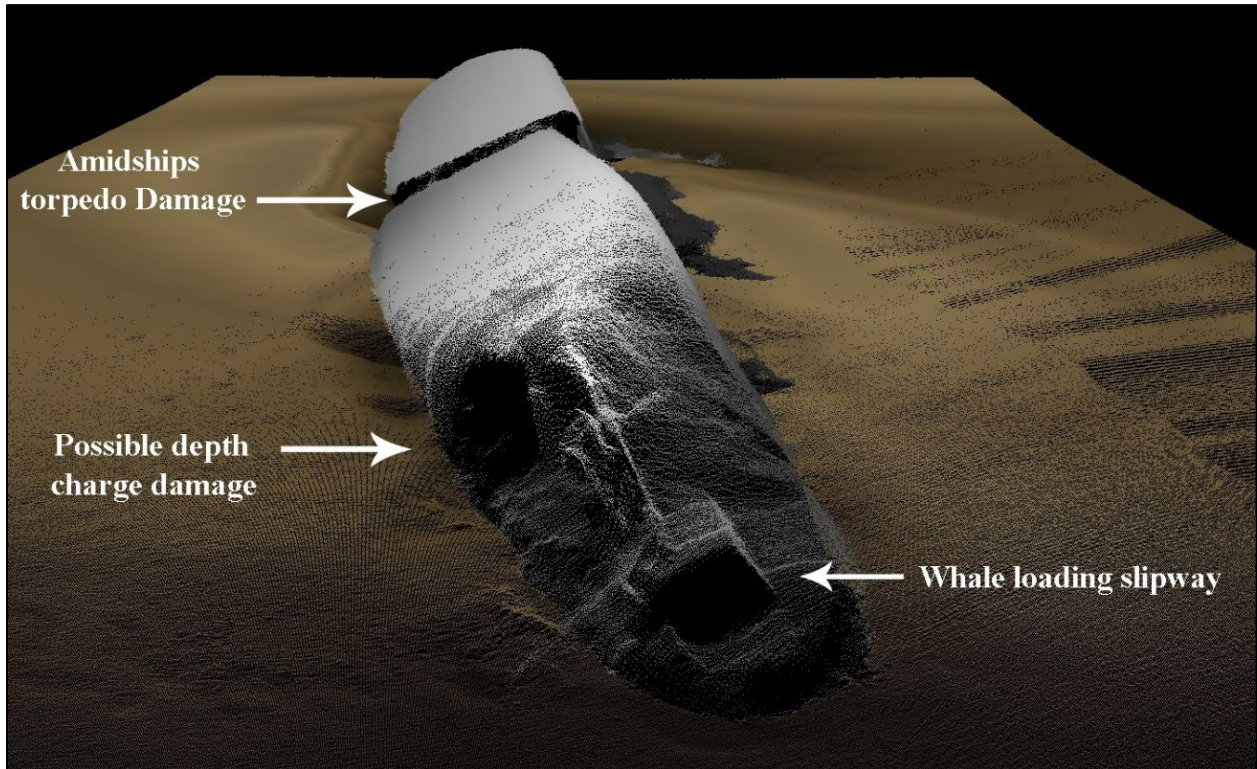
Figure 7-204 Isometric SONAR visualization of the *Lancing* wreck site clearly depicting the starboard side torpedo damage, depth charge damage, and the whale-loading slipway.  
Source: ADUS

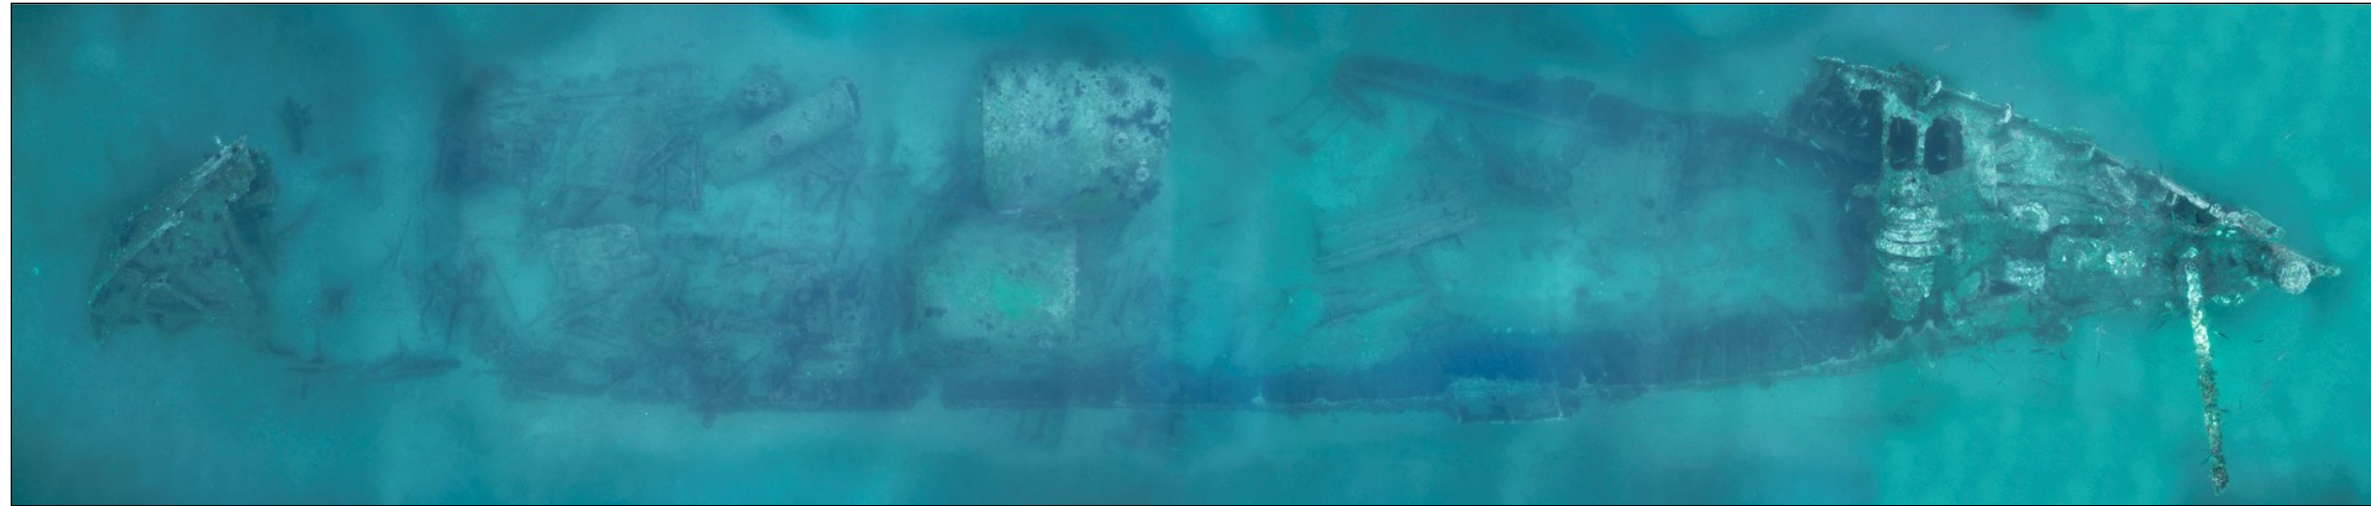
Figure 8-31 Planview photomosaic of *Keshena* - Source: NOAA

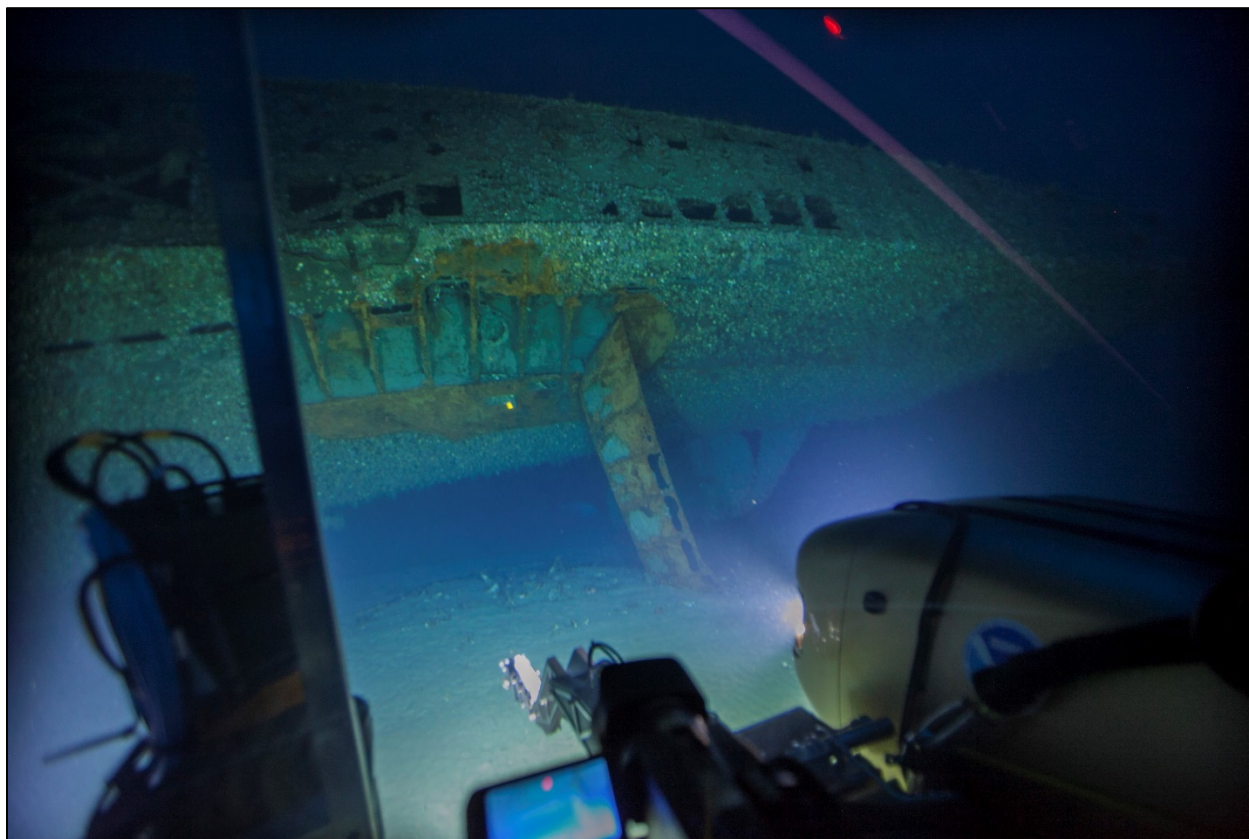
**Figure 9-57** Area of damage to the outer hull fairing on the starboard side bow area.

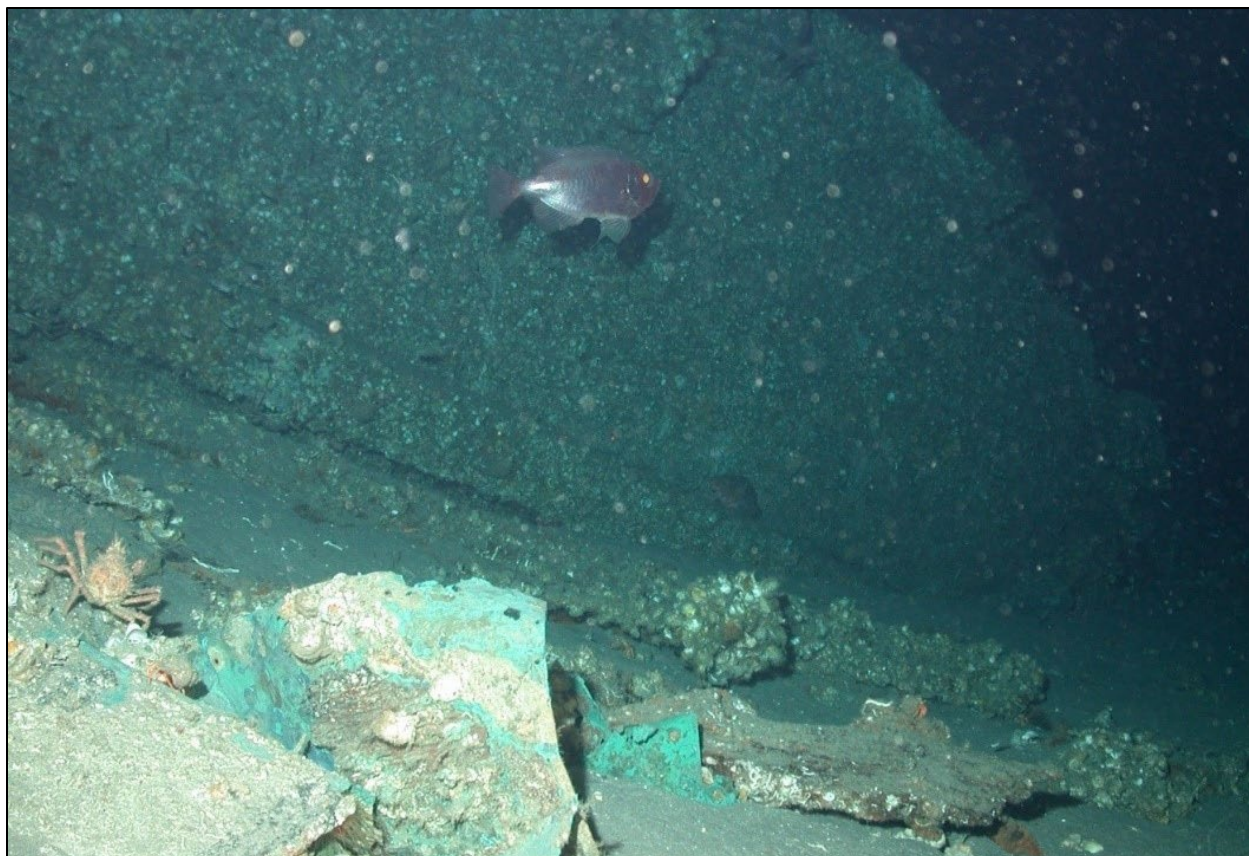
**Figure 11-14** Screen capture from ROV dive on unknown 19th century vessel remains showing copper sheathing.  
Source: NOAA/UNCW
