New York Collaborative Archaeological Survey

November 2021

Hoffman, W., Hoyt, J., and Sassorossi, W. 2021. New York Collaborative Archaeological Survey. Final Report to the U.S. Department of the Interior, Bureau of Ocean Energy Management, Office of Renewable Energy Programs, Sterling, VA and U.S. Department of Commerce, National Oceanic and Atmospheric Administration, Office of National Marine Sanctuaries, Silver Spring, MD. OCS Study BOEM 2021-077.

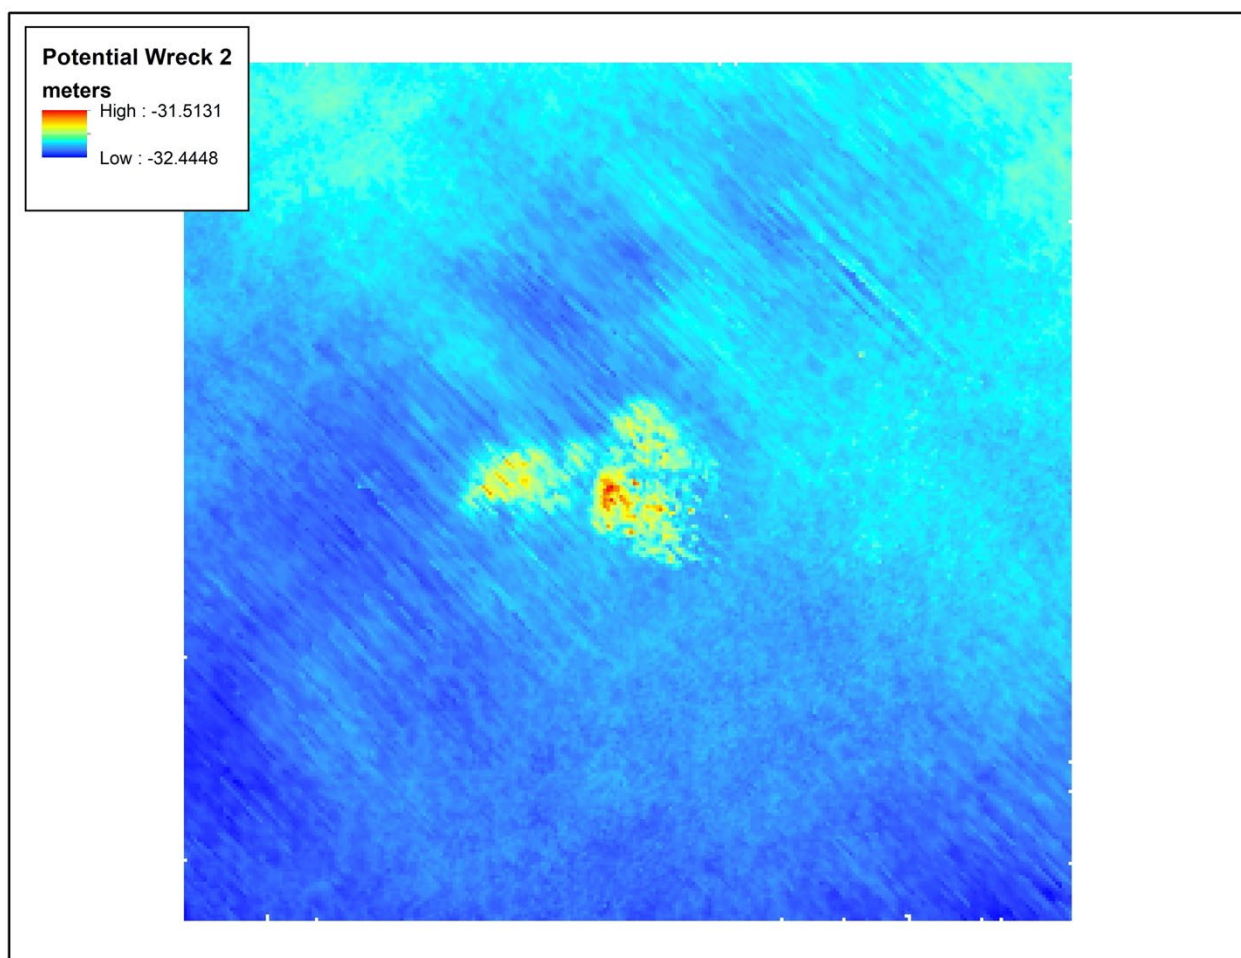
Figure 9: Multibeam Imagery of Potential Wreck 2 (NCCOS).

On July 27, 2019, one dive was made on the coordinates provided from the multibeam survey on a target designated as Potential Wreck 2 by Hoyt, McCord, and Hoffman. Similar to Potential Wreck 1, the NCCOS survey noted this area of limited relief as a possible ballast scatter or shipwreck (Figure 9). Following an orderly search, the dive investigation resulted in no observed evidence of any seafloor relief or potential cultural remains. Side-scan sonar data was not acquired at this site. With the inability to locate visible remains, either cultural or geological during the dive investigation, it was concluded that an archaeological site is not present at this location and that the area may represent seafloor reflectivity caused by biological materials. However, an additional remote sensing survey is recommended to confirm.

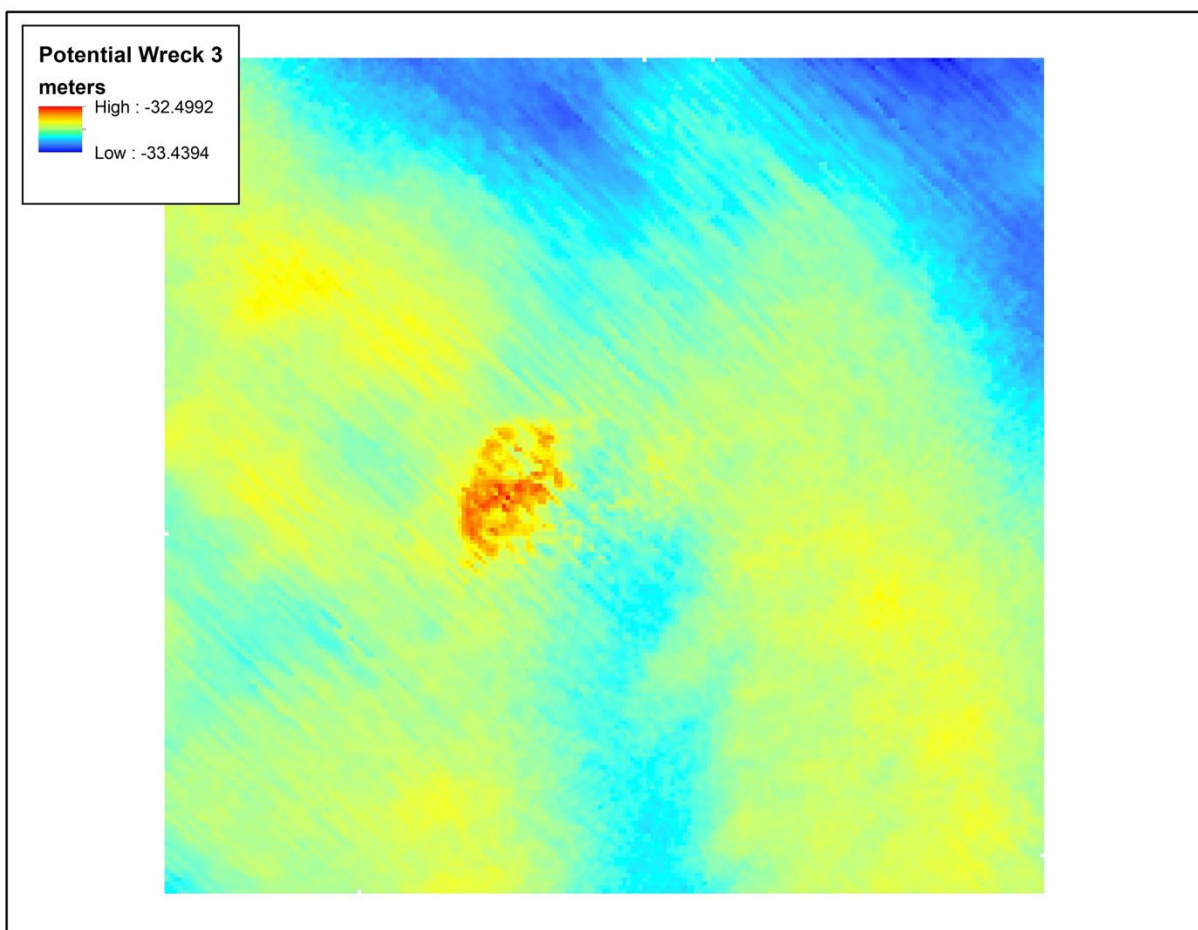
Figure 10: Multibeam sonar image of Potential Wreck 3 (NCCOS).

On July 29, 2019, one dive was made by Sassorossi and Hoffman on the coordinates provided from the multibeam survey of a target designated as Potential Wreck 3. The target was identified during the previous survey as a discrete area of limited relief possibly indicating the presence of a ballast pile or shipwreck site (Figure 10). Following an orderly search, the dive investigation resulted in no observed evidence of any seafloor relief, cultural or geological in nature, and no potential cultural remains were identified. On August 6, 2019, the research team returned to the coordinates to make multiple side-scan sonar passes over the target area (Figure 11). Using a 100-m range with the side-scan sonar, the resulting information could not determine any evidence resembling the results from the previous multibeam survey (Figure 12). In summary, one dive investigation and multiple passes of side-scan sonar operations over the coordinates were unable to locate any cultural remains. No archaeological materials were identified at this location.

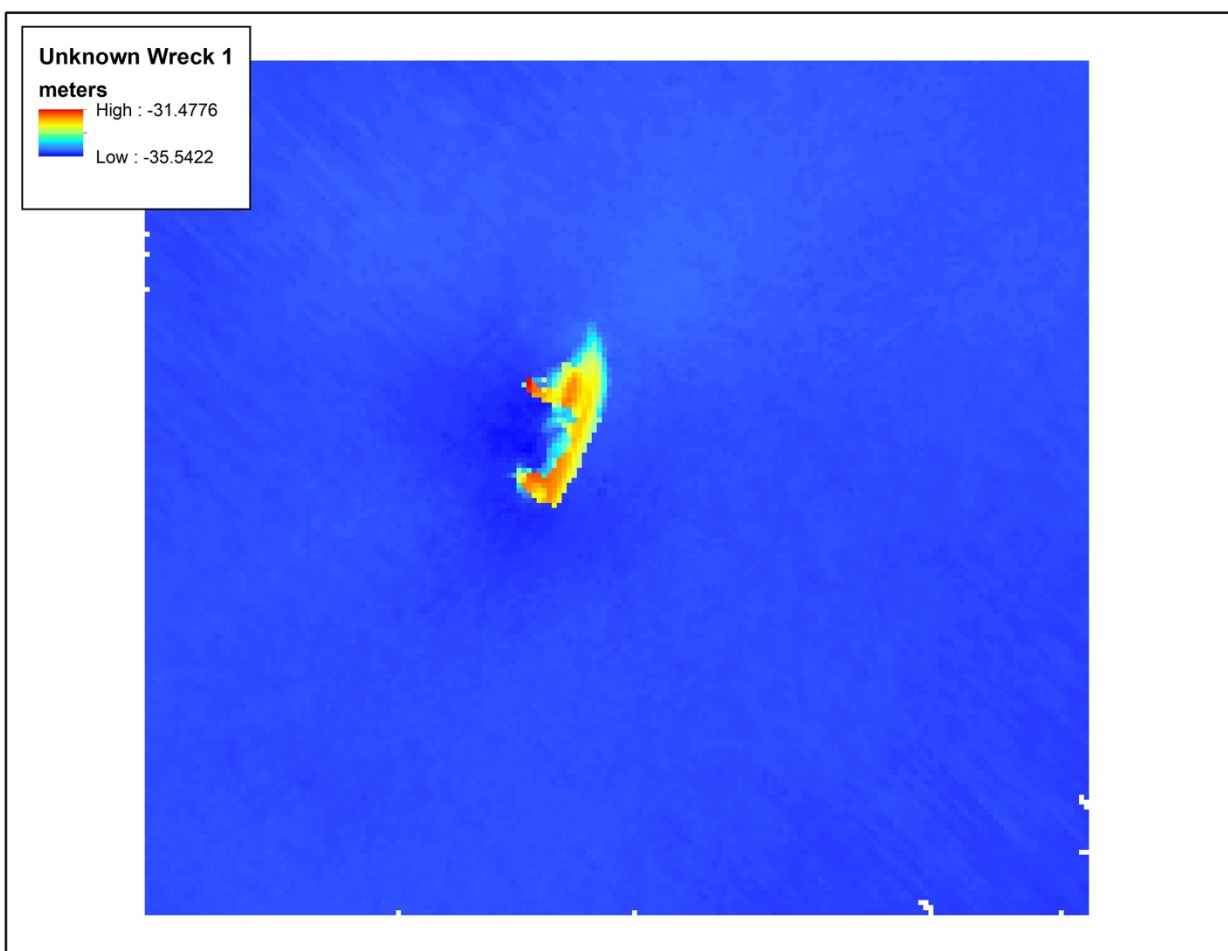
Figure 13: Multibeam imagery of Wreck 1 (NCCOS).

The target designated as Wreck 1 was the first priority site visited that was definitively a cultural feature observed in the NCCOS survey (Figure 13). Initial interpretations of the multibeam imagery were that the

Wreck 1	Unidentified modern-era commercial fishing trawler. Intact site with limited debris field.	Site may be potentially eligible for listing in the NRHP; however identification would be required to further assess significance. Preliminary avoidance of this target is recommended by 50 m (164 ft) from the extent of the intact hull remains. Additional investigation is recommended to document and monitor the site. Additional archival investigation recommended.
Wreck 2	MBES was suggestive of a potential wreck site. Follow-up investigation determined no archaeological remains to be present at the location. Acoustic signature from MBES may be transient marine life or characteristic of seafloor substrate.	No further investigation recommended at this location.
Wreck 3	MBES was suggestive of a potential wreck site. Follow-up investigation determined no archaeological remains to be present at the location. Acoustic signature from MBES may be transient marine life or characteristic of seafloor substrate.	No further investigation recommended at this location.

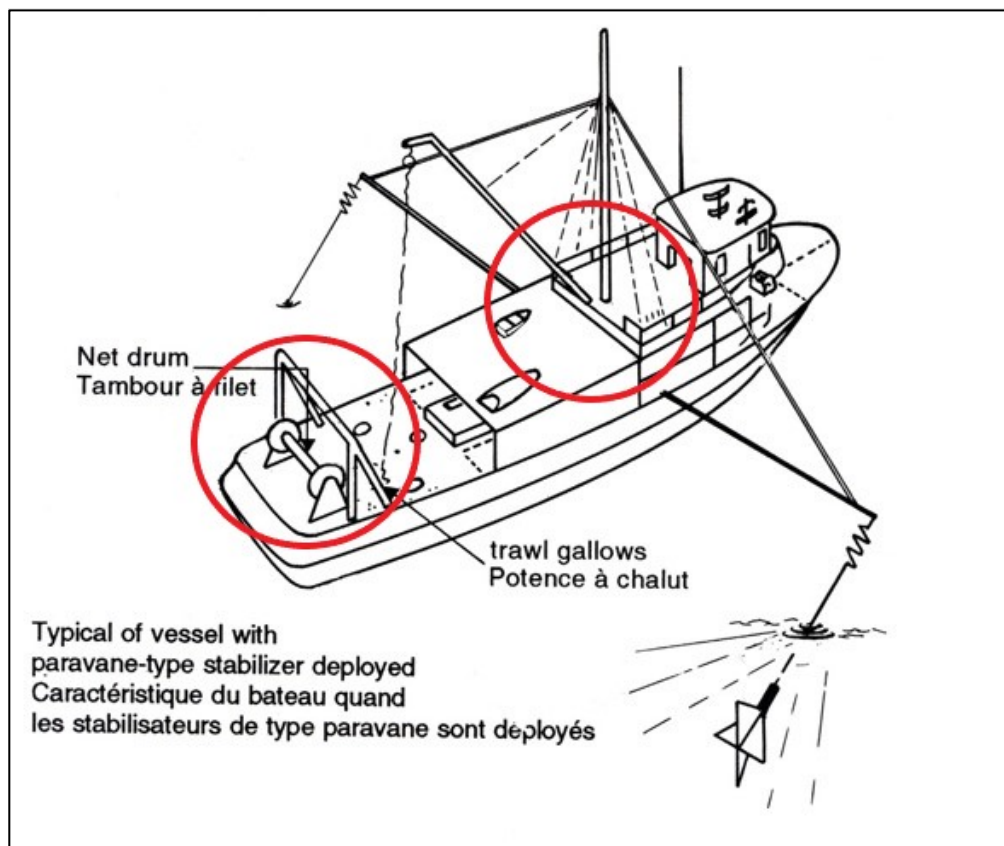
Located at the stern is a large winch and drum indicative of a fishing trawler. This winch is used to deploy and haul in either fishing nets or other bottom trawling gear. The fishing nets are spooled on the drum and are deployed at the stern and dragged behind the vessel. Fishing nets can still be seen spooled on the drum of the winch, along the centerline of the vessel. Other noticeable features are red hull paint at the water line, as well as yellow hull paint above the red paint. The paint is visible in only a few areas, as the majority of the hull is encrusted with marine growth.

Moving forward from the stern along the outer starboard edge, the hull is intact and contiguous. Amidships is a structure, resembling a fishing tower or trawl towing boom or outrigger, that is folded in on itself, indicative of a fishing trawler (Figure 16). The red circled areas on Figure 16 indicate similar location placement for the winch and drum at the stern, with the stabilizer boom amidships. The vessel type in Figure 16 is a wooden longline/dragger of similar length and breadth to Wreck 1 (Transportation Safety Board of Canada 2019). Further investigation is recommended at this site to gather additional information to determine the vessel's identity.

Figure 16: Image showing general arrangement of fishing vessel with features observed on Wreck 1 (Transportation Safety Board of Canada 2019).

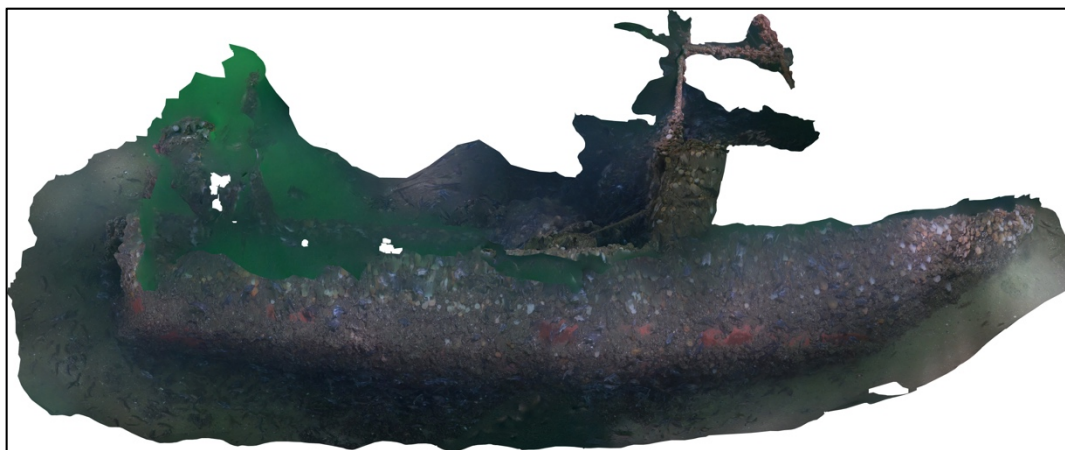
Figure 17: Partial orthomosaic of the stern and starboard of Wreck 1.

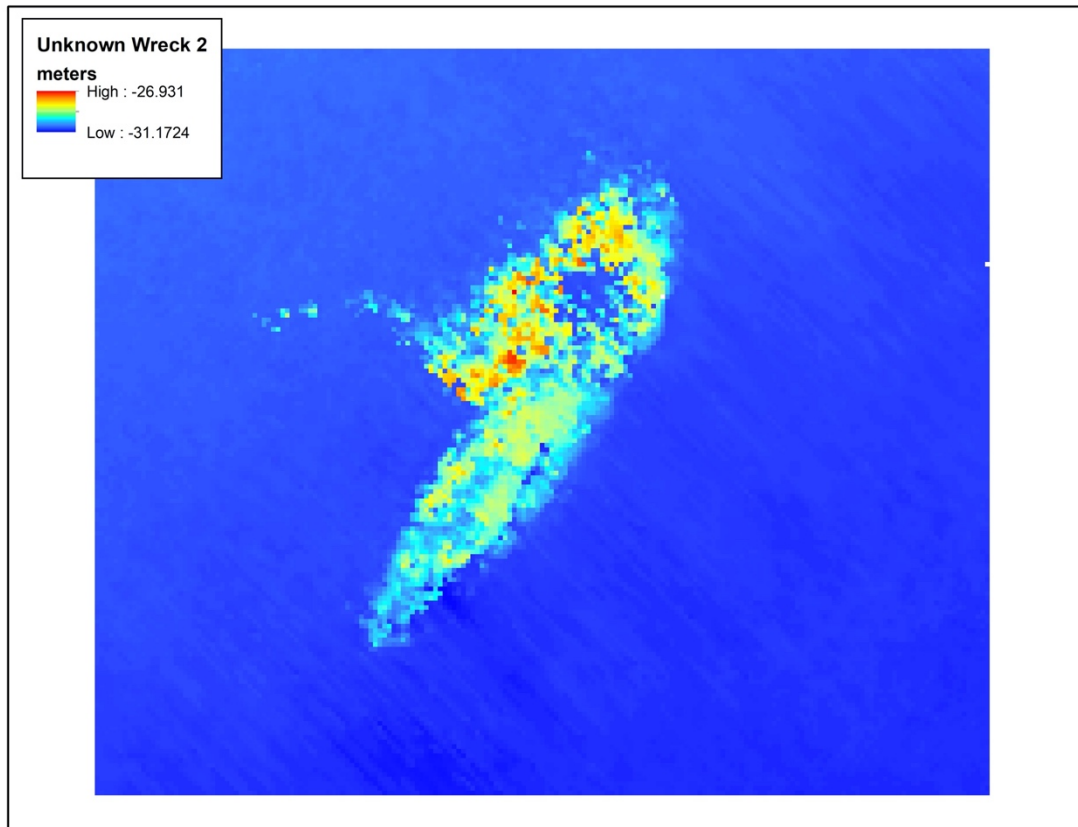
Figure 18: Multibeam imagery of Wreck 2 (NCCOS).

On July 29, 2019, one dive was made by McCord and Nunn on the target designated through the NCCOS survey as Wreck 2 (Figure 18). The target was interpreted through the previous survey as a vessel-shaped area of relief, possibly indicating the location of a shipwreck. Following an orderly search, the dive investigation resulted in no observed evidence of any relief, cultural or geological, and no potential cultural

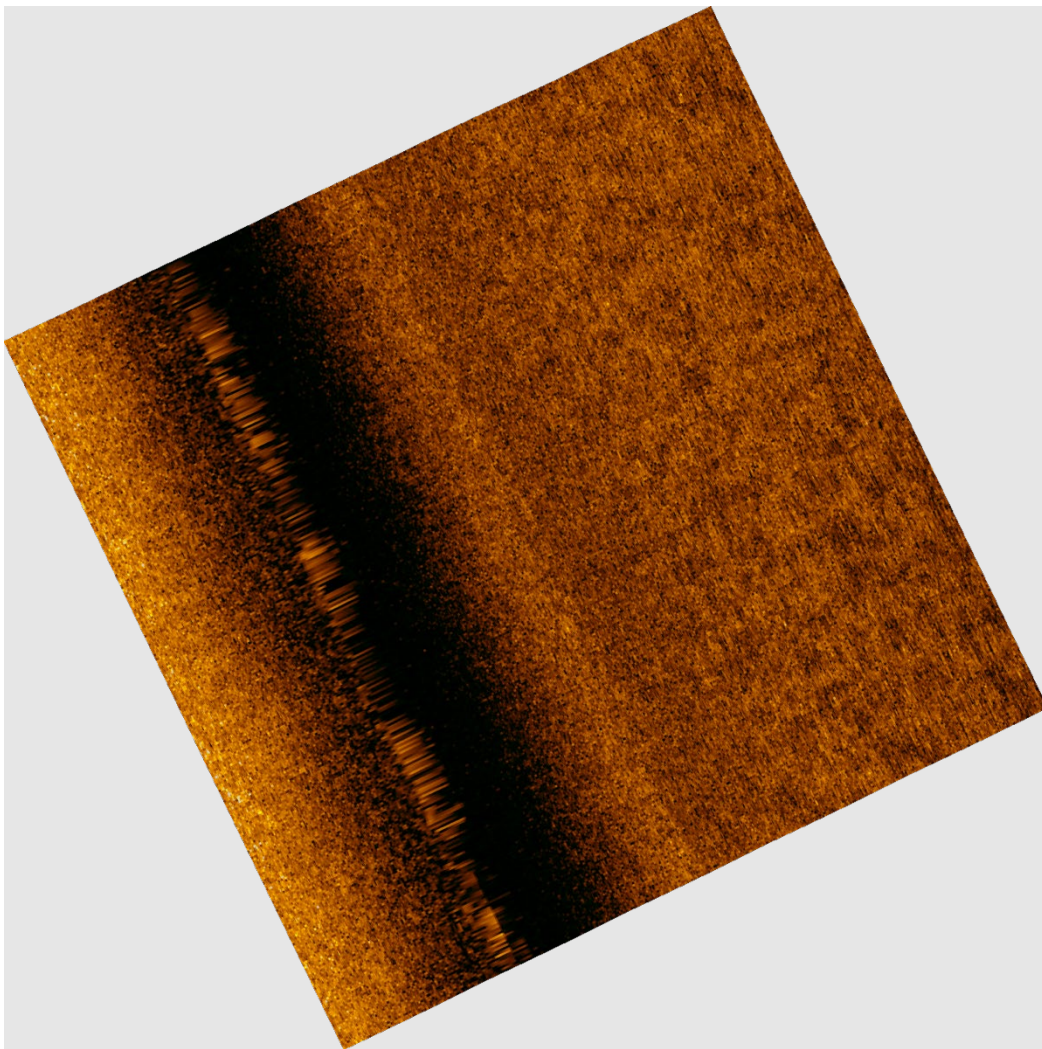
Figure 19: Side-scan sonar image of Wreck 2 location.

remains were identified. On August 6, 2019, the research team returned to the coordinates to make multiple side-scan sonar passes over the target area (Figure 19). Using a 100-m range with the side-scan sonar, the resulting survey did not identify any features resembling the results from the previous multibeam survey (Figure 20). With the inability to locate visible remains, either cultural or geological, during both in-water diver investigation and through the side-scan survey, the team concluded that no archaeological remains are present at this location.

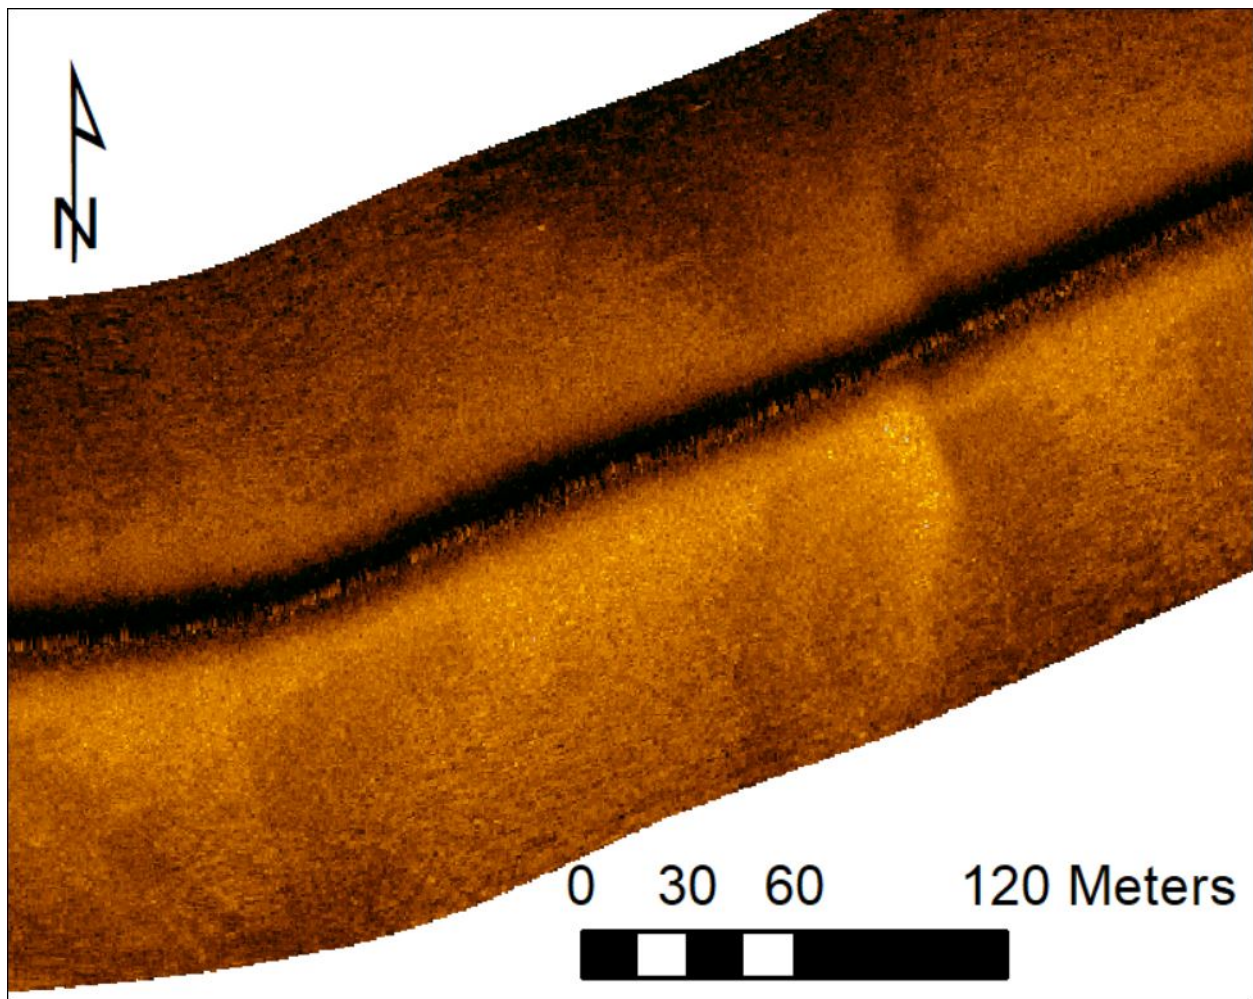
Figure 22: Side-scan sonar image of Wreck 3 location.

coordinates to make multiple side-scan sonar passes over the target area (Figure 22). Using a 100-m range with the side-scan sonar, the resulting acoustic imagery did not identify any features resembling the results from the previous multibeam survey (Figure 23). No archaeological remains were identified at this location.

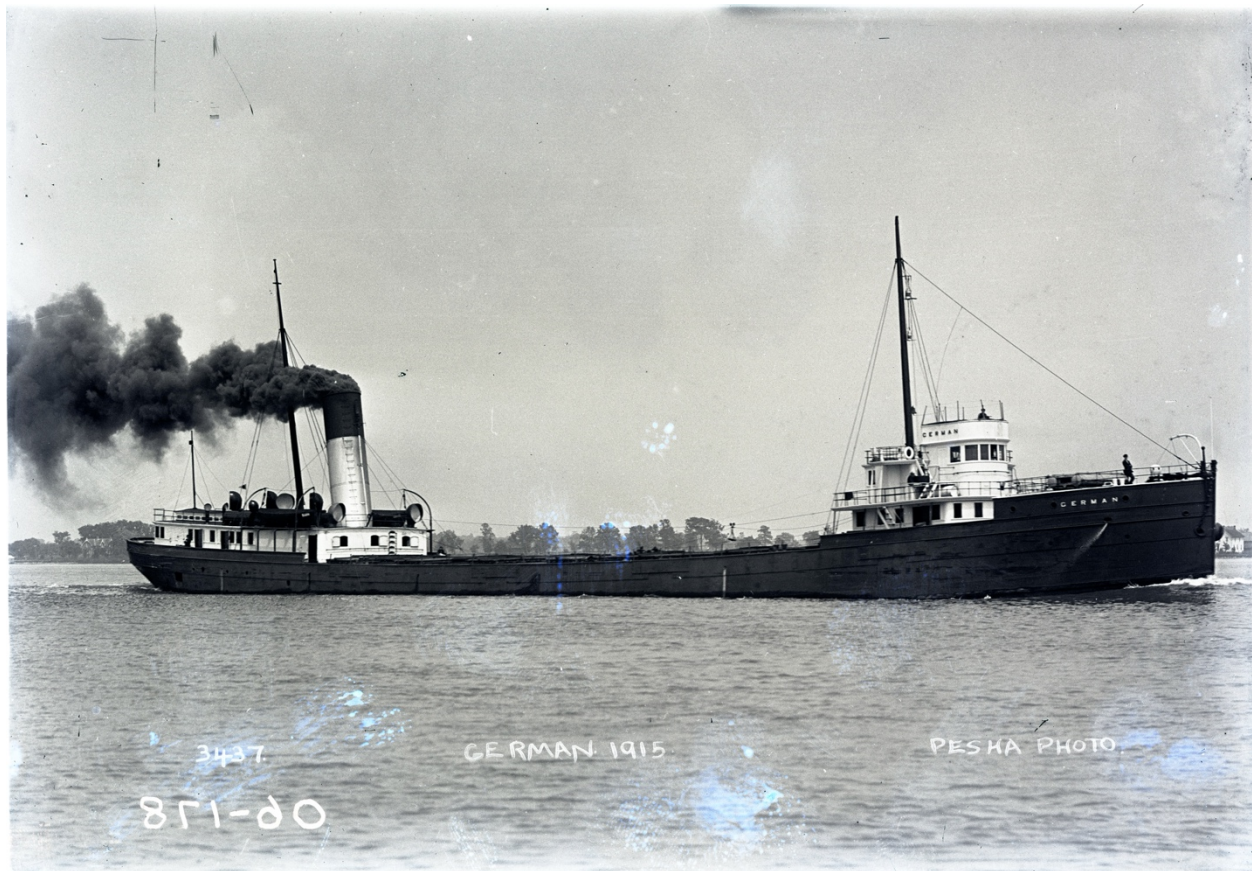
Figure 24: German (Yankee) pictured in 1915 (Detroit Historical Society).

The NCCOS target designated as Wreck 4 is the location of the shipwreck identified as *Yankee* (Figure 24). Discovered by a local diver in the 1950s, the site has been referred to as “Gloria and Doris” or the “G&D” and the name remained until further avocational investigations revealed the shipwrecks’ identity. In 1995, a dining plate was recovered from the site and later identified as from the Pittsburgh Steamship Company. Further research revealed that five vessels from the company, which mainly had vessels operating in the Great Lakes, were moved to other locations during World War I. Four of those vessels were barges without engines, with the fifth being the vessel *Yankee* (Berg 2010; New Jersey Scuba Diving 2018; New York Times 1995; Wrecksite 2013).

The vessel *Yankee* was built in 1890 at the Globe Iron Works shipyard in Cleveland, OH, and originally named *German*. The steel hulled *German* was built as a cargo steamer to operate in the Great Lakes. *German* measured 296.20 ft (89.06 m) in length, by 40.40 ft (12.31 m) at beam. Displacing 2,418 tons, the vessel was powered by coal fired steam, utilizing two boilers and a triple expansion engine. *German* operated for the Calumet Transportation Company from 1891 to 1901 when it was then sold to the Pittsburgh Steamship Company, operating in the Great Lakes until 1917. In 1917, the United States Shipping Board bought the vessel and transported it from the Great Lakes to work on the East Coast. In order to get the large vessel to the Atlantic Coast, *German* had to be cut in two for transport through the canal system and then reassembled. *German* was subsequently named *Yankee* and began operating as a coal transport along the East Coast (Berg, 2010; Great Lakes Vessel Database 2020; Great Lakes Vessel History 2015; New York Times 1995; Sheard 1998; Shipbuilding History 2015; Wrecksite 2013).

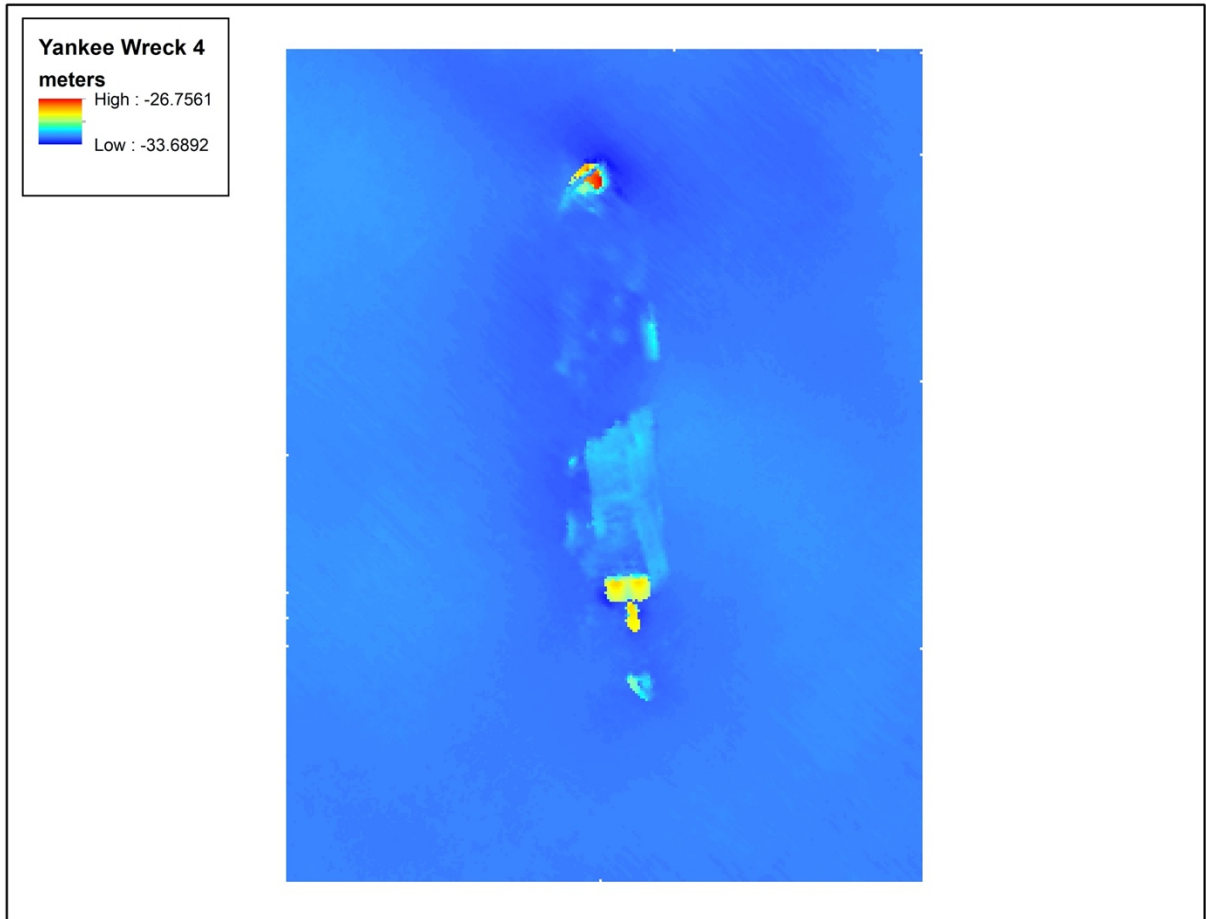
Figure 25: Multibeam imagery of Wreck 4, Yankee (NCCOS).

The research team was able to reacquire the NCCOS MBES target (Figure 25) and gather additional side scan-sonar data (Figure 26). The site is a mostly contiguous structure, oriented north to south, bow to stern. Resting at a depth of 110 ft (33.53 m), the overall site length measures approximately 108.94 m (357.41 ft) and approximately 28.85 m (94.65 ft) at the widest beam. Prominent features like the boilers measure approximately 6.25 m (20.50 ft) in length, and approximately 5.36 m (17.58 ft) wide. The engine, directly aft of the two boilers, measures approximately 8.38 m (27.49 ft) in length, and approximately 3.83 m (12.56 ft) at the widest point. The prominent bow section is sitting upright on the sand, listing toward the port side. The stern section is also sitting upright on the sand, with the steering mechanism visible.

Wreck 4	Site identified as freighter <i>Yankee</i> , lost in 1919. Bow, stern, and engineering spaces remain intact with disarticulation amidships.	Site is considered eligible for listing in the NRHP. Preliminary avoidance of this target is recommended by 50 m (164 ft) from the discernable extent of the hull remains. Additional investigation is recommended to document and monitor the site.
Durley Chine	Target selected from ASD due to proximity to survey area. SSS survey was unable to locate any observable remains at the reported location.	Update ASD to reflect confidence level in reported site location. Additional survey in the area is recommended to locate site.
“Happy Days”	Unidentified shipwreck consisting of deck machinery and potential wooden hull remains.	Site may be eligible for the NRHP. Preliminary avoidance of this target is recommended by 50 m (164 ft) from the extent of the site, which may contain buried features and additional hull remains. Additional investigation is recommended to document and monitor the site.

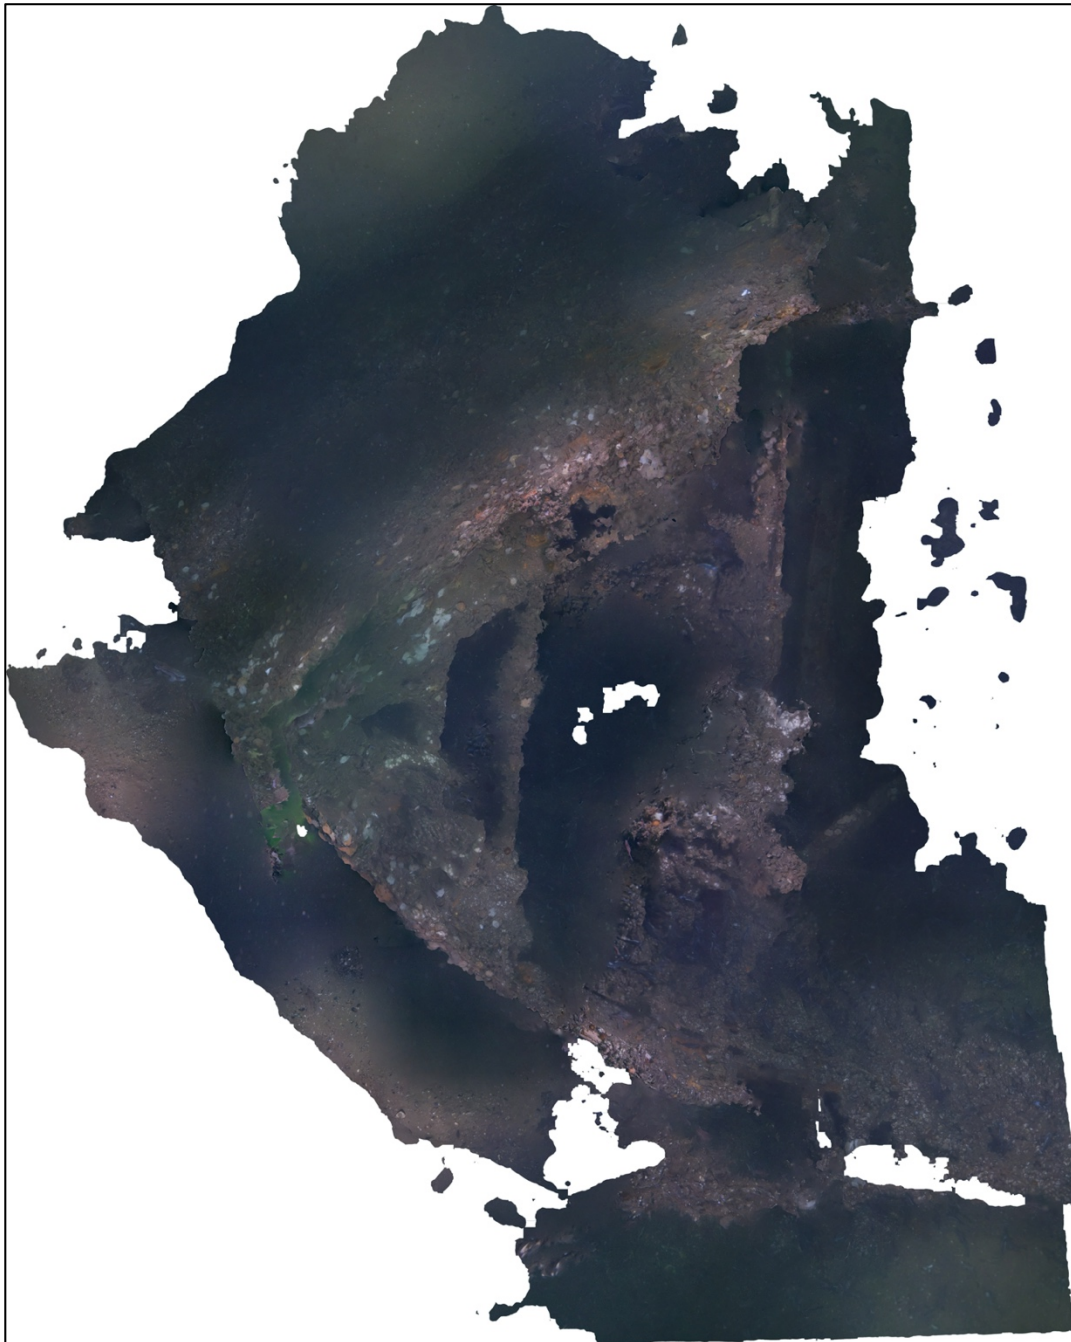
While the entirety of the *Yankee* wreck site was not examined, the main priorities of the dive investigations focused on the bow, engine, boilers, and the stern sections. These sections are the most prominent and allowed for the ability to document utilizing photogrammetry. The bow section is generally intact with the stem post still attached to hull plating, resting upright on the sand (Figure 27). The bow section is listing to the port side, but still in-line along the keel. Minimal deck plating is evident towards the stem post, as well as horizontal framing patterns attached to the outer hull plating. The most prominent part of the bow section, as documented with photogrammetry, is the stem post, with high degree of relief of approximately 6.09 m (20.00 ft). The overall bow section measures approximately 8.45 m (27.72 ft) in length and 8.89 m (29.17 ft) at beam.

Figure 27: Partial plan view orthomosaic of the bow section of Wreck 4/Yankee.

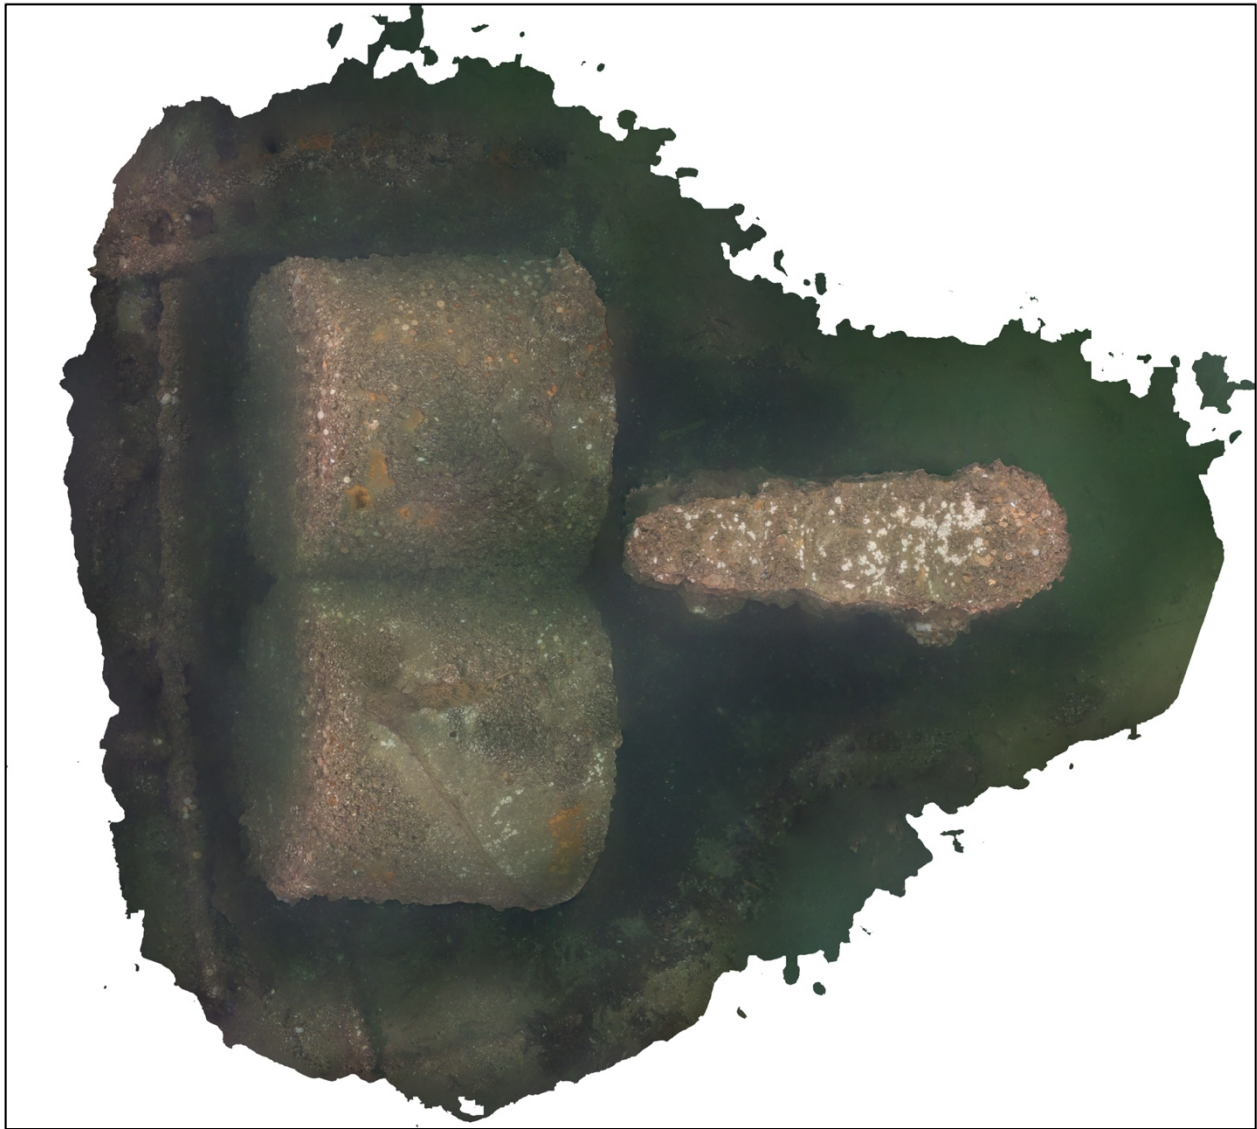
Continuing aft of this section are the remains of a low lying hull structure and potential deck structure, before reaching a distinct gap in the sand measuring approximately 9 m (29.52 ft). Aft of this gap, marks continued from various low relief hull/deck plating or other mechanical remains, before reaching the two boilers and the triple expansion engine. Both boilers are intact and upright, along with the engine itself (Figure 28). Relief at this section measures approximately 6.09 m (20.00 ft). The engine machinery is consistent with the details outlined in the historical narrative, providing evidence for the site's attribution as *Yankee*.

Figure 28: Partial plan view orthomosaic of the engines and boilers on Wreck 4/Yankee.

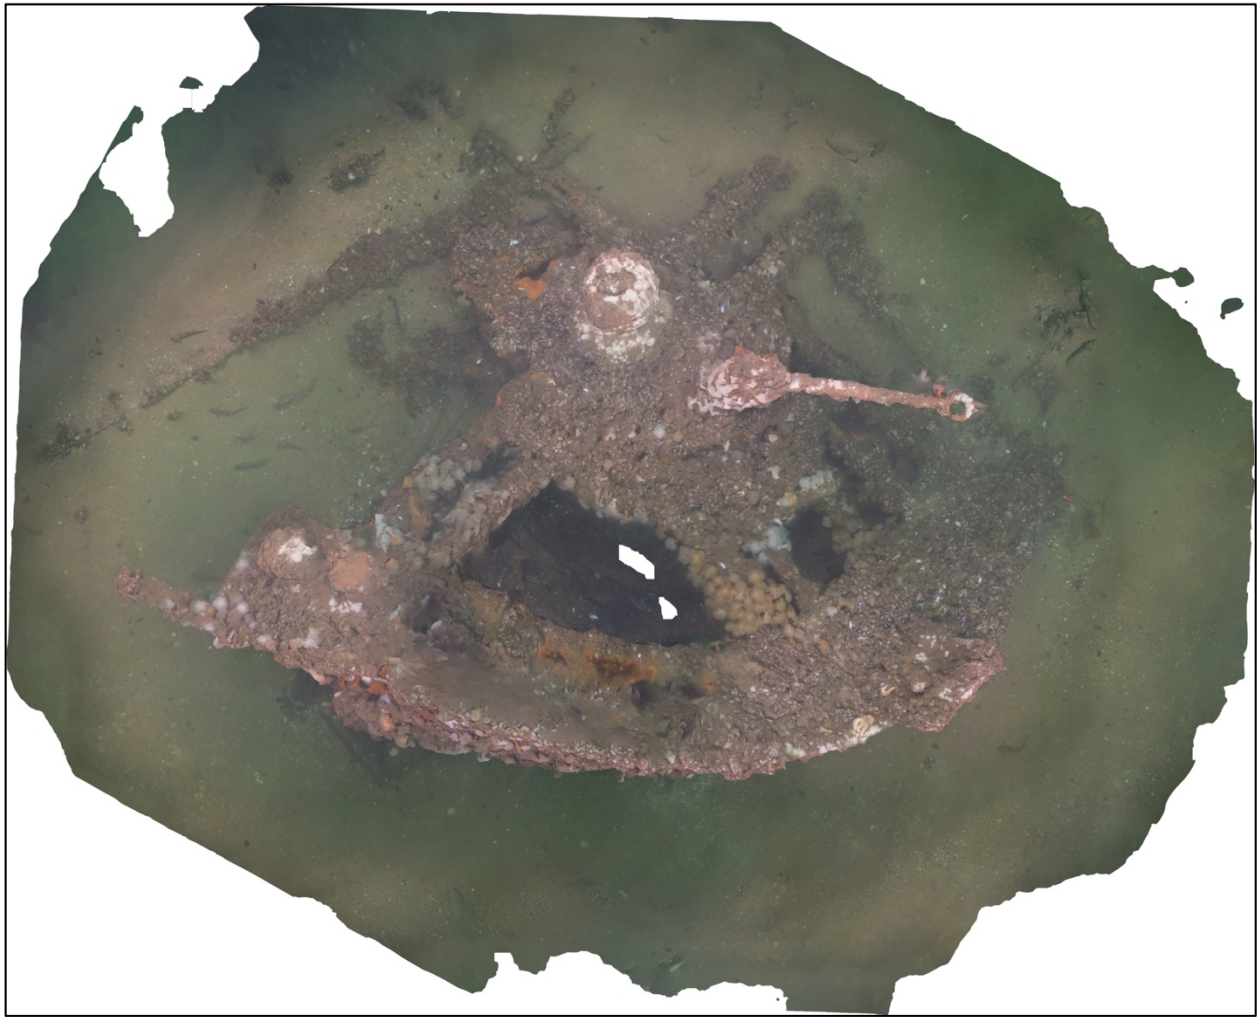
Further aft of the engine is mostly sand until the stern and steering mechanism is located. This stern section measures approximately 5.73 m (18.79 ft) in length and 5.70 m (18.70 ft) at beam. Slightly tilted at an angle on the port side, the stern section still contains evidence of deck and hull plating. The tiller post is evident as part of the steering mechanism, with the rudder post and rudder potentially buried in the sand (Figure 29). Each section, as described, is oriented along the keel axis of the vessel with little evidence of disarticulated features outside of the main wreck site.

Figure 29: Partial plan view orthomosaic of the stern assembly on Wreck 4/Yankee.

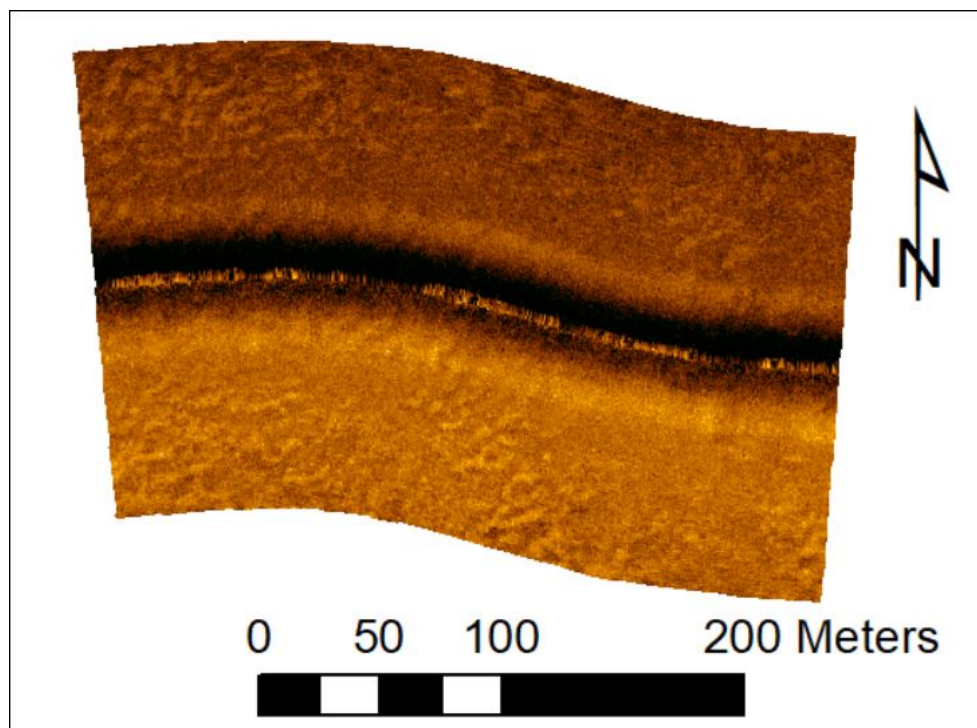
Figure 30: Side-scan Sonar Image of reported Durley Chine Location.

On August 6, 2019, the research team utilized the coordinates from the ASD to make multiple side-scan sonar passes over the reported *Durley Chine* target area (Figure 30). Using a 100-m range with the side-scan sonar, the resulting survey did not identify any visible remains at the location reported. Based on the information from the local diving community the site does exist; however, it is not located at the position as reported in the ASD.

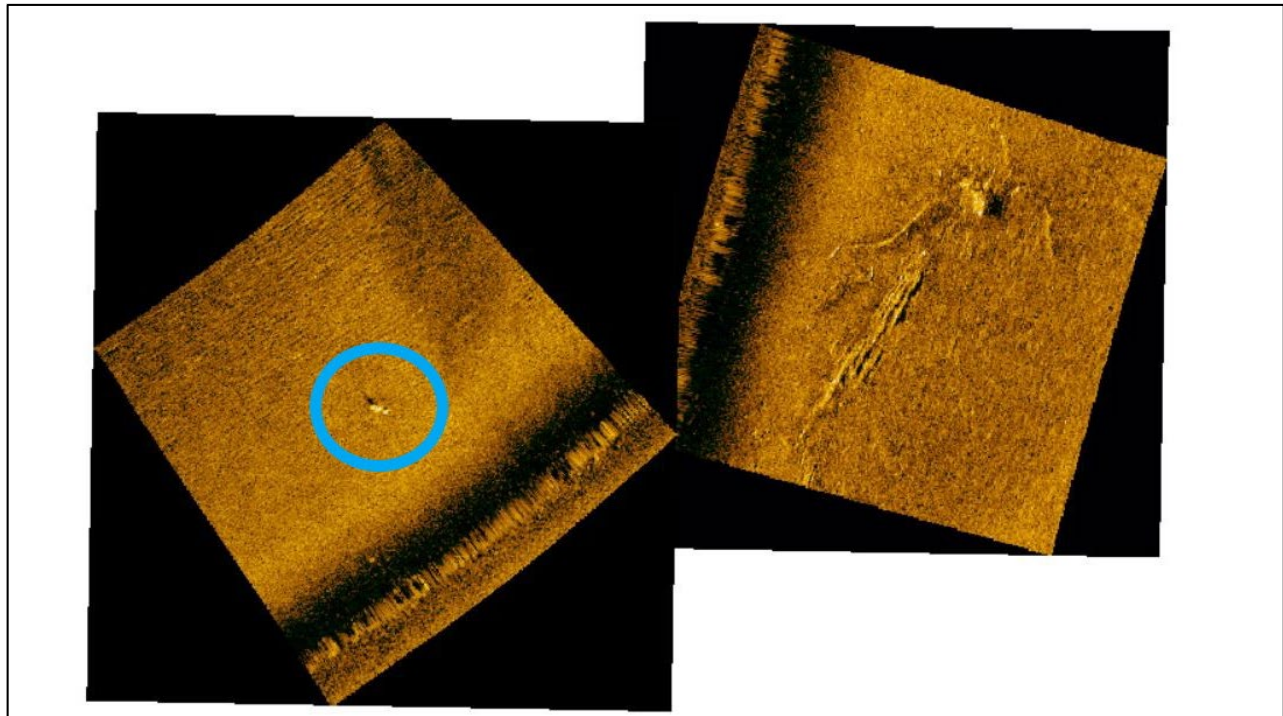
Figure 31: Side-scan Sonar Imagery of the "Happy Days" wreck site.

The overall site measures approximately 88.09 m (289.01 ft) by approximately 41.21 m (135.20 ft) and is oriented roughly NNE to SSW. The site contains two distinct features, as visible in the side-scan sonar image. The first feature is the windlass or other deck machinery remains (Figure 32). This feature measures approximately 3.4 m (11.50 ft) by 1.1 m (3.61 feet) and has approximately 1 m (3.3 ft) of relief. This machinery is located approximately 92.02 m (301.90 ft) due west of the second feature, which is an area of low relief indicating the potential presence of wooden hull remains and other machinery. This area was not investigated by divers during this study. Evaluating the entire site, the vessel remains are disarticulated and spread out over a large area and there is the potential for the presence of buried features or hull remains.

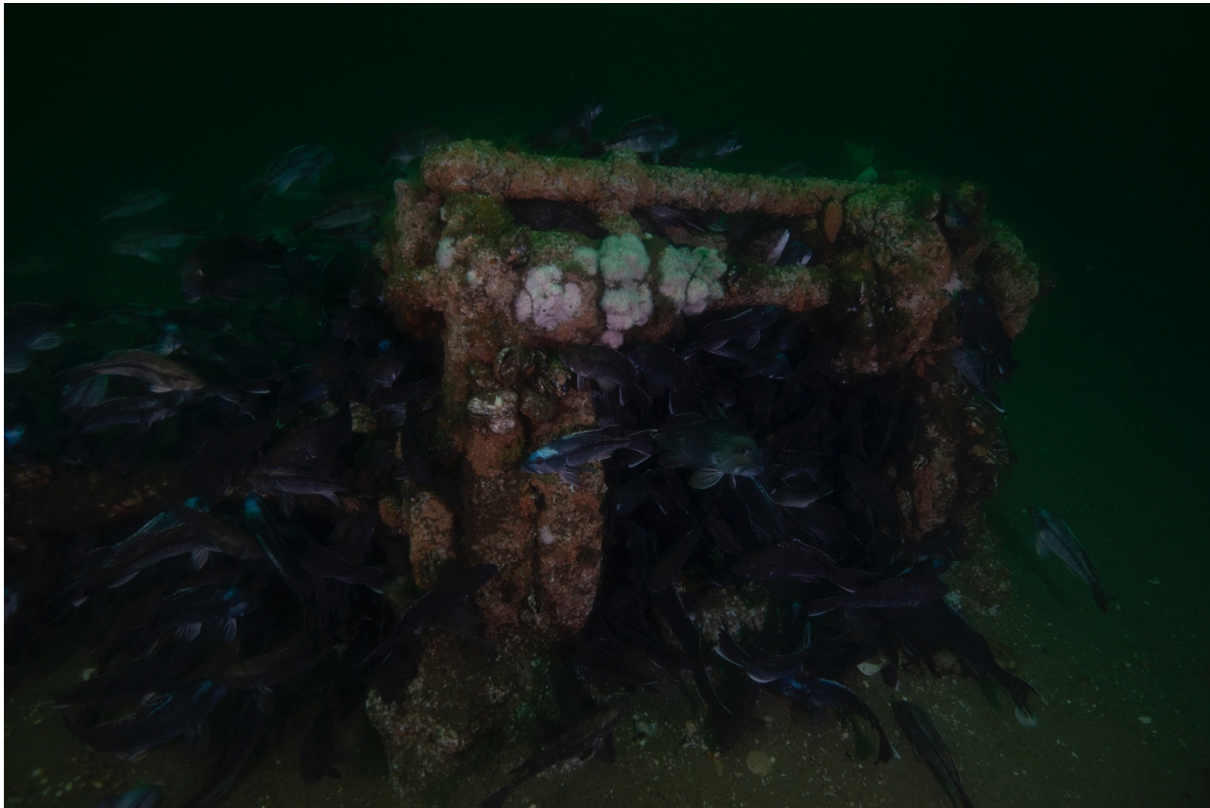
The presence of wood indicates a wooden sailing vessel and, given the size, it was most likely designed for trade rather than recreation, but the function of the vessel cannot be definitively determined at this time.

Figure 32: Image of winch machinery observed at “Happy Days” wreck site.

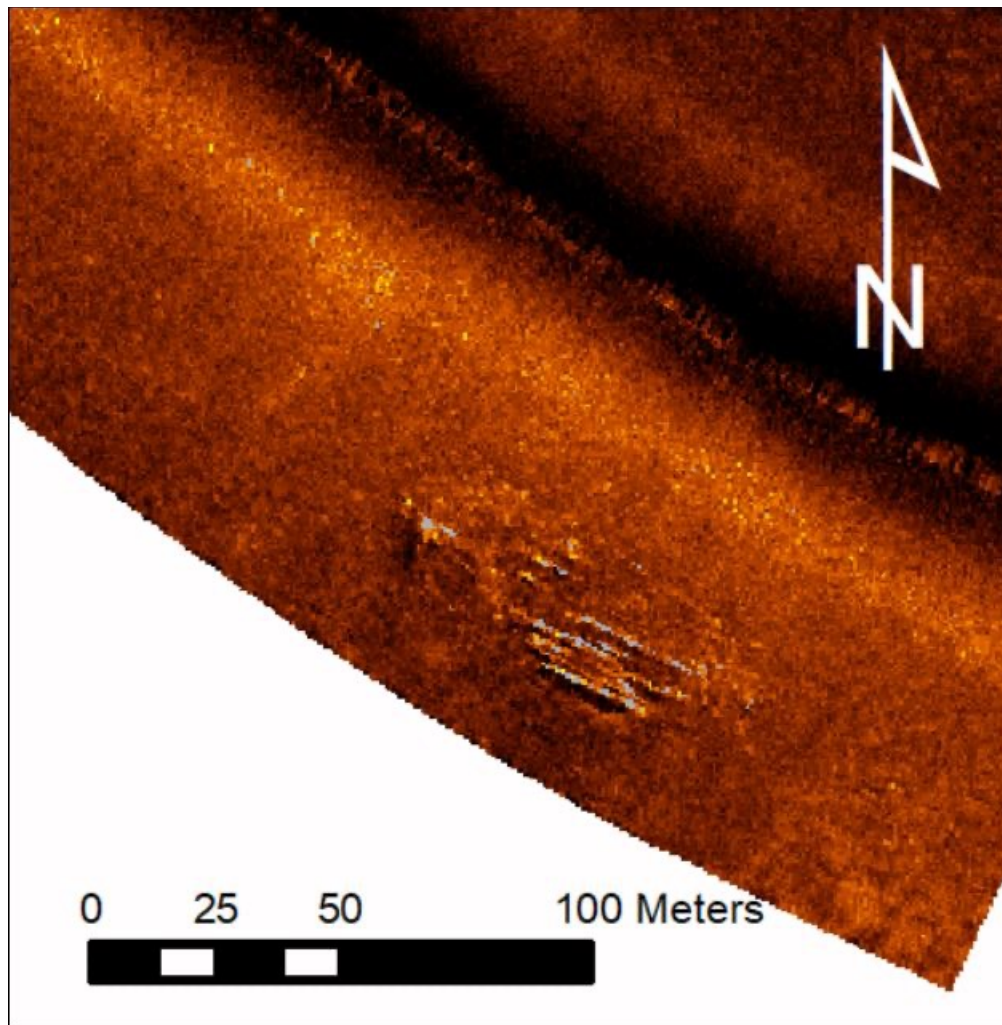
Figure 33: Side-scan Sonar Imagery of Irma C wreck site.

The site has generally low relief and measures approximately 57.25 m (187.83 ft) in length and 21.80 m (71.52 ft) at beam. The highest relief is at the remains of a winch or other deck machinery located at the bow of the wreck which extends approximately 2.10 m (6.89 ft) off the seafloor, as measured by the shadow of the feature in the side-scan sonar imagery. The site is oriented along a northwest to southeast axis, bow to stern. The wreck site is at a water depth of 35.05 m (115 ft).

Irma C	Remains of reported <i>Irma C</i> steam barge. Site consists of wooden hull remains with deck machinery.	Site is considered potentially eligible. Preliminary avoidance of this target is recommended by 50 m (164 ft) from the extent of the site, which may contain buried features and additional wooden hull remains. Additional investigation is recommended to document and monitor the site.
