New York Collaborative Archaeological Survey

November 2021

Hoffman, W., Hoyt, J., and Sassorossi, W. 2021. New York Collaborative Archaeological Survey. Final Report to the U.S. Department of the Interior, Bureau of Ocean Energy Management, Office of Renewable Energy Programs, Sterling, VA and U.S. Department of Commerce, National Oceanic and Atmospheric Administration, Office of National Marine Sanctuaries, Silver Spring, MD. OCS Study BOEM 2021-077.

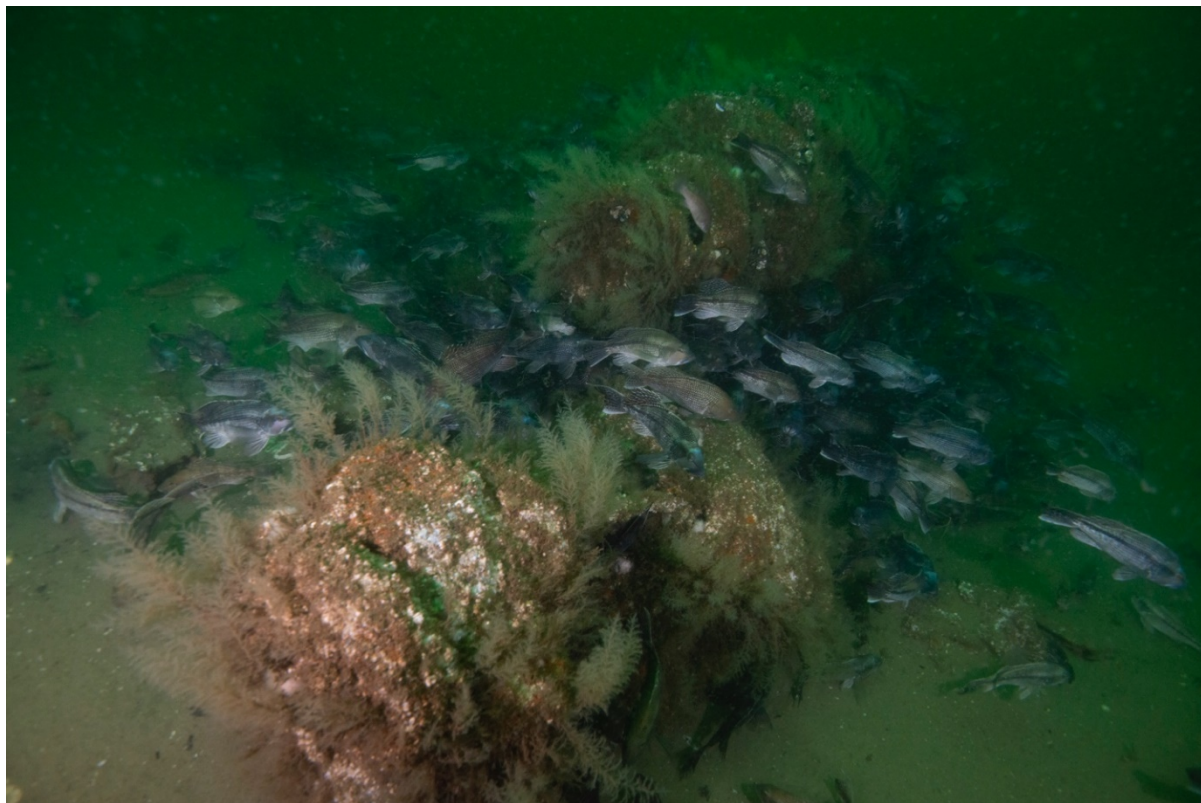
A large mechanical winch is located toward the bow of the vessel, along with other machinery remains (Figure 34), including a potential capstan (Figures 35). Remains of articulated wooden hull planking and framing are visible and there is a high potential for additional hull remains to be buried at and surrounding the site (Figure 36). Other than the winch, no other machinery pieces were located, indicating it was either a sailing vessel or a barge, and not motorized. No coal was observed at the site. It could not necessarily be confirmed from this investigation that the remains are in fact a coal barge, however, the site does merit further investigation.

Figure 34: Remains of a windlass on wreck site of *Irma C*.

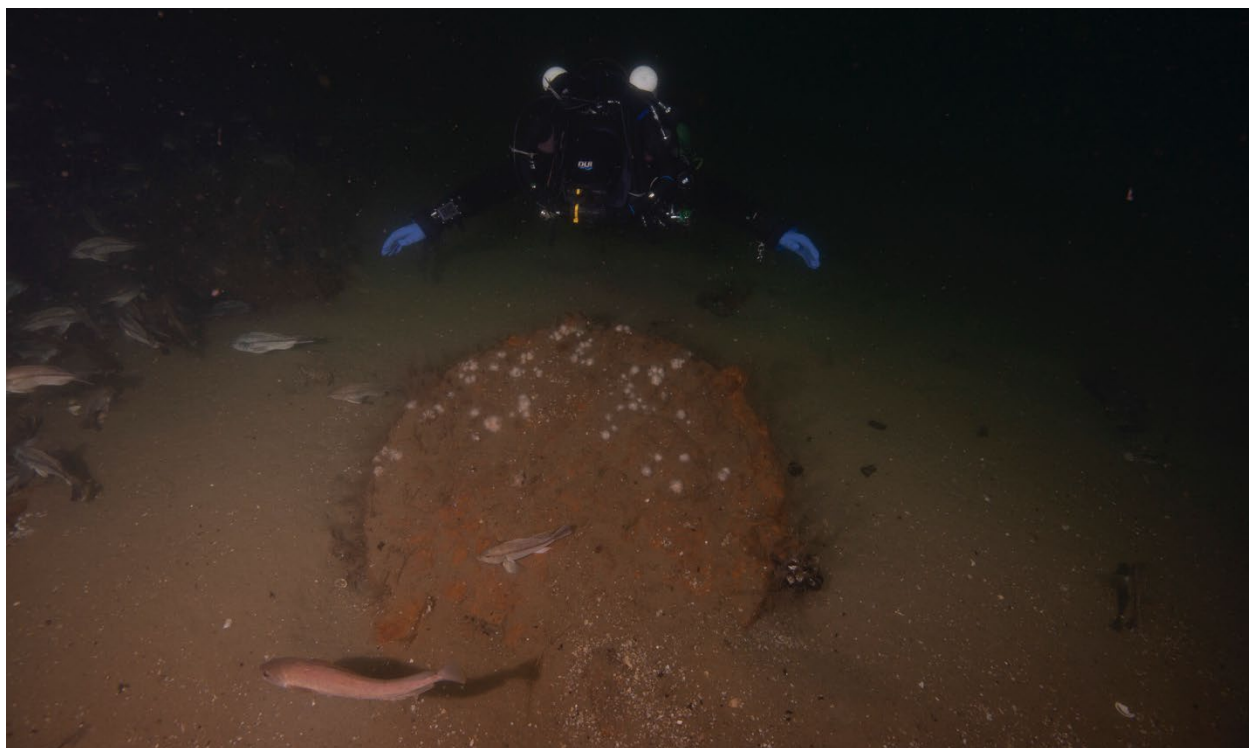
Figure 35: Possible top of capstan observed on *Irma C* site.

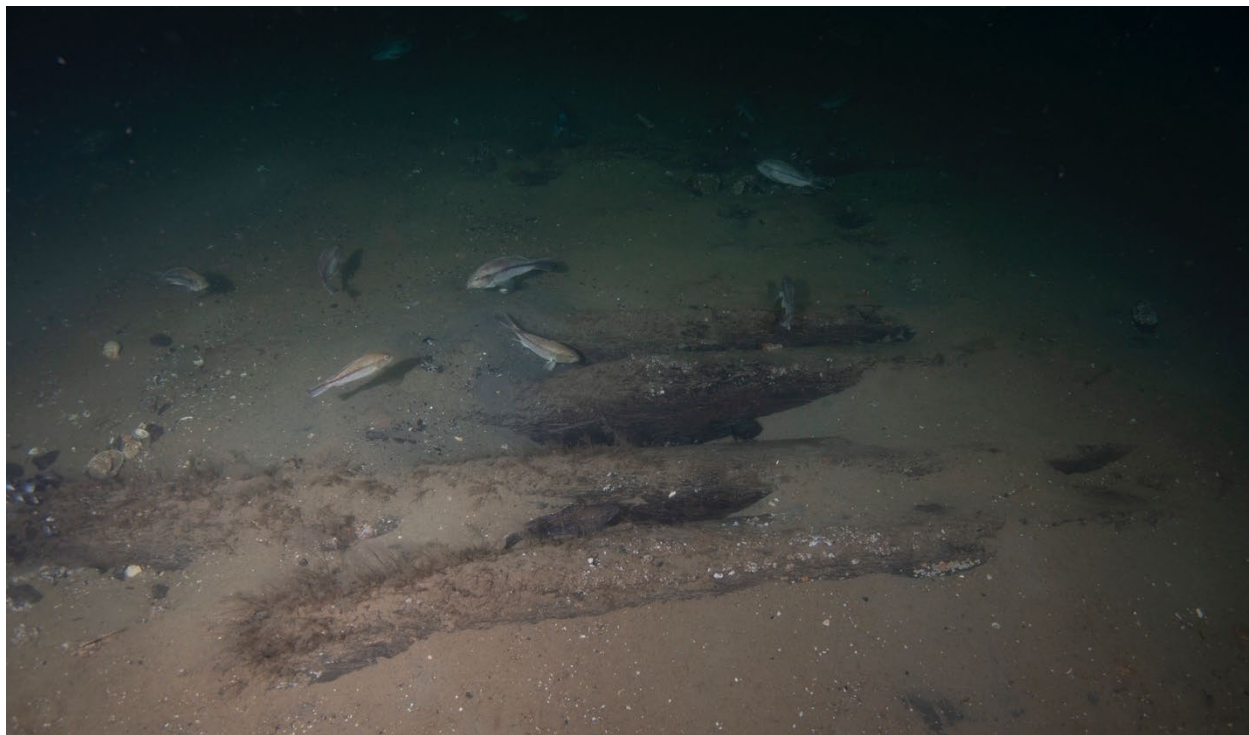
Figure 36: Wood frames on wreck of Irma C.

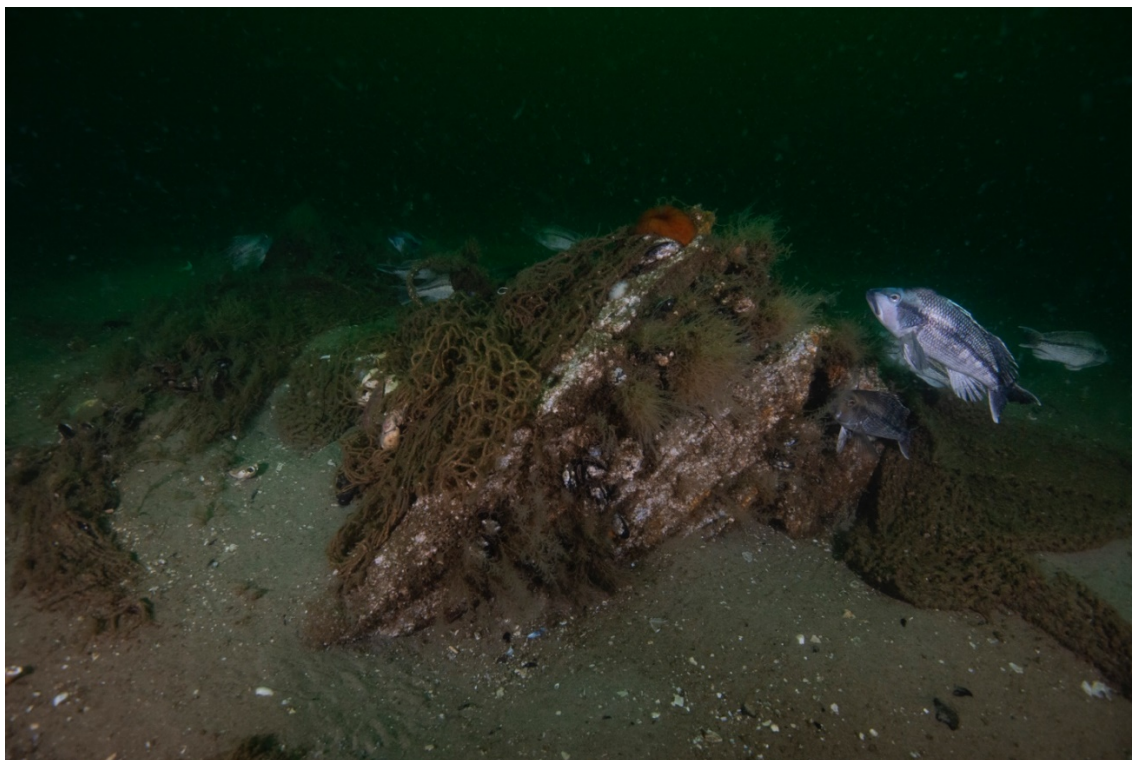
Figure 37: Derelict fishing gear observed on Irma C.
