OCS Study BOEM 2020-019

Seafloor Disturbance and Recovery Monitoring at the Block Island Wind Farm, Rhode Island – Summary Report

March 2020

Prepared under BOEM Award Contract No. M15PC00002 Task Order No. M17PD00015 By HDR 9781 S Meridian Boulevard, Suite 400 Englewood, CO 80112

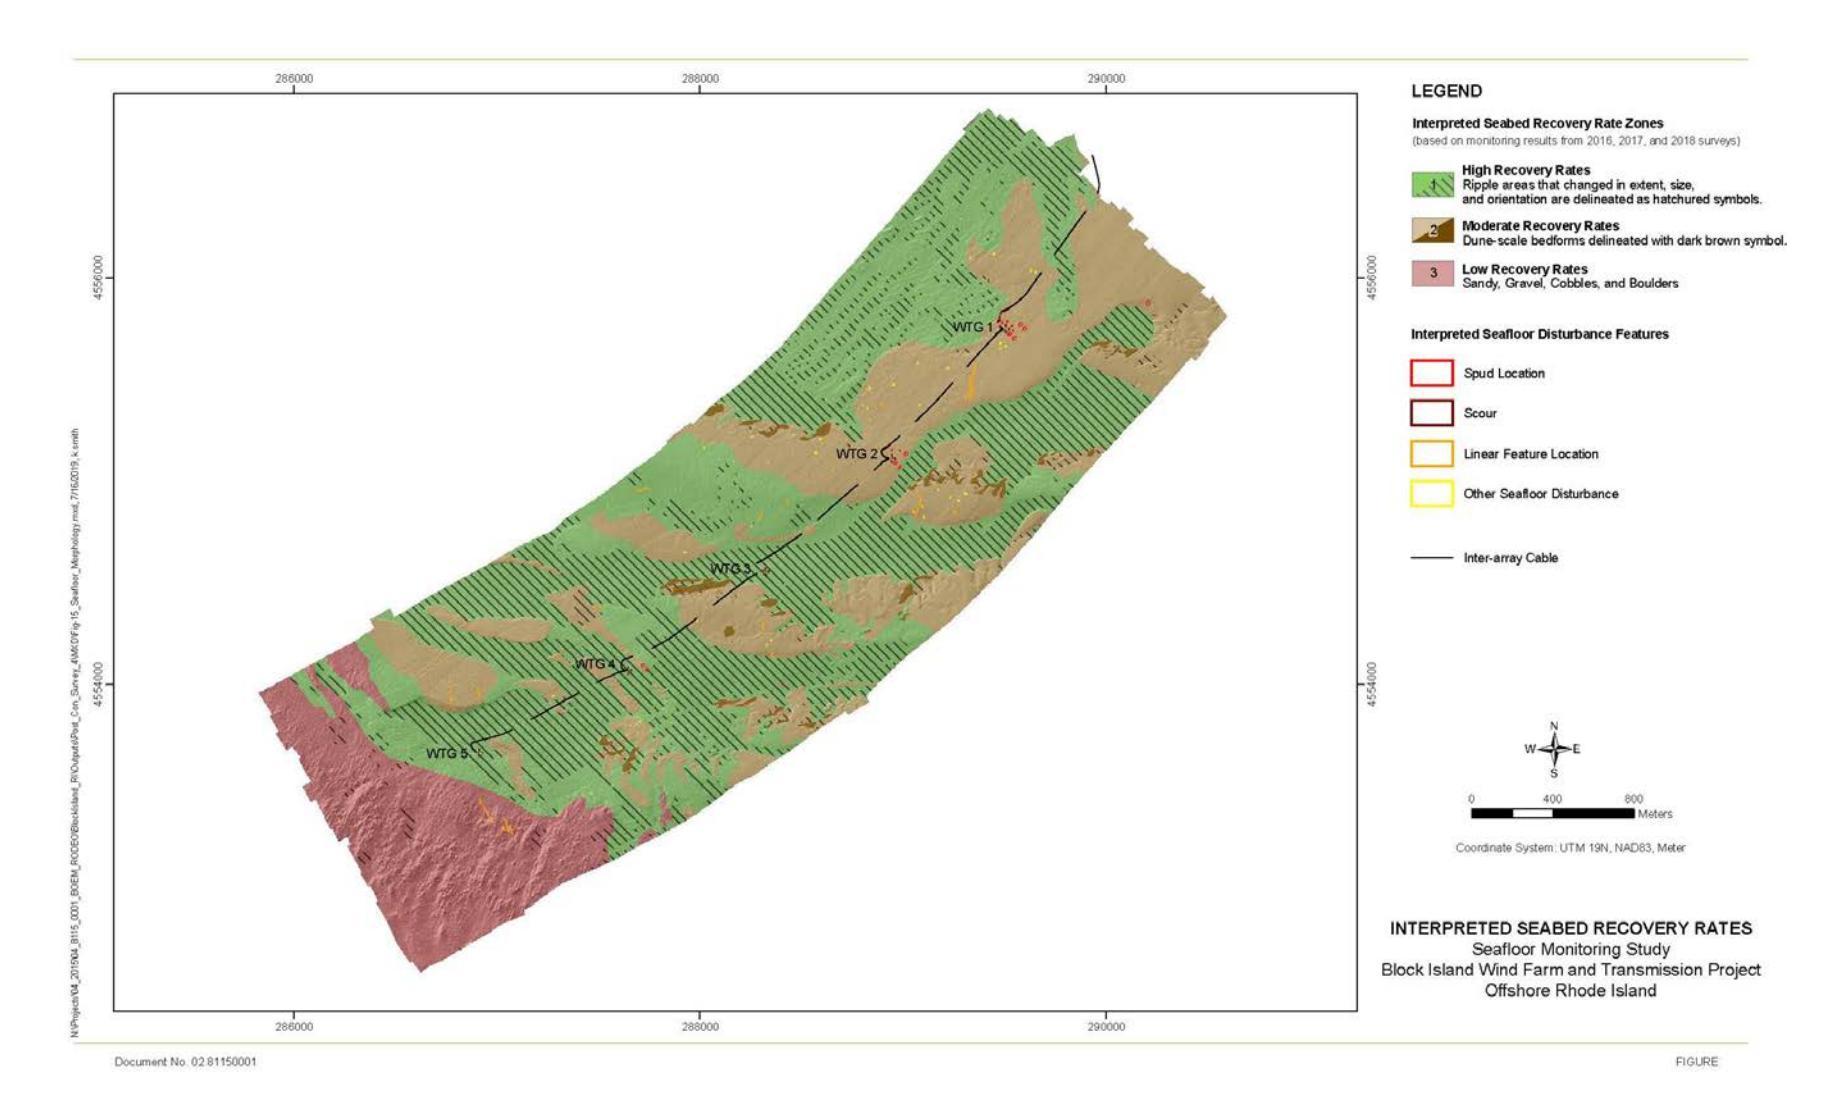
Figure 7. Interpreted seafloor recovery rates over the five surveys.

Seafloor recovery estimates per zone is summarized in Table 8 and Figure 7.

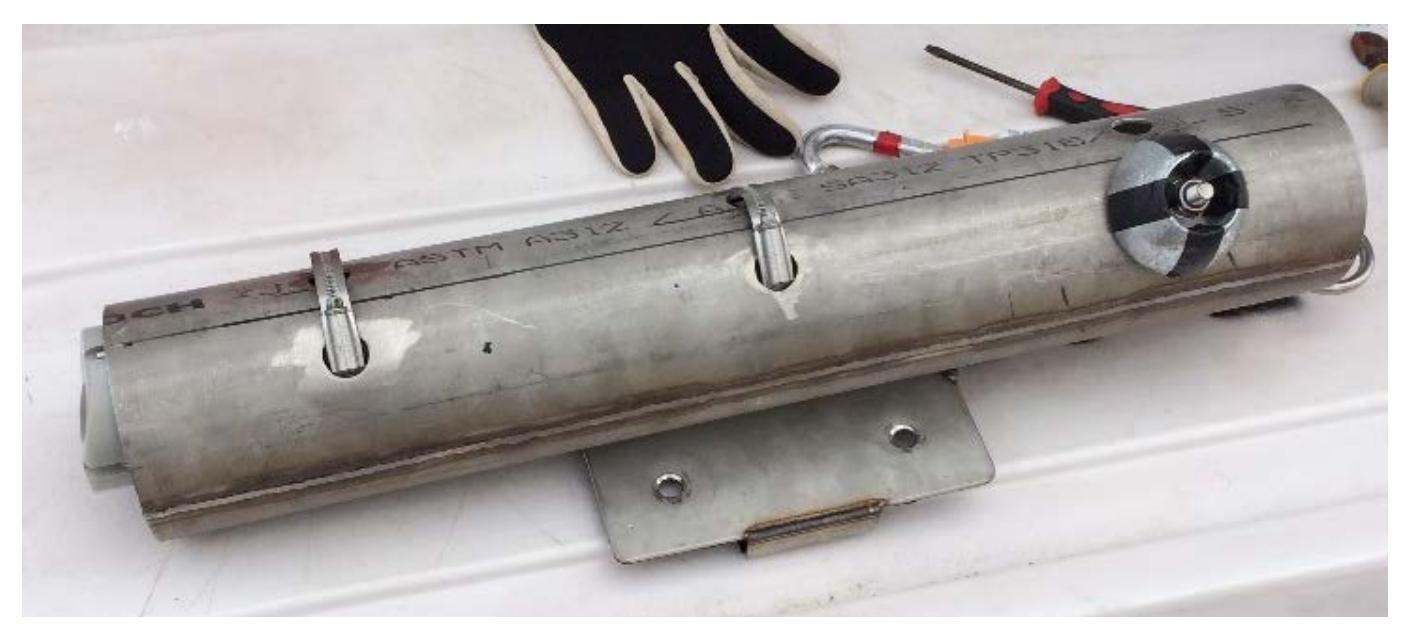
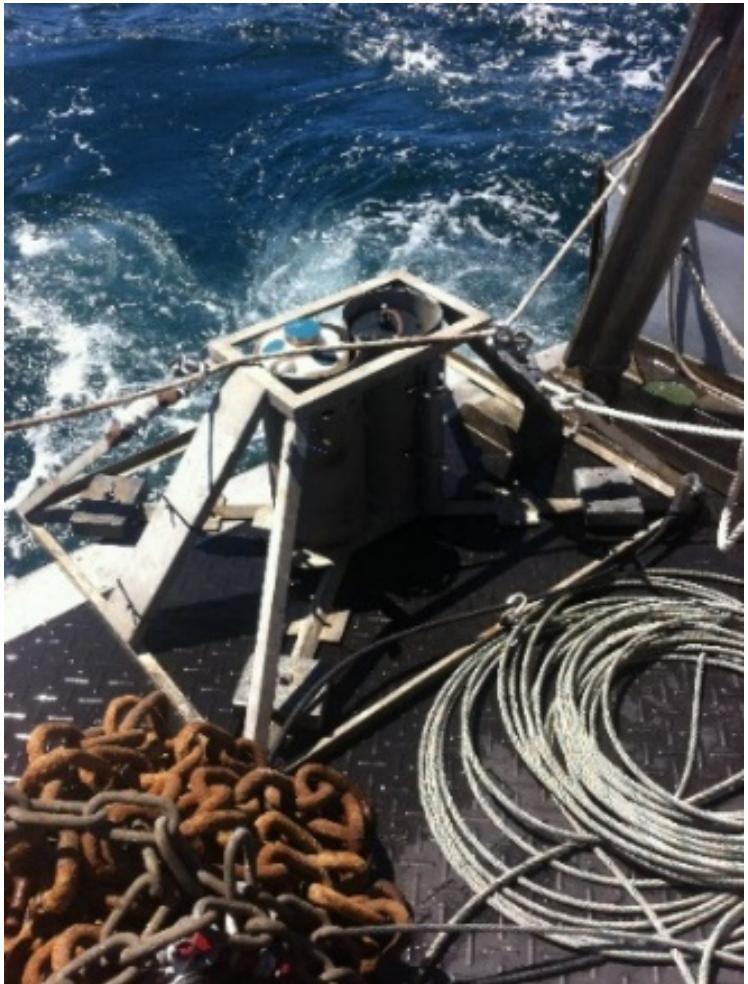
Figure 8. Scour monitor in bracketing (top); seafloor frame and AWAC (bottom).

Two innovative scour monitors (**Figure 8**) were installed on the foundation of Turbine 3, and changes in seafloor levels (scouring patterns) near this foundation were tracked in real time over an approximately 14-month period.³ The units were serviced every 3 months. A frame-mounted acoustic wave and current profiler (AWAC) also was simultaneously deployed on the seafloor approximately 500 m (1,640.4 ft) southeast of Turbine 3 (**Figure 8**). Site-specific oceanographic data collected by the AWAC supported analyses and interpretation of data obtained from scour monitors.

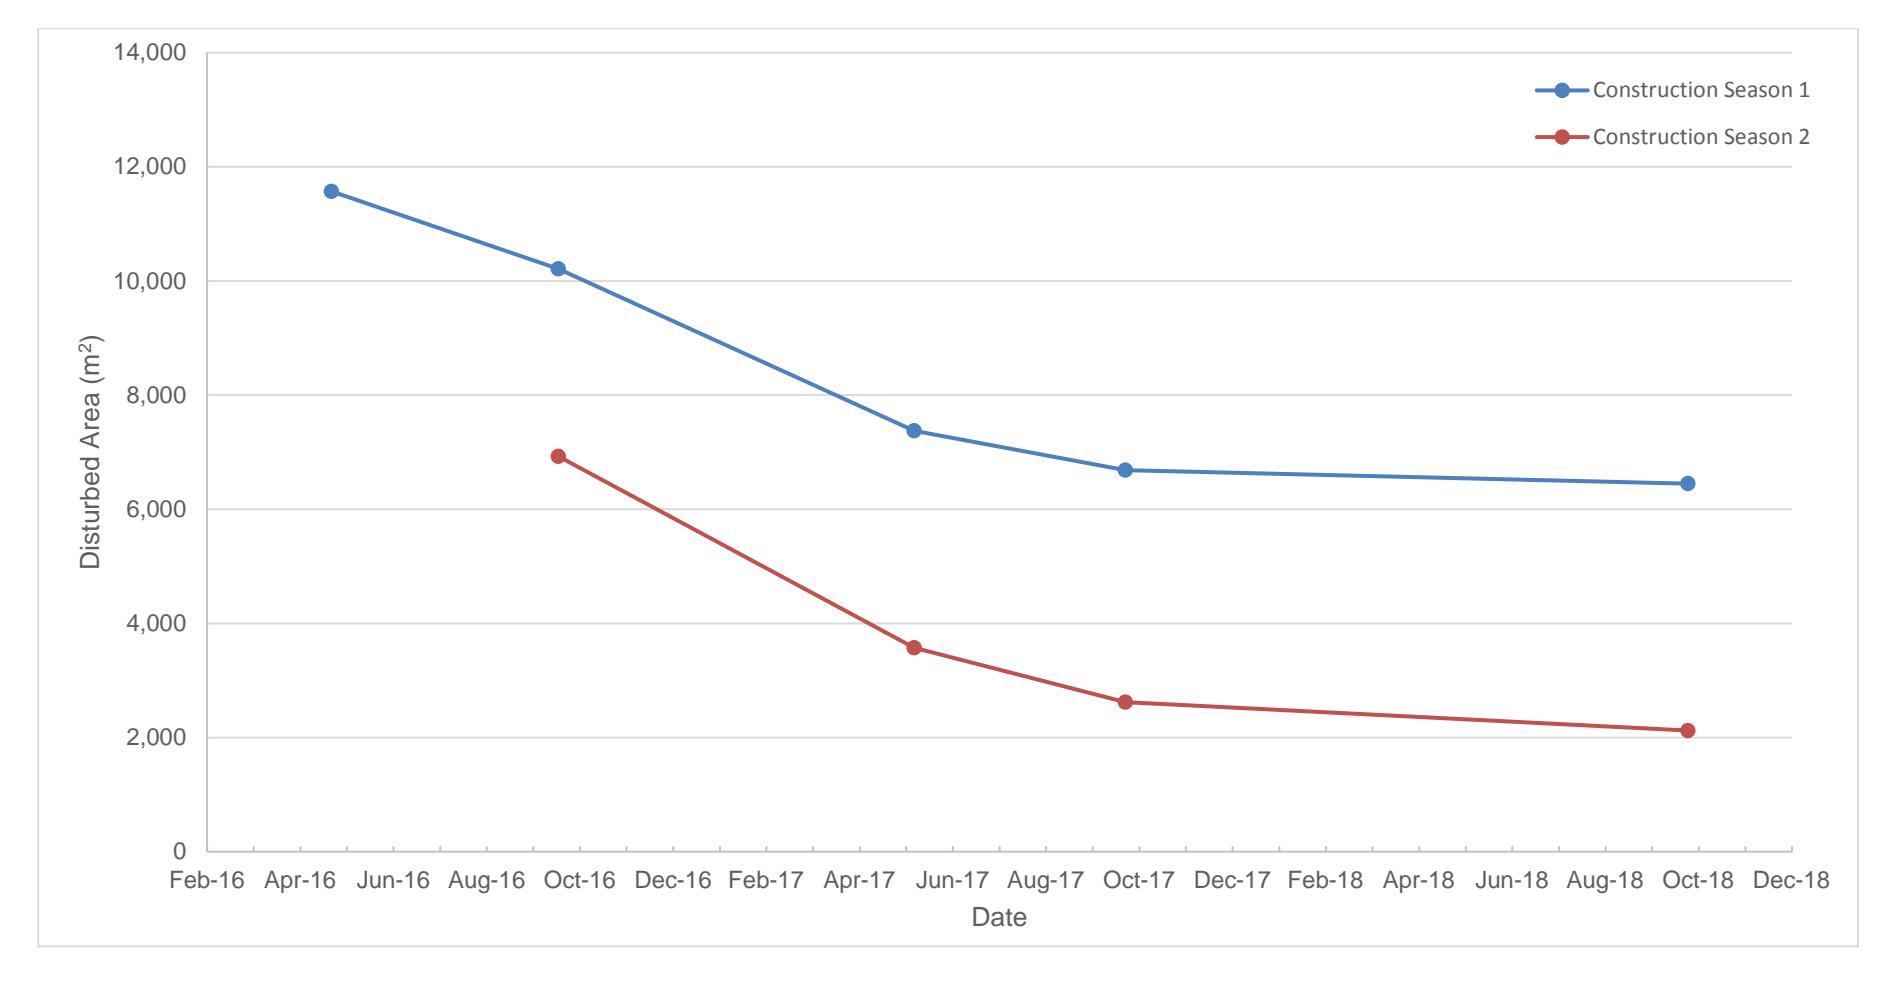
Inset graph (left) presents a summary of the disturbed seafloor area interpreted from each survey.

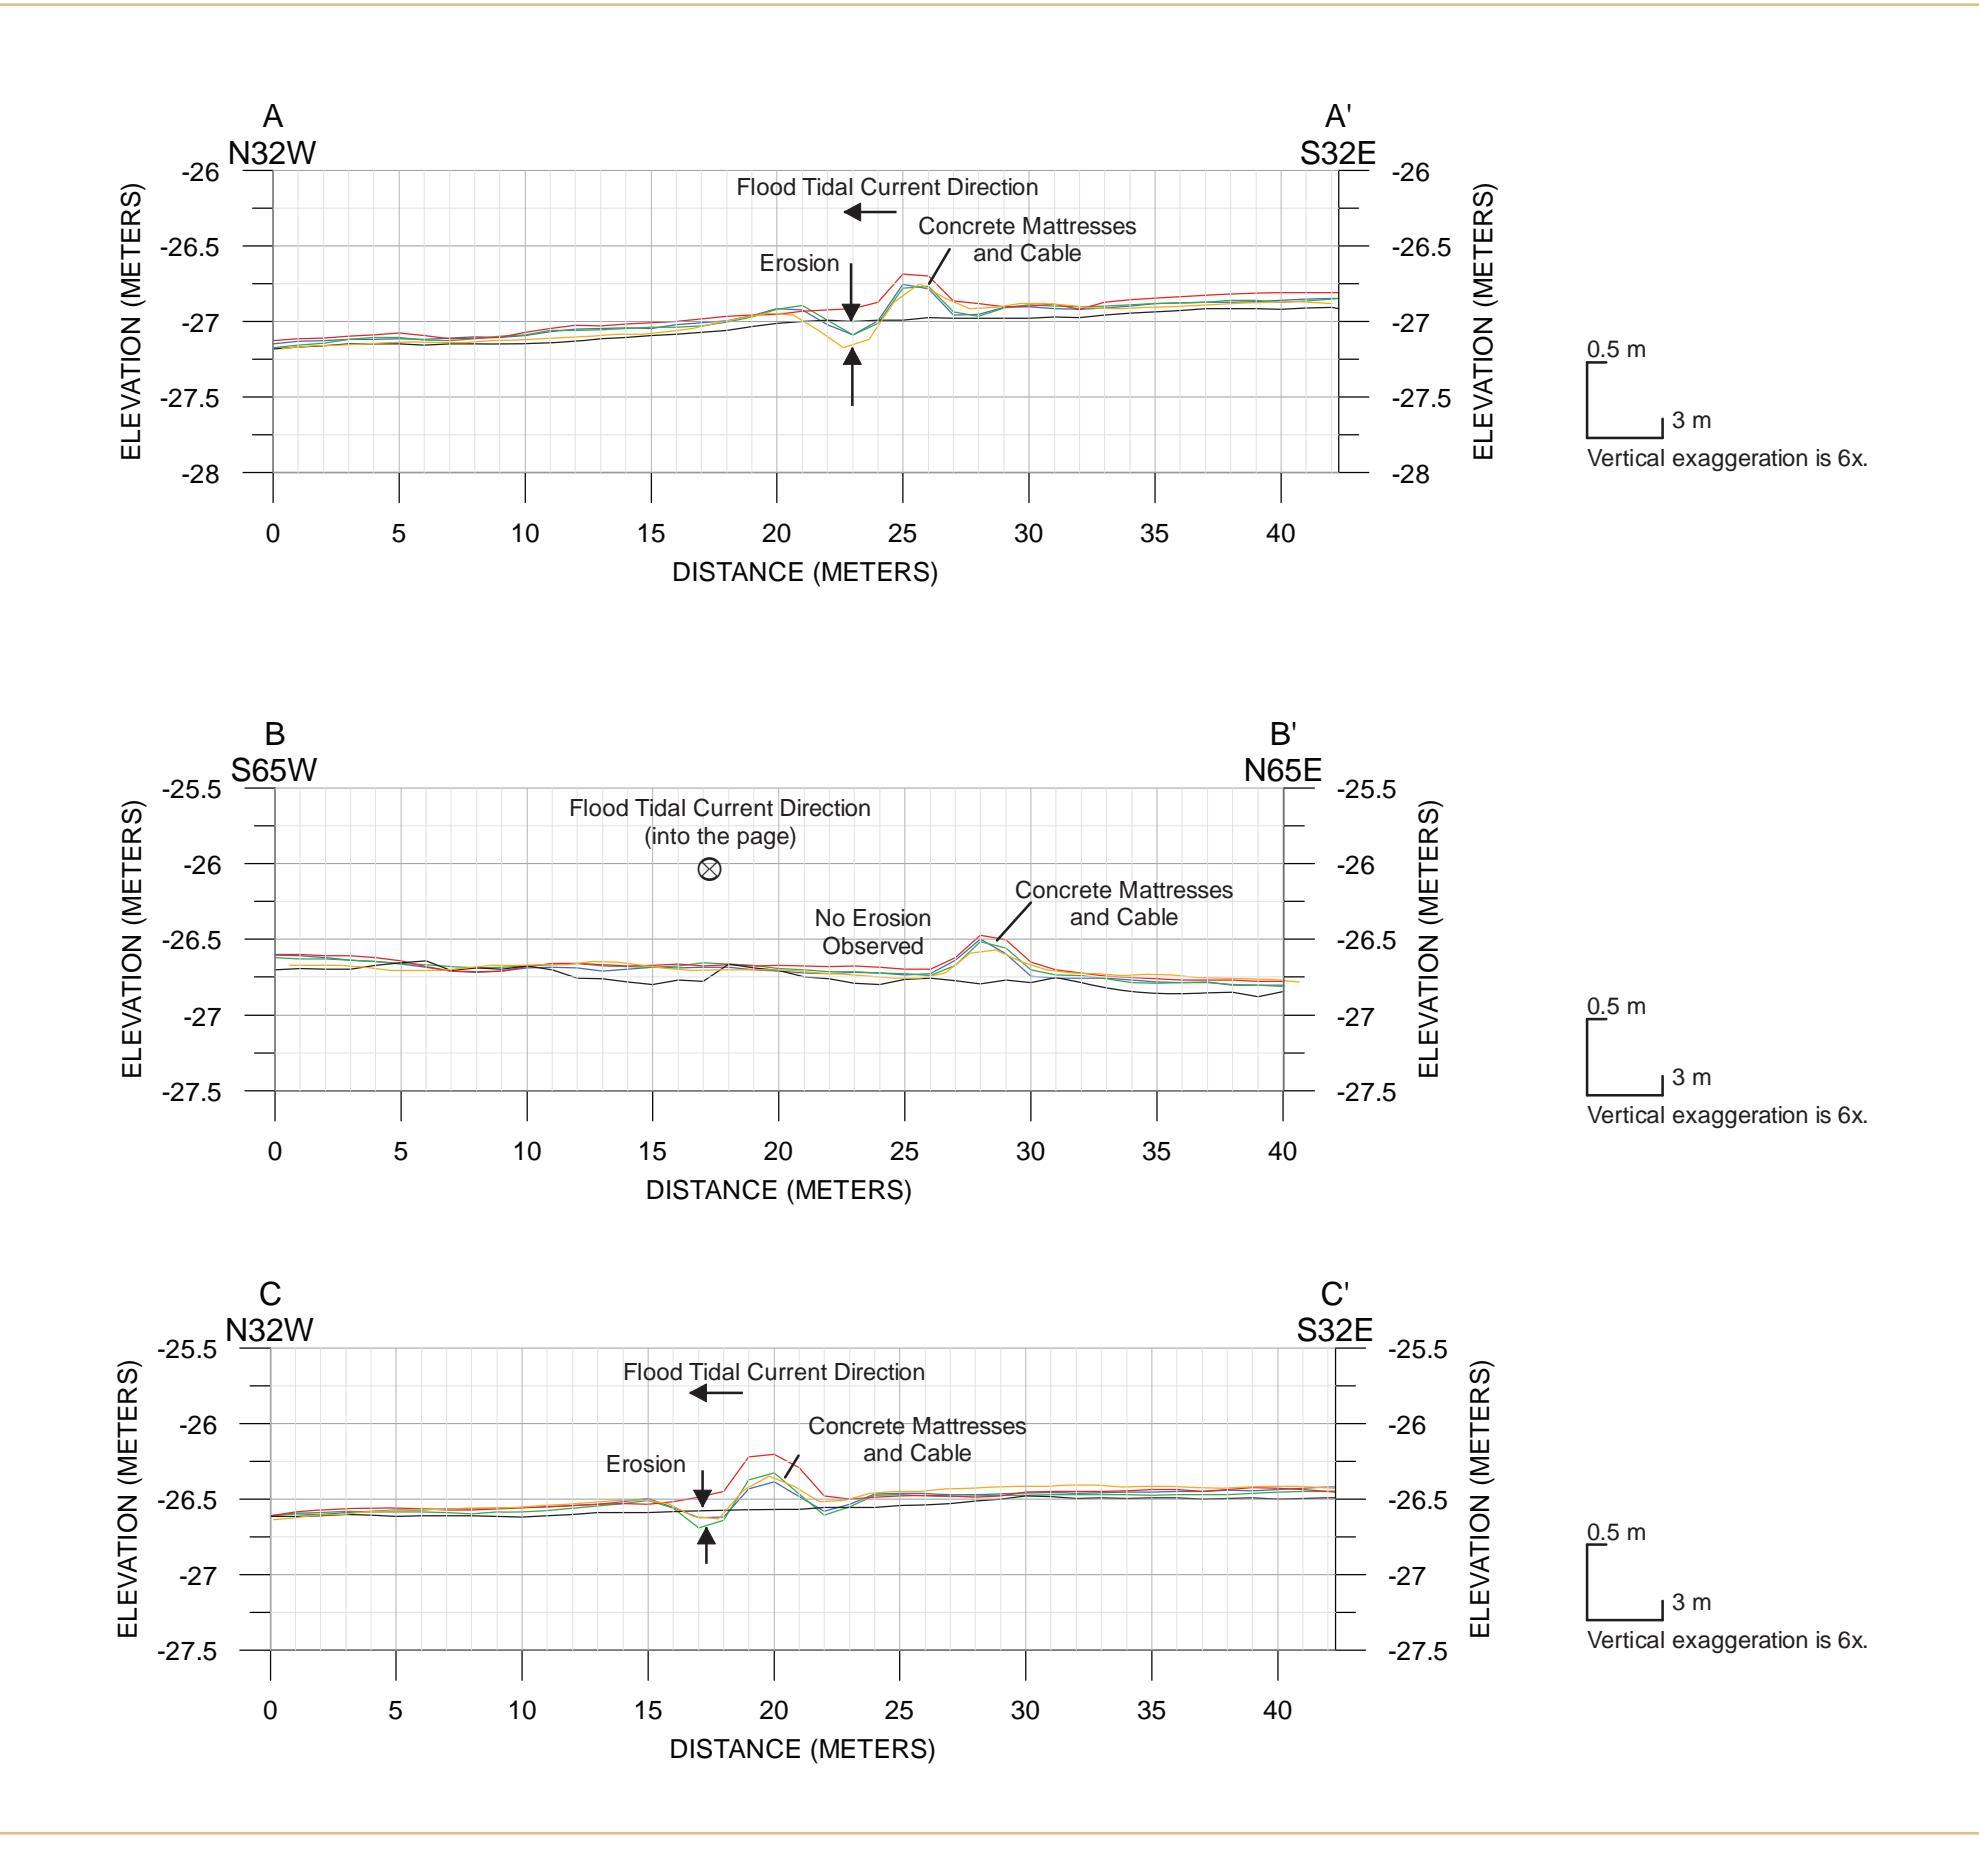
Survey 1 was conducted before the cable and concrete mattresses were installed.

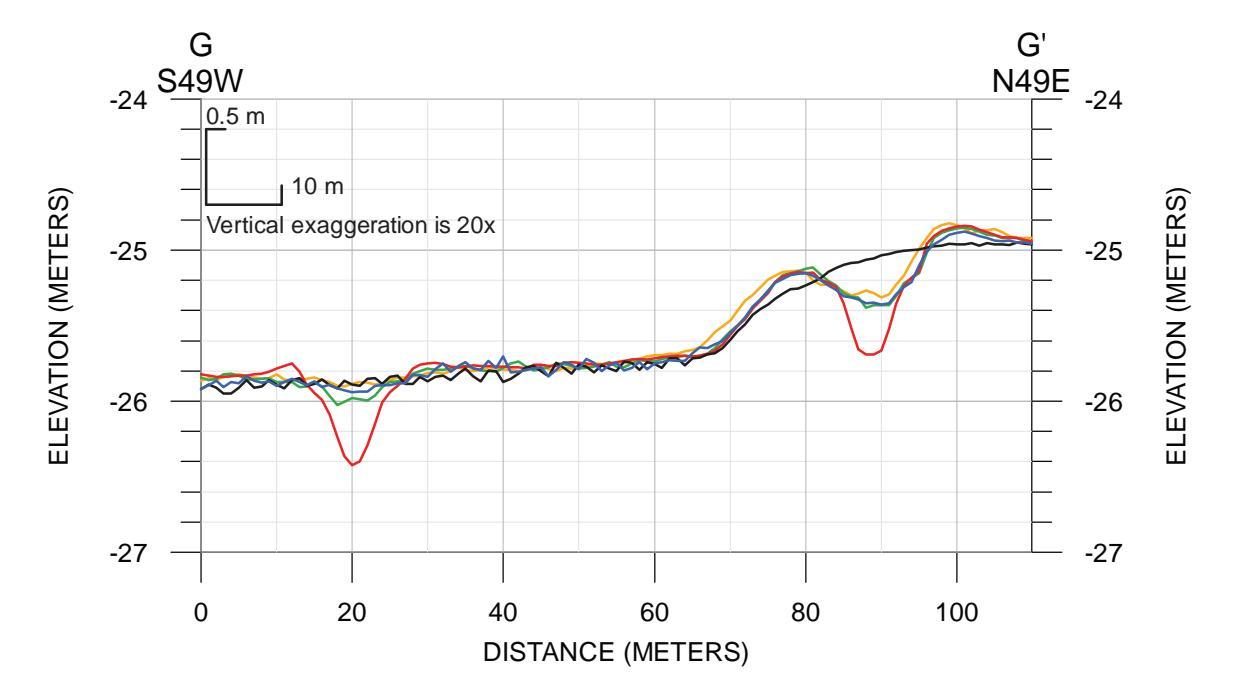
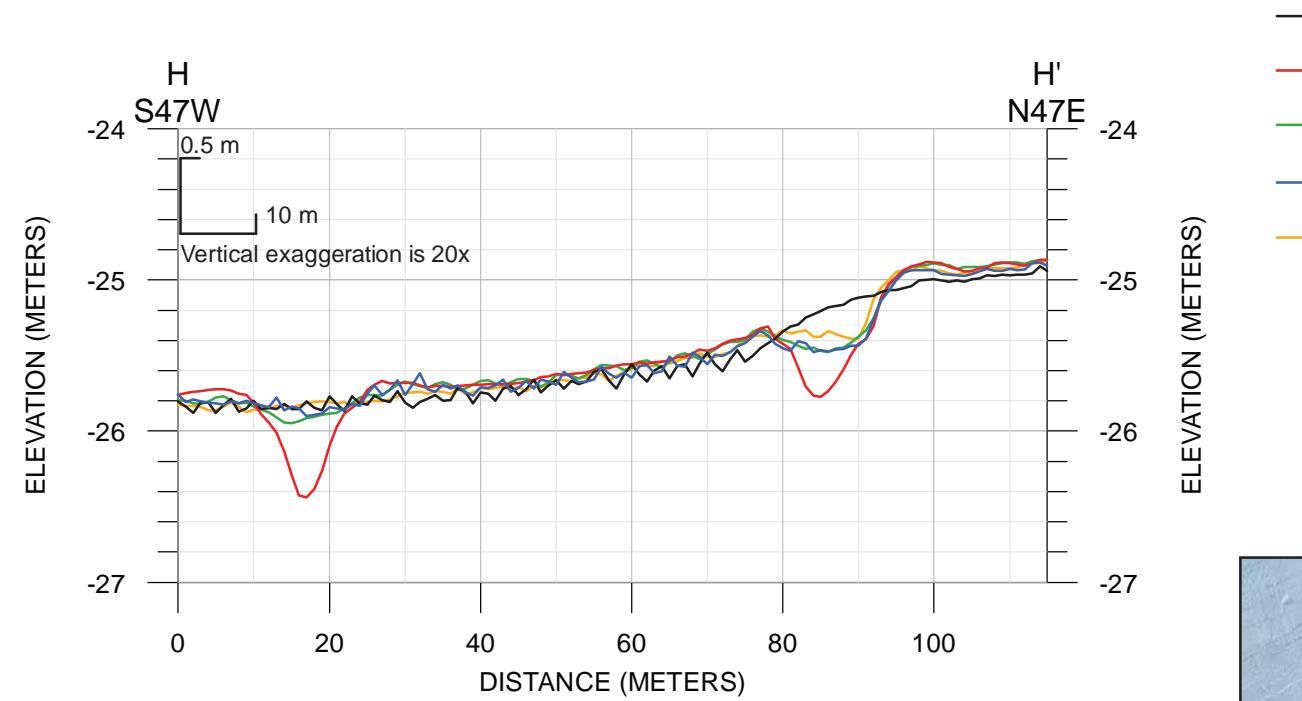
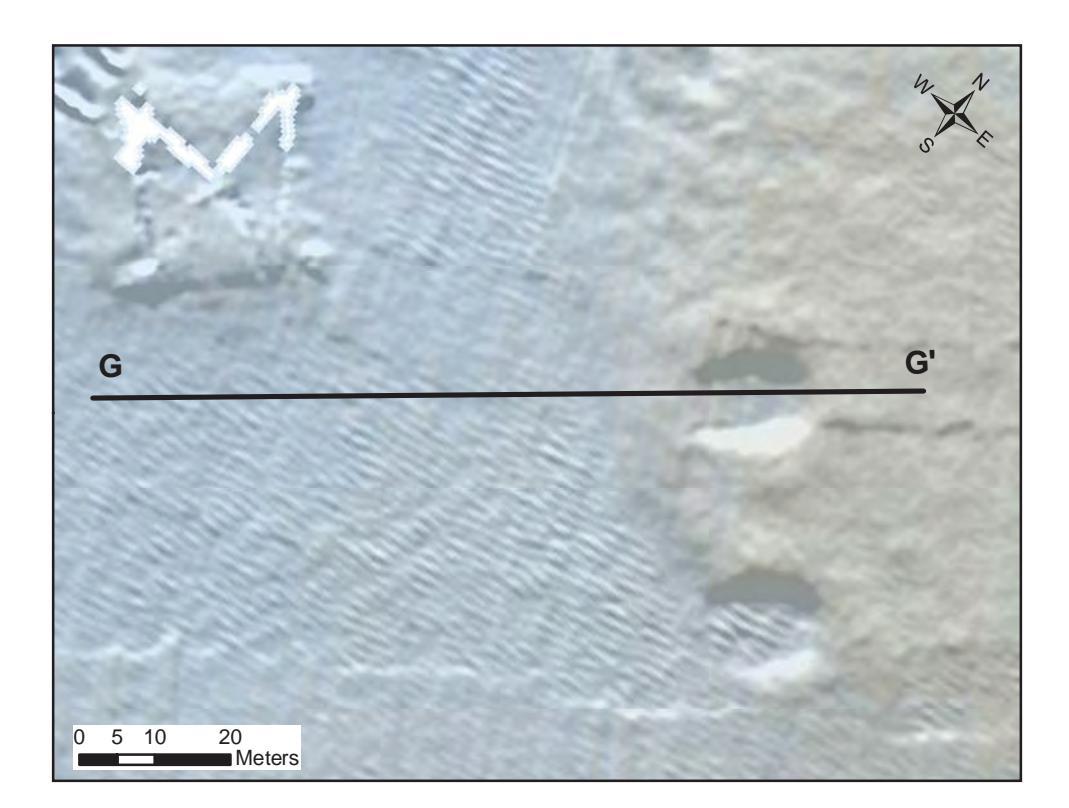
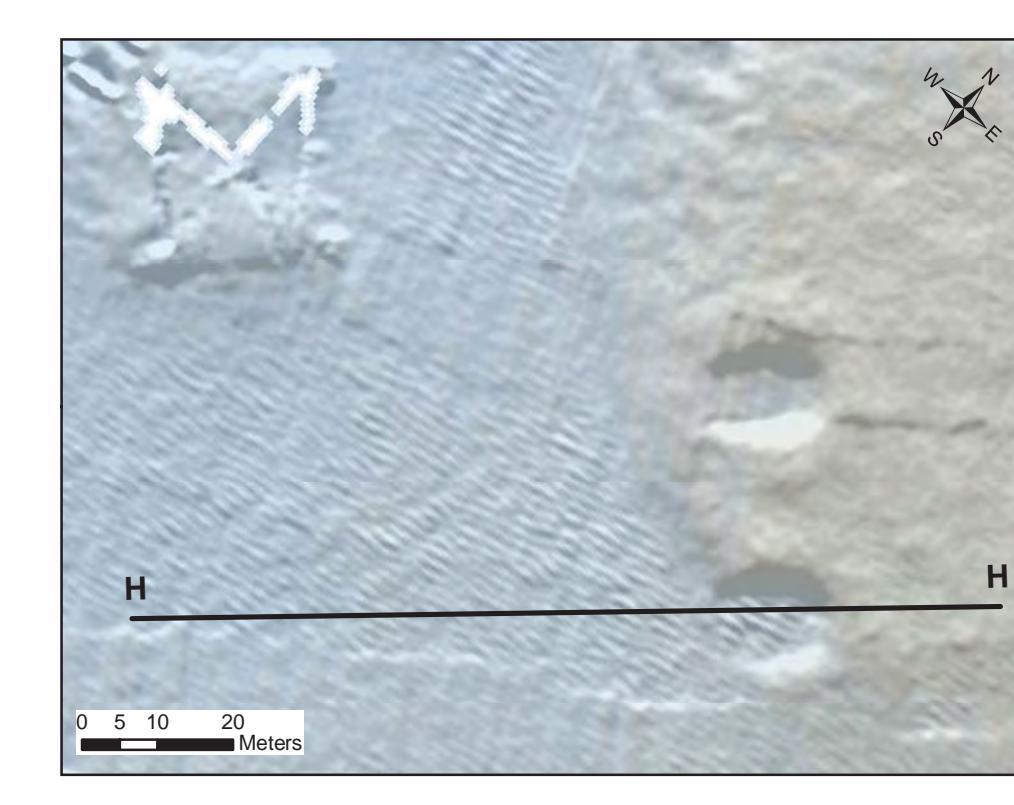
EXAMPLE OF SEAFLOOR RECOVERY WIND TURBINE GENERATOR NO. 4

The depressions shown in this figure were created by the L/B Brave Tern vessel while installing the wind turbine during Construction Season 2 that occurred in between Surveys 1 and 2. Bathymetry data shown in the plan views are from Survey 5.

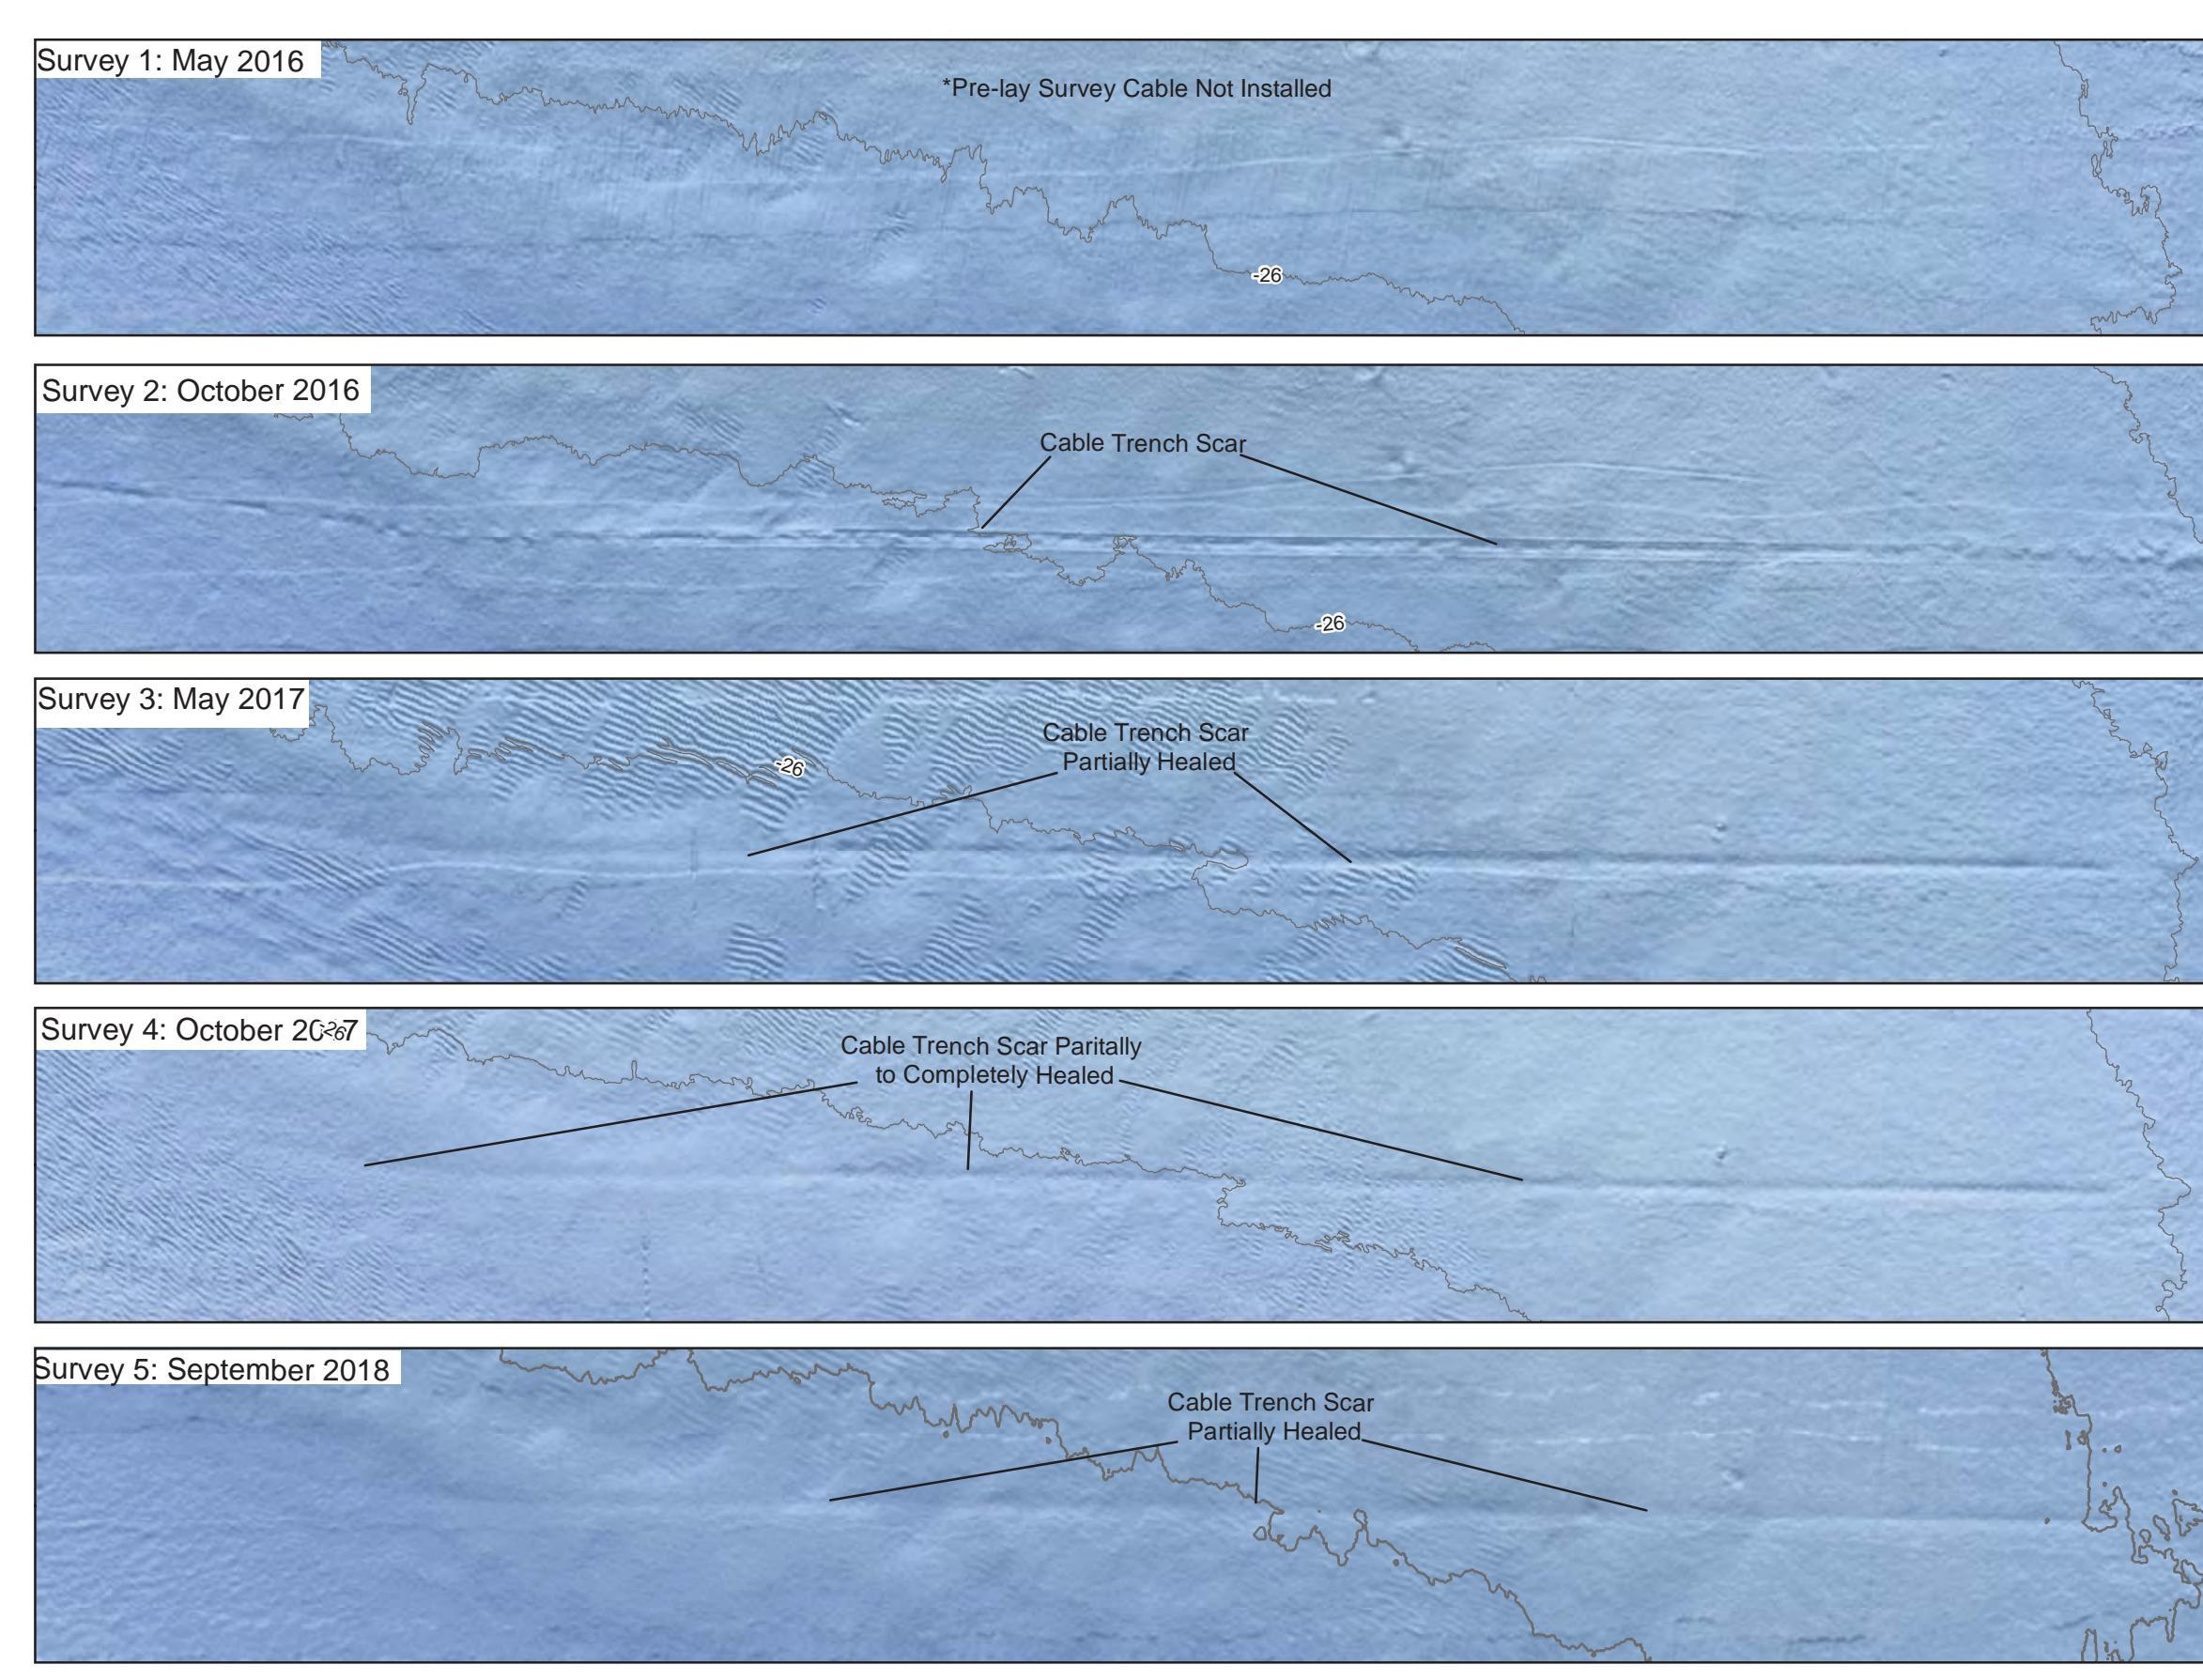
INTER-ARRAY CABLE TRENCH MAY 2016 THROUGH SEPTEMBER 2018 SURVEYS Seafloor Monitoring Study Block Island Wind Farm and Transmission Project Offshore Rhode Island

The comparison of the inter-array cable from the four surveys (May 2016 through October 2017), indicate that cable trench scar has partially healed. The inter-array cable was installed between June and July 2016, and Survey 2 (Oct. 2016) showed that the trench scar was up to approximately 10 cm in depth in this area. Survey 3 (May 2017) showed in this same area that portions of the cable trench had completely healed while other areas were up to 7 cm deep. Survey 4 (Oct. 2017) showed that most of the cable trench in this extent had healed, with a few areas up to approximately 5 cm in depth.

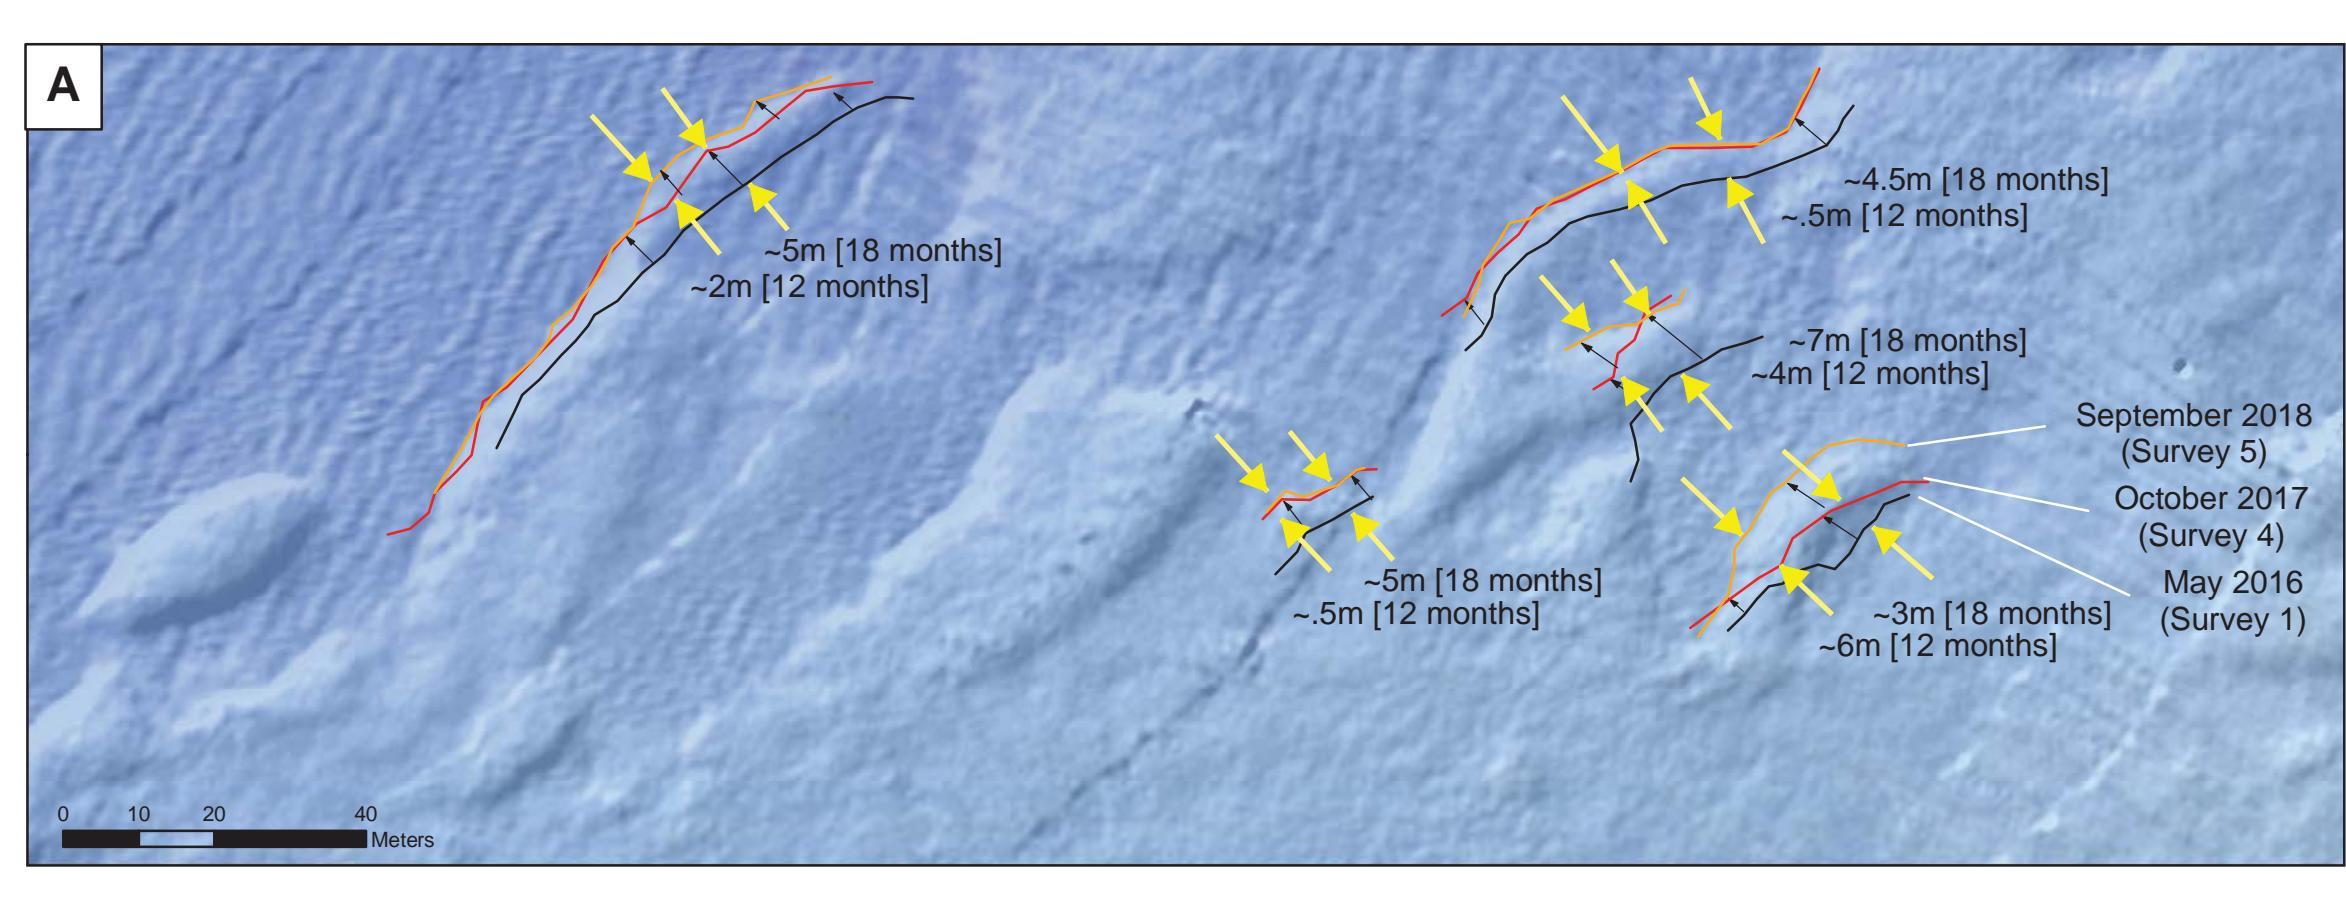
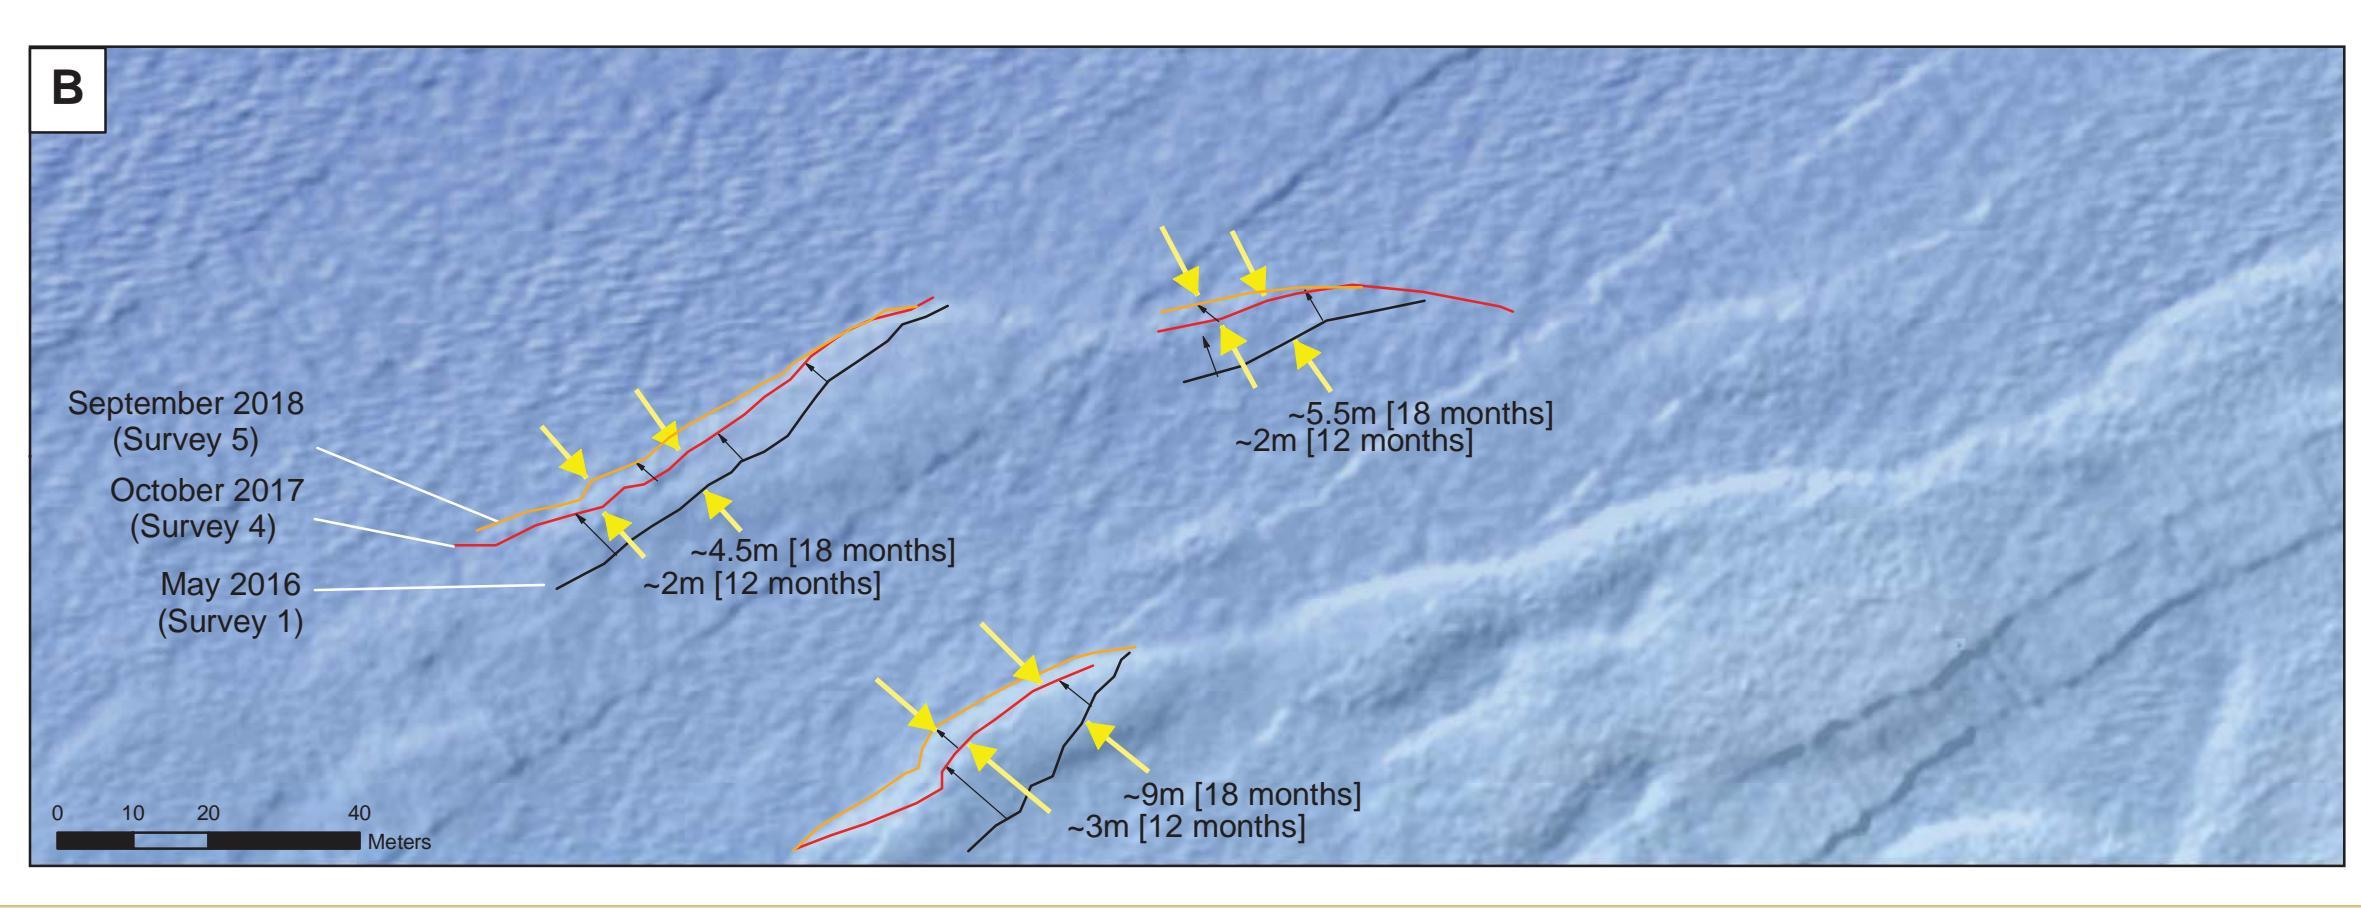
BEDFORM CHANGES REVEALED BY OCTOBER 2017 AND SEPTEMBER 2018 SURVEYS Seafloor Monitoring Study

The comparison of bedform features from the two surveys (October 2017 and September 2018) conducted over one year apart, indicate that the bedforms have shifted approximately 2 to 6 meters to the northwest compared to the previous comparison of 3 to 9 meters from May 2016 and October 2017. The orange, red, and black lines represent the interpreted features from the September 2018, October 2017, and May 2016 surveys, respectively.

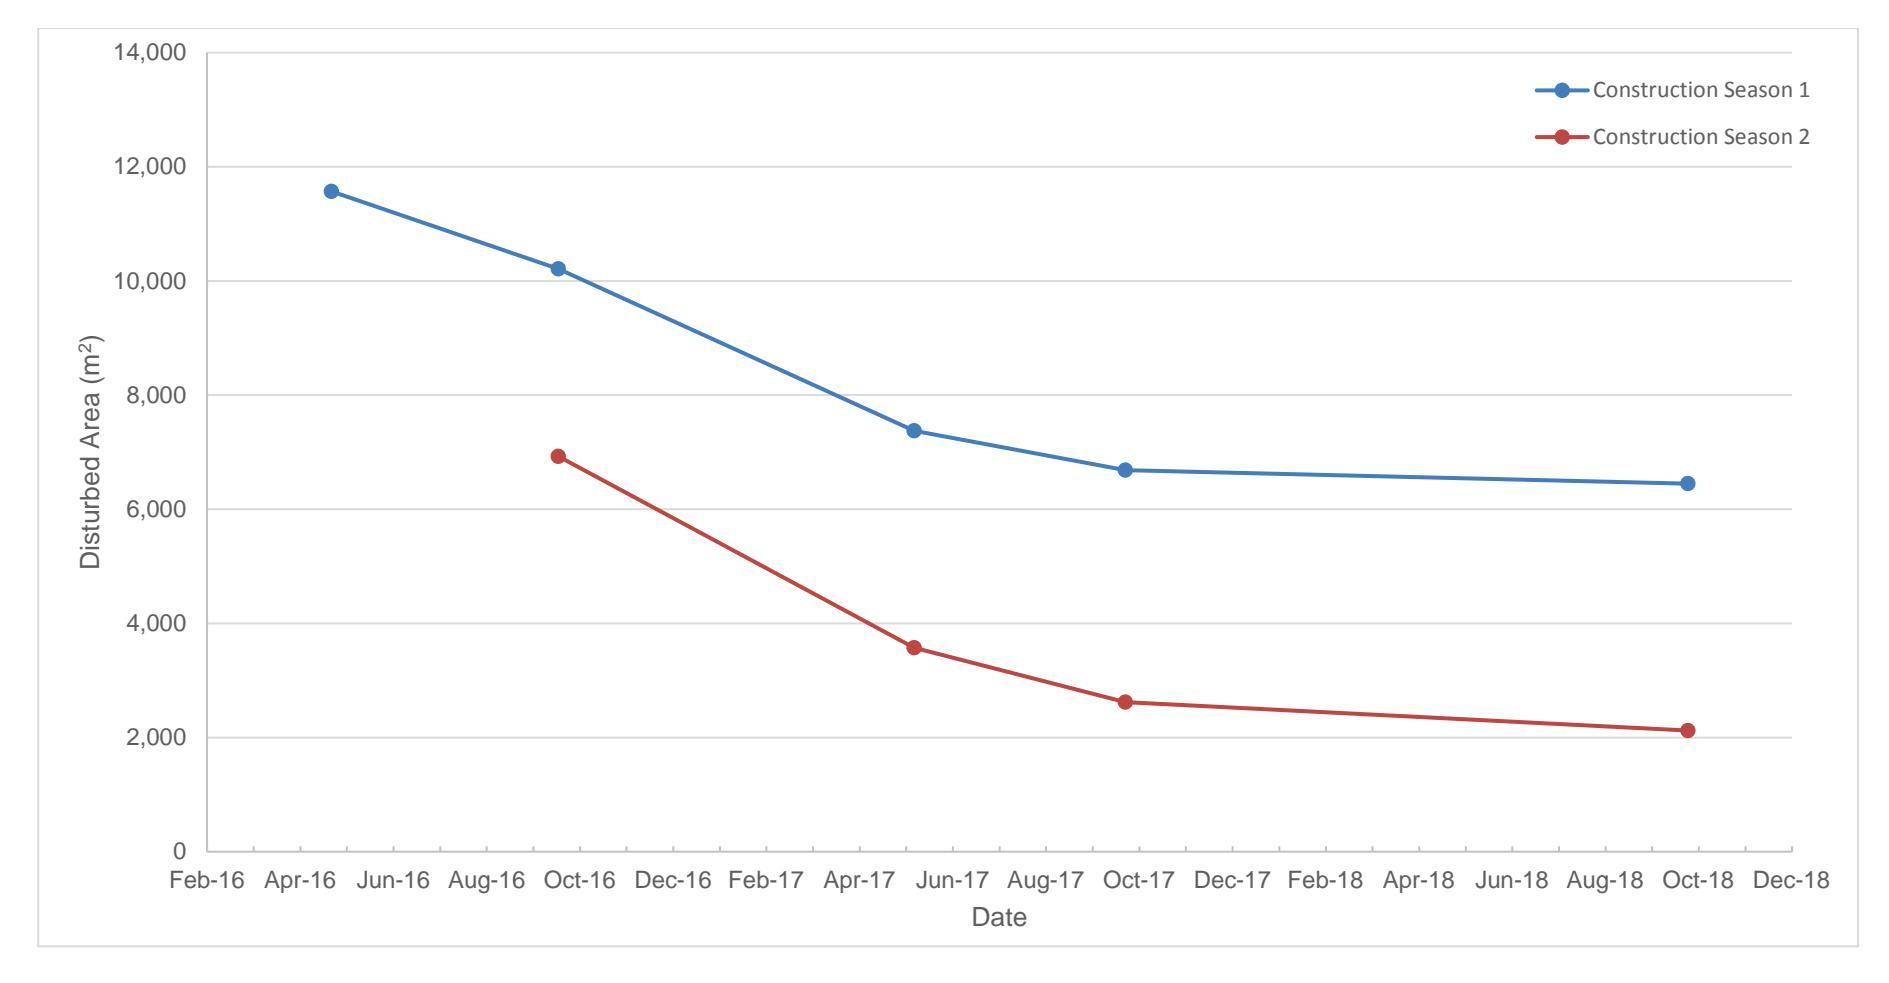
Inset graph (left) presents a summary of the disturbed seafloor area interpreted from each survey.
