OCS Study BOEM 2020-019

Seafloor Disturbance and Recovery Monitoring at the Block Island Wind Farm, Rhode Island – Summary Report

March 2020

Prepared under BOEM Award Contract No. M15PC00002 Task Order No. M17PD00015 By HDR 9781 S Meridian Boulevard, Suite 400 Englewood, CO 80112

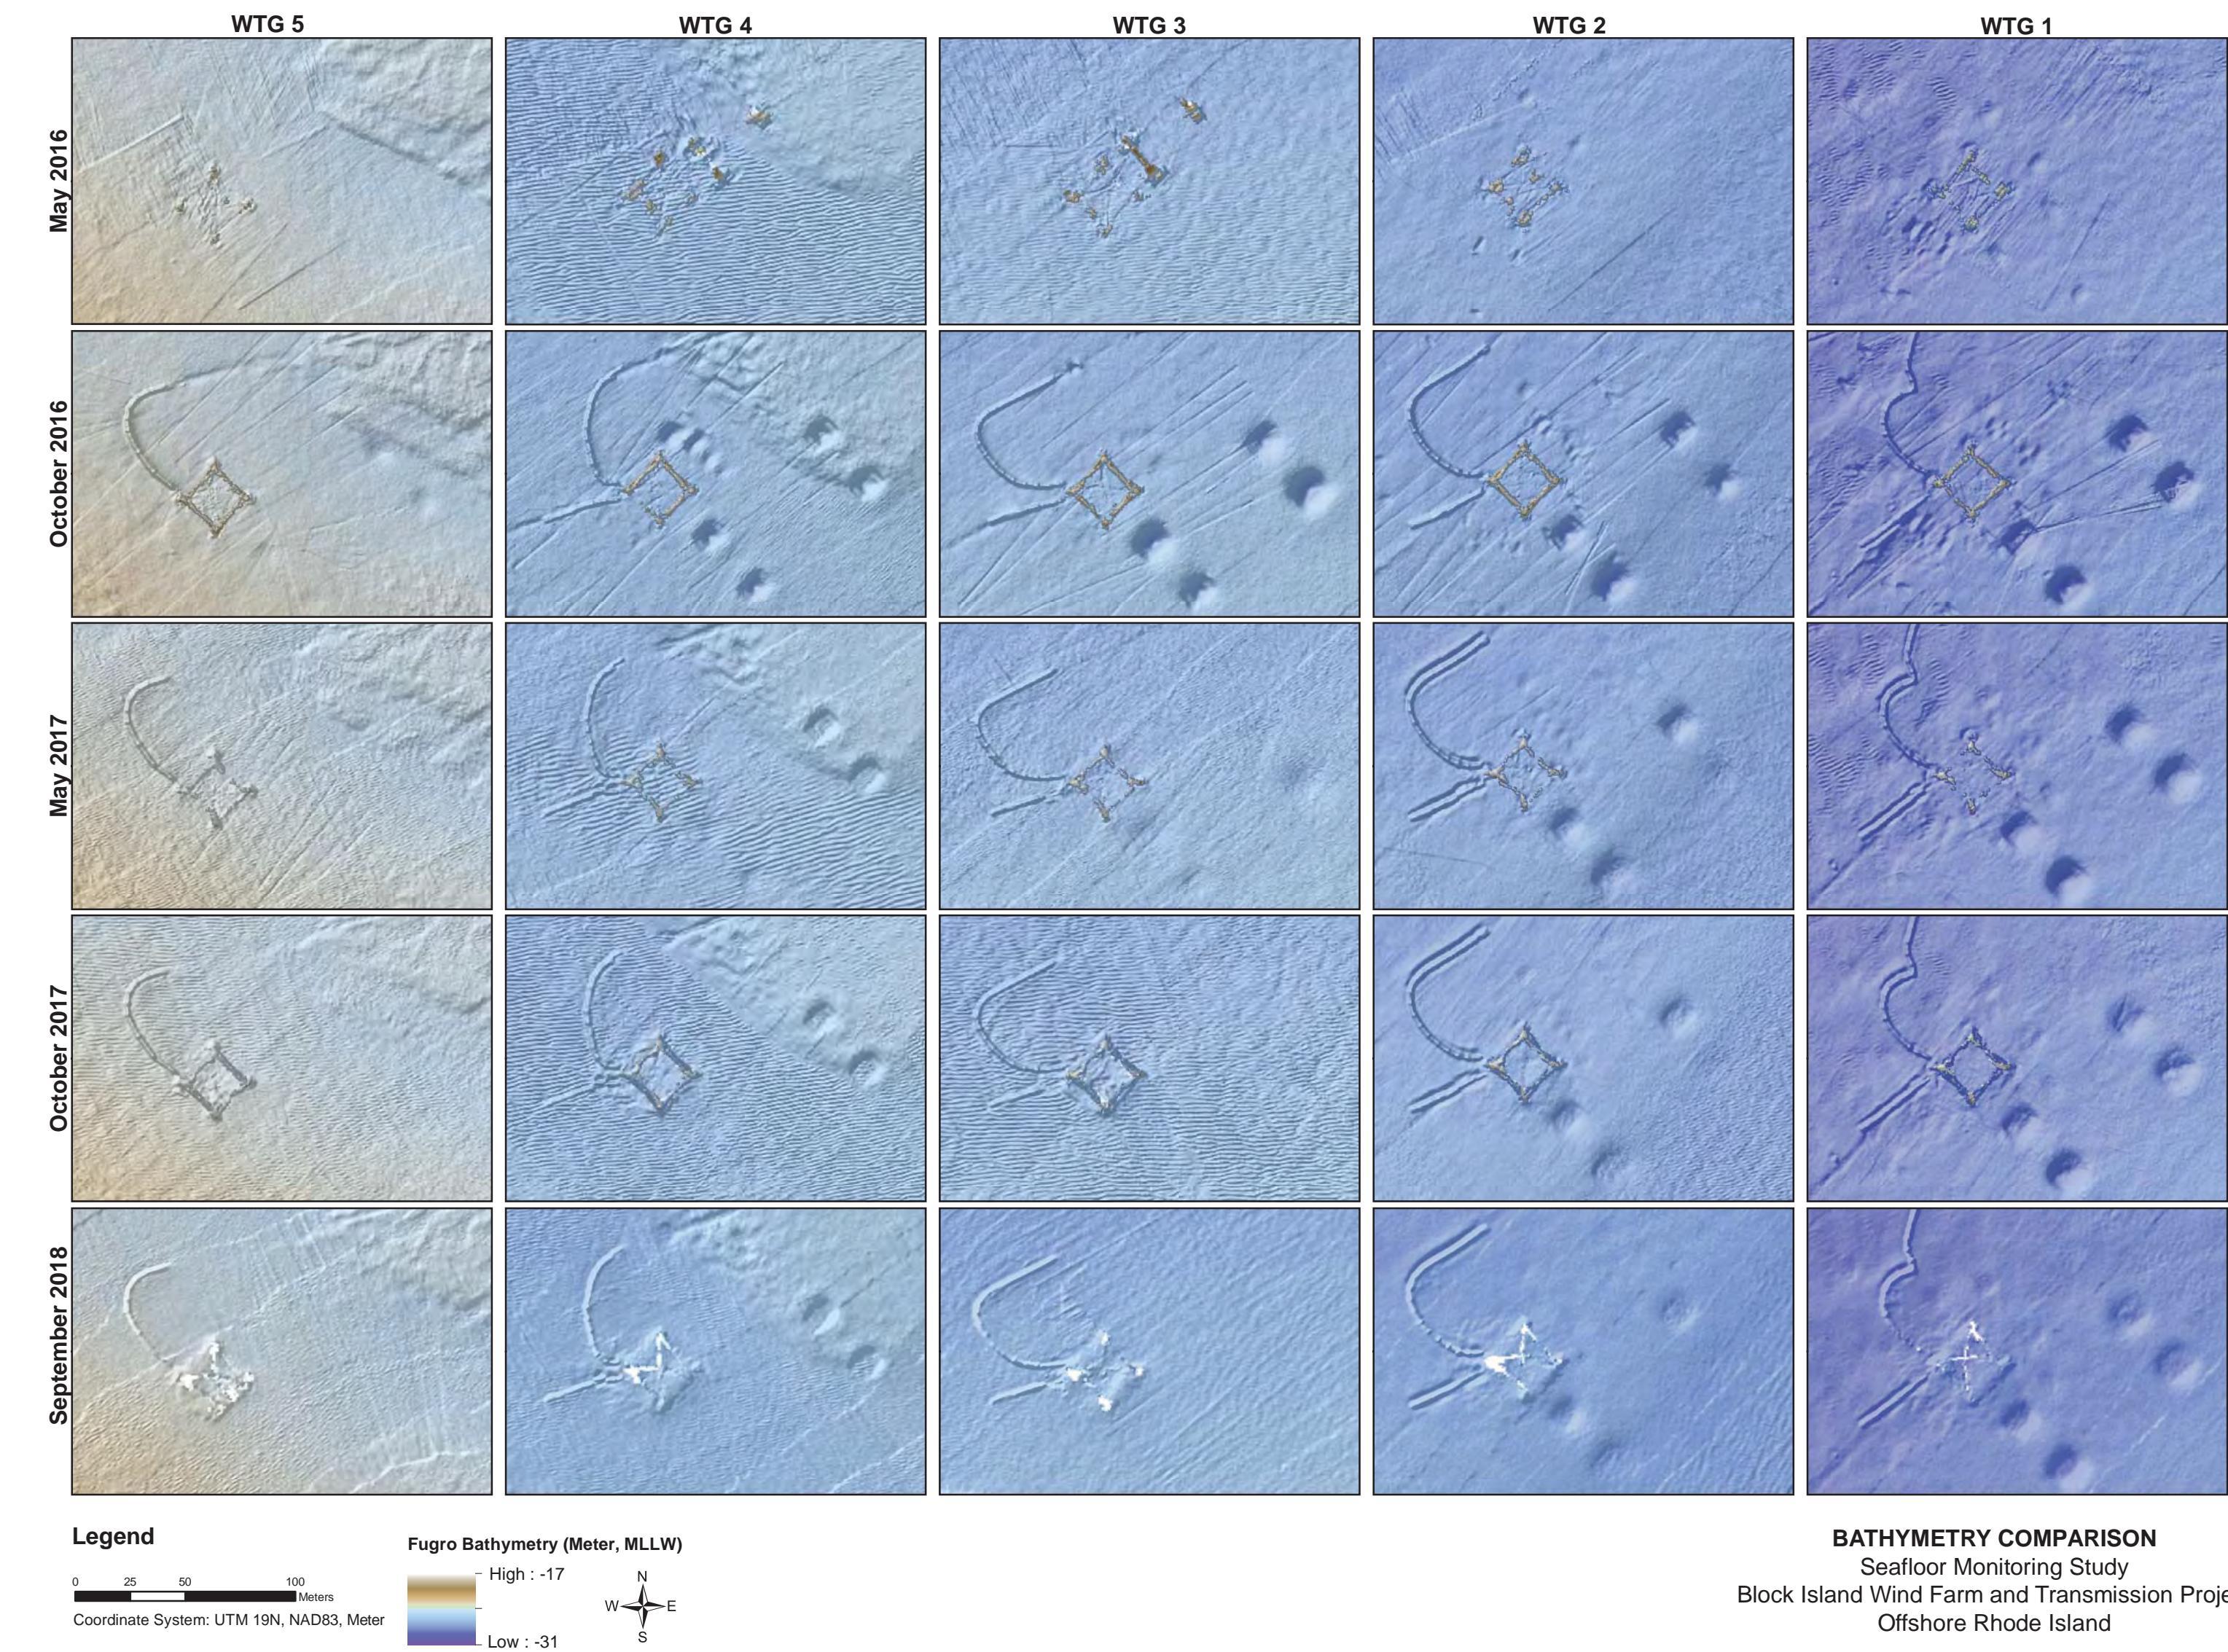
N:Projects/04_2015/04_8115_0001_BOEM_RODEO/BlockIsland_R/I/Outputs/Post_Con_Survey_SMXD/Fig-7c_WTG5_Bathymetry_with_Interp.mxd, 1/11/2019, T.Weathers

Wind Turbine Generator 5 (WTG 5) is located in the southwestern-most section of the study area. The surficial sediment surrounding WTG 5 is predominantly medium to coarse sand. Figures 7a, 7b, 7c, and Chart 2 display the local bathymetry and the interpreted seafloor disturbances that have occurred around WTG 5. Seafloor disturbances that were created during Construction Season 1 and those that were created during Construction Season 2 are differentiated in Figure 7c. All disturbance features extents are outlined from Surveys 1 to 5 (if possible) to aid in discerning if changes in their size or position has occurred (Figure 7c).

<u>Construction Season 2 Features</u>: All four of the seafloor disturbance features (F176-F179) that were identified in the Construction Season 2 baseline survey (Survey 2—Oct. 2016) appear to have completely healed and are not discernable in the September 2018 (Survey 5) survey data (Figures 7b, 7c, and Table C-1).
